**PRELIMINARY INVESTIGATIONS OF LANDSLIDES ZONES IN KANGRA AND CHAMBA  
REGION AS PER NOTIFICATION NO REV (DMC) (F) 11-09/2021- LM DEPARTMENT OF  
REVENUE (DM CELL), GOVT OF HIMACHAL PRADESH.**

***STATE DISASTER MANAGEMENT AUTHORITY***

**PROF. AMBRISH KUMAR MAHAJAN**

**DATE: 26<sup>TH</sup> February 2024**

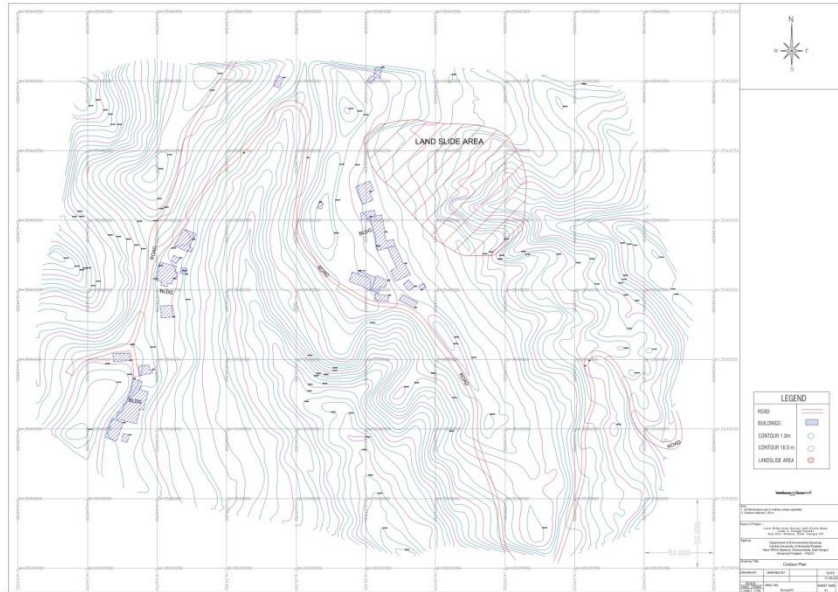
The third zone which is on extreme left of the Parmar Nagar has slid the landmass by 15-18 ft but the scarp has taken a turn before a building located in the region. The contour map develop suing Lidar in this indicate slope and the slide has followed the contours (Fig. 7). There is no serious threat to this

building at present as the contours have taken a turn towards the east from the corner of that house (Fig.8). However, further detailed studies are required to be done to furnish complete reports of the third slide zone, which may require detailed investigation on geotechnical and geophysical ERT and seismic survey of the slide zone. The Lidar survey report is still awaited as it needs three four days for processing which will be submitted on its arrival. Hope the administration may be benefitted by the preliminary investigation and suggestions provided and will help to provide assistance to the local communities.

Fig.8 Shows the contour map landslide portion of slide zone 3 with contours of the Parmar Nagar

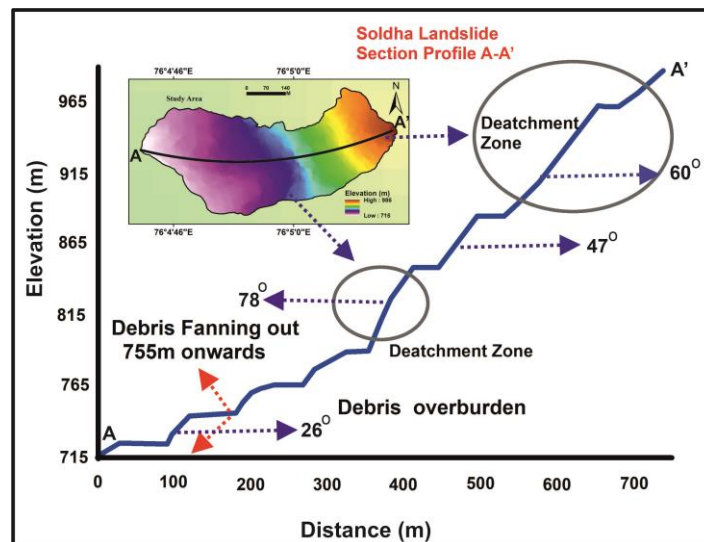
The slide is very steep at the crown part and has moderate slopes in the lower part, with elevation variations from 715 m at the toe to 977 m at the crown region within a distance of 0.78 km. The slope gradient along section A' (inset) indicates steeper slopes with break-in slopes at different parts of the slide zones. Fig. 18 shows the general trend of the hill at various parts of the slide zone. The detachment zones at the crown and first scarp and the areas with debris material at different parts of the slide zone are shown along the elevation profile.

Fig. 18 Cross section of the slide zone depicting elevation variation along the A-A' section
