**PRELIMINARY REPORT ON THE ASSESSMENT OF
LANDSLIDE SITES IN SHIMLA DISTRICT,
HIMACHAL PRADESH**

**Submitted
to
STATE DISASTER MANAGEMENT AUTHORITY
GOVERNMENT OF HIMACHAL PRADESH, SHIMLA**

February-2024

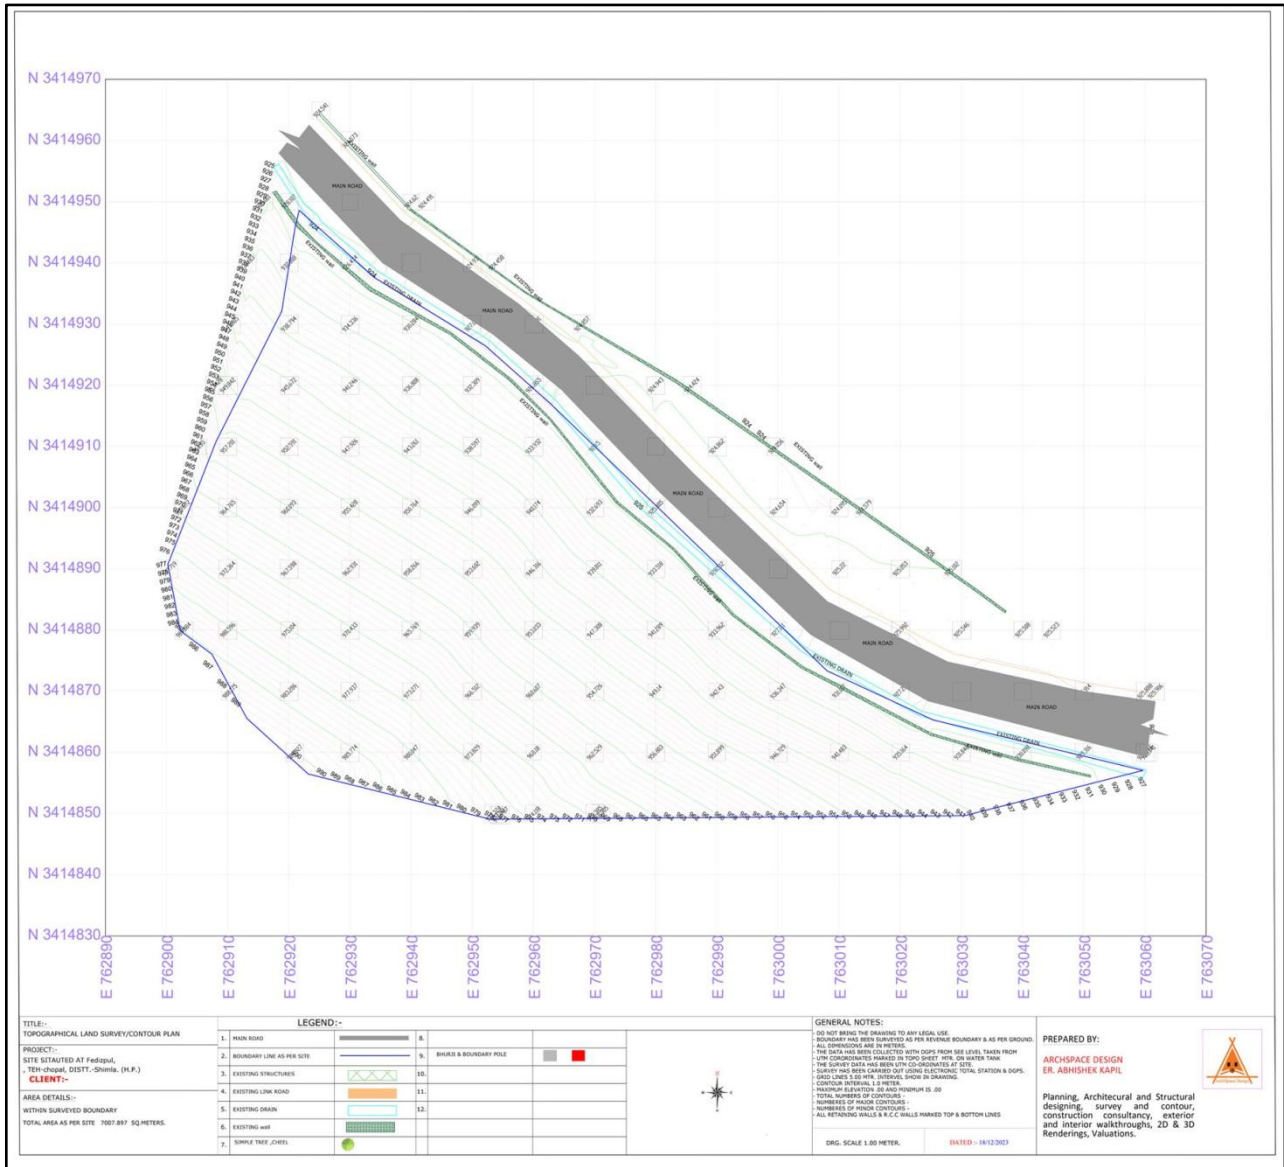
Fig. 9 presents the contour map of the NH- 707B near Fedzipul landslide prepared at an interval of 1 m. It describes a complex terrain with steep slopes, especially near the crown where the angles are close to vertical, transitioning to a consistent incline of 45° along the main body of the slide. The contours' delineation indicates a steep gradient and a high degree of slope instability. **Fig. 10** and **Fig. 11** portray the panoramic view and the field photograph of the site respectively. **Fig. 11** illustrates the toe cutting by the Shalvi Khad and loose material. **Fig. 12** displays the disintegrated rock mass, with boulders of various sizes, alongside a 145-meter-long RCC protection wall that has been erected as a mitigation

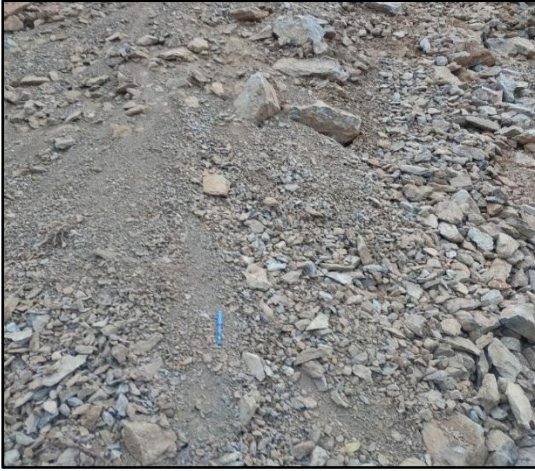
measure by the National Highway authorities. **Fig. 13** and **Fig. 14** depict the extent of debris runout and the distribution of loose slide material from the identified landslide, providing valuable insights into the dynamics and characteristics of the event.

Fig. 13. Debris runout

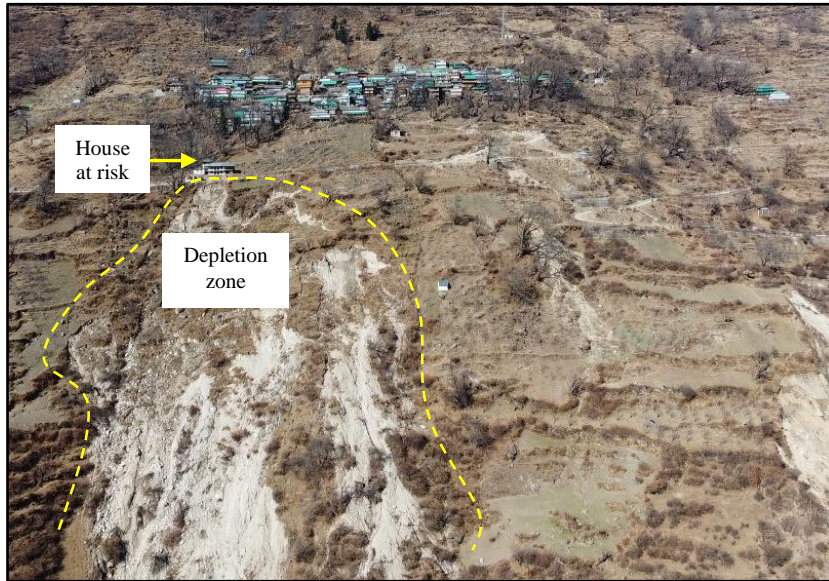
Fig. 17 Depletion Zone below the Tangnu Road

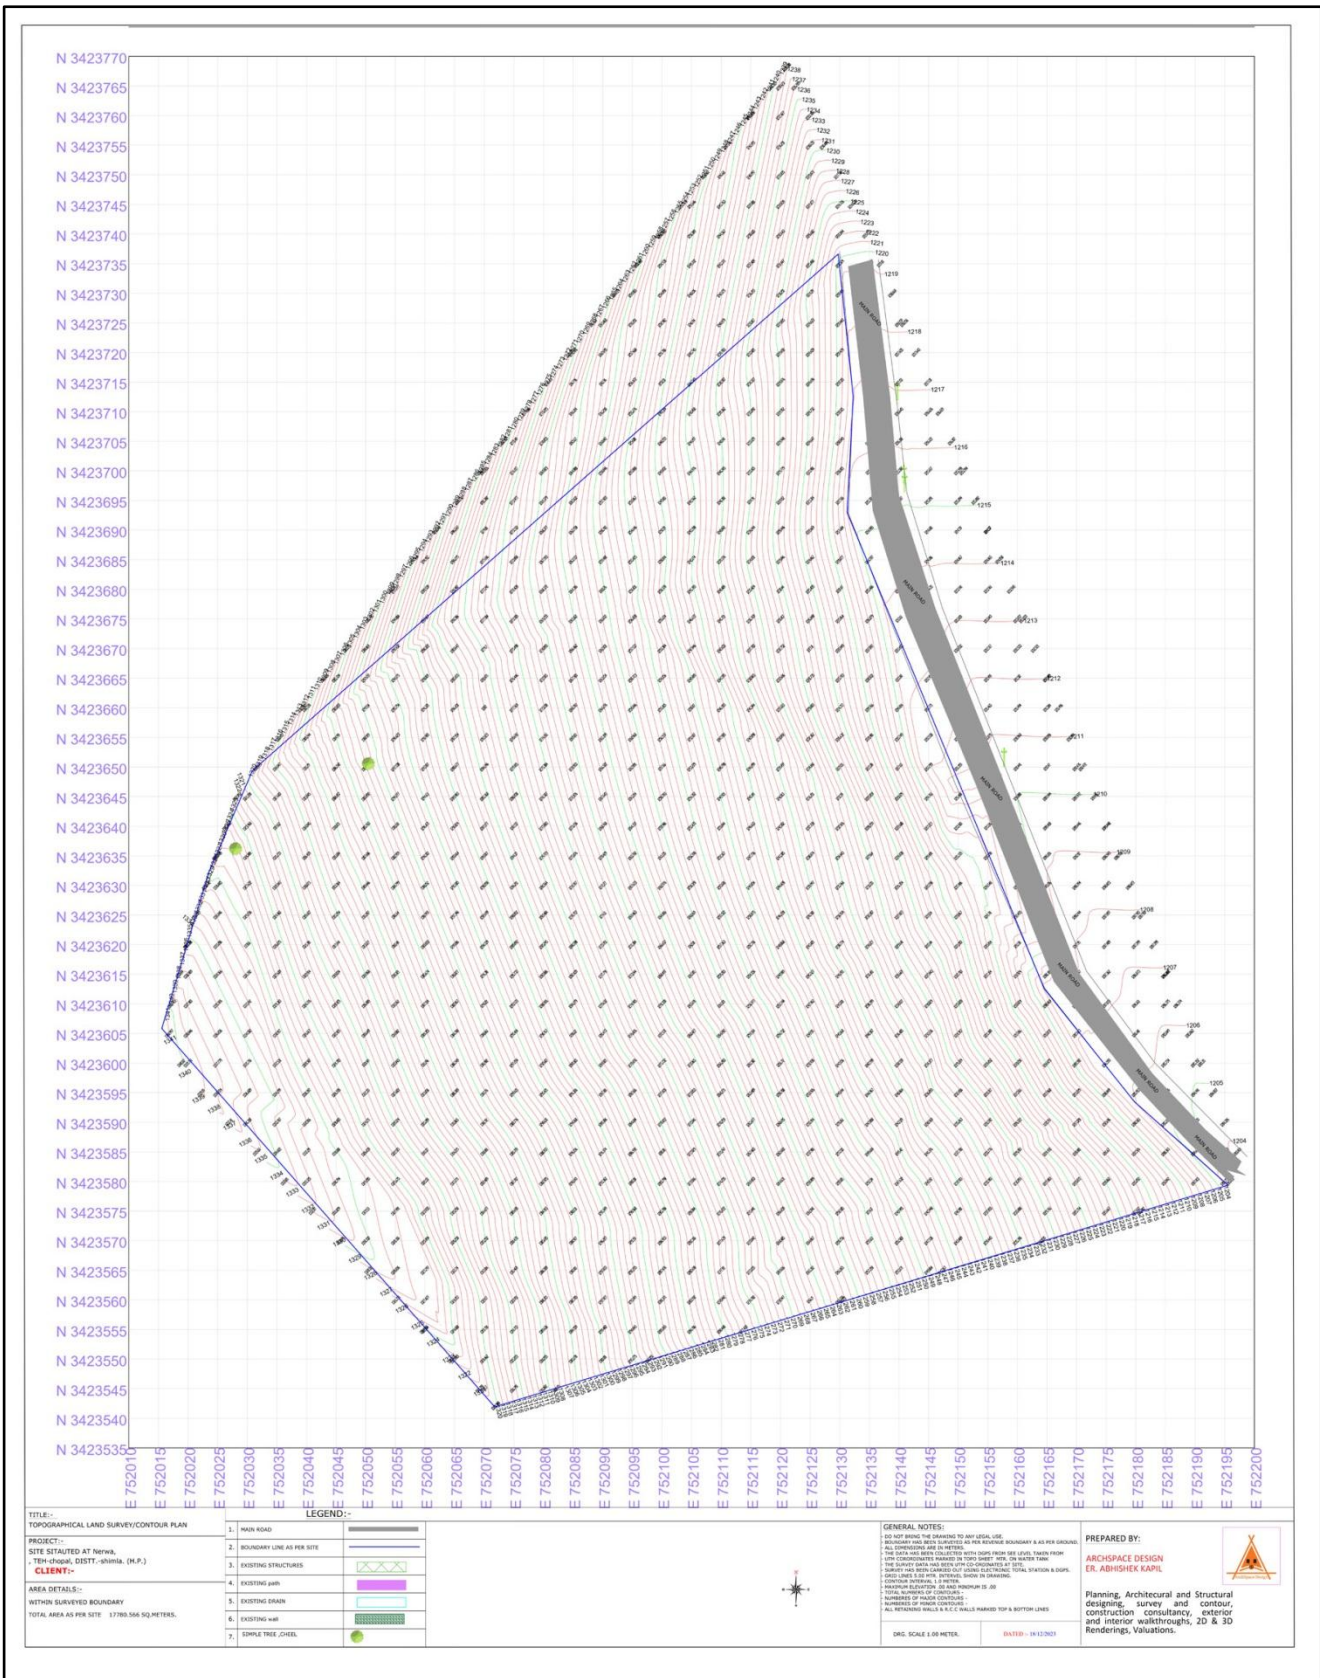
Fig. 22 presents the contour map of the PWD rest house, Nerwa landslide. The contour map of the landslide site, with 1-meter interval contours, demonstrates a steep topographic profile, indicating a high susceptibility to slope failure. **Fig. 23** and **Fig. 24** illustrate the panoramic and the field photograph of the site respectively. **Fig. 24** depicts the debris runout material and the exposed, vulnerable mass seeking protection, as well as the restored road linking Nerwa with Chopal. **Fig. 25** shows the transport depot, Nerwa and other structures that could be impacted if the landslide is not mitigated in the future.

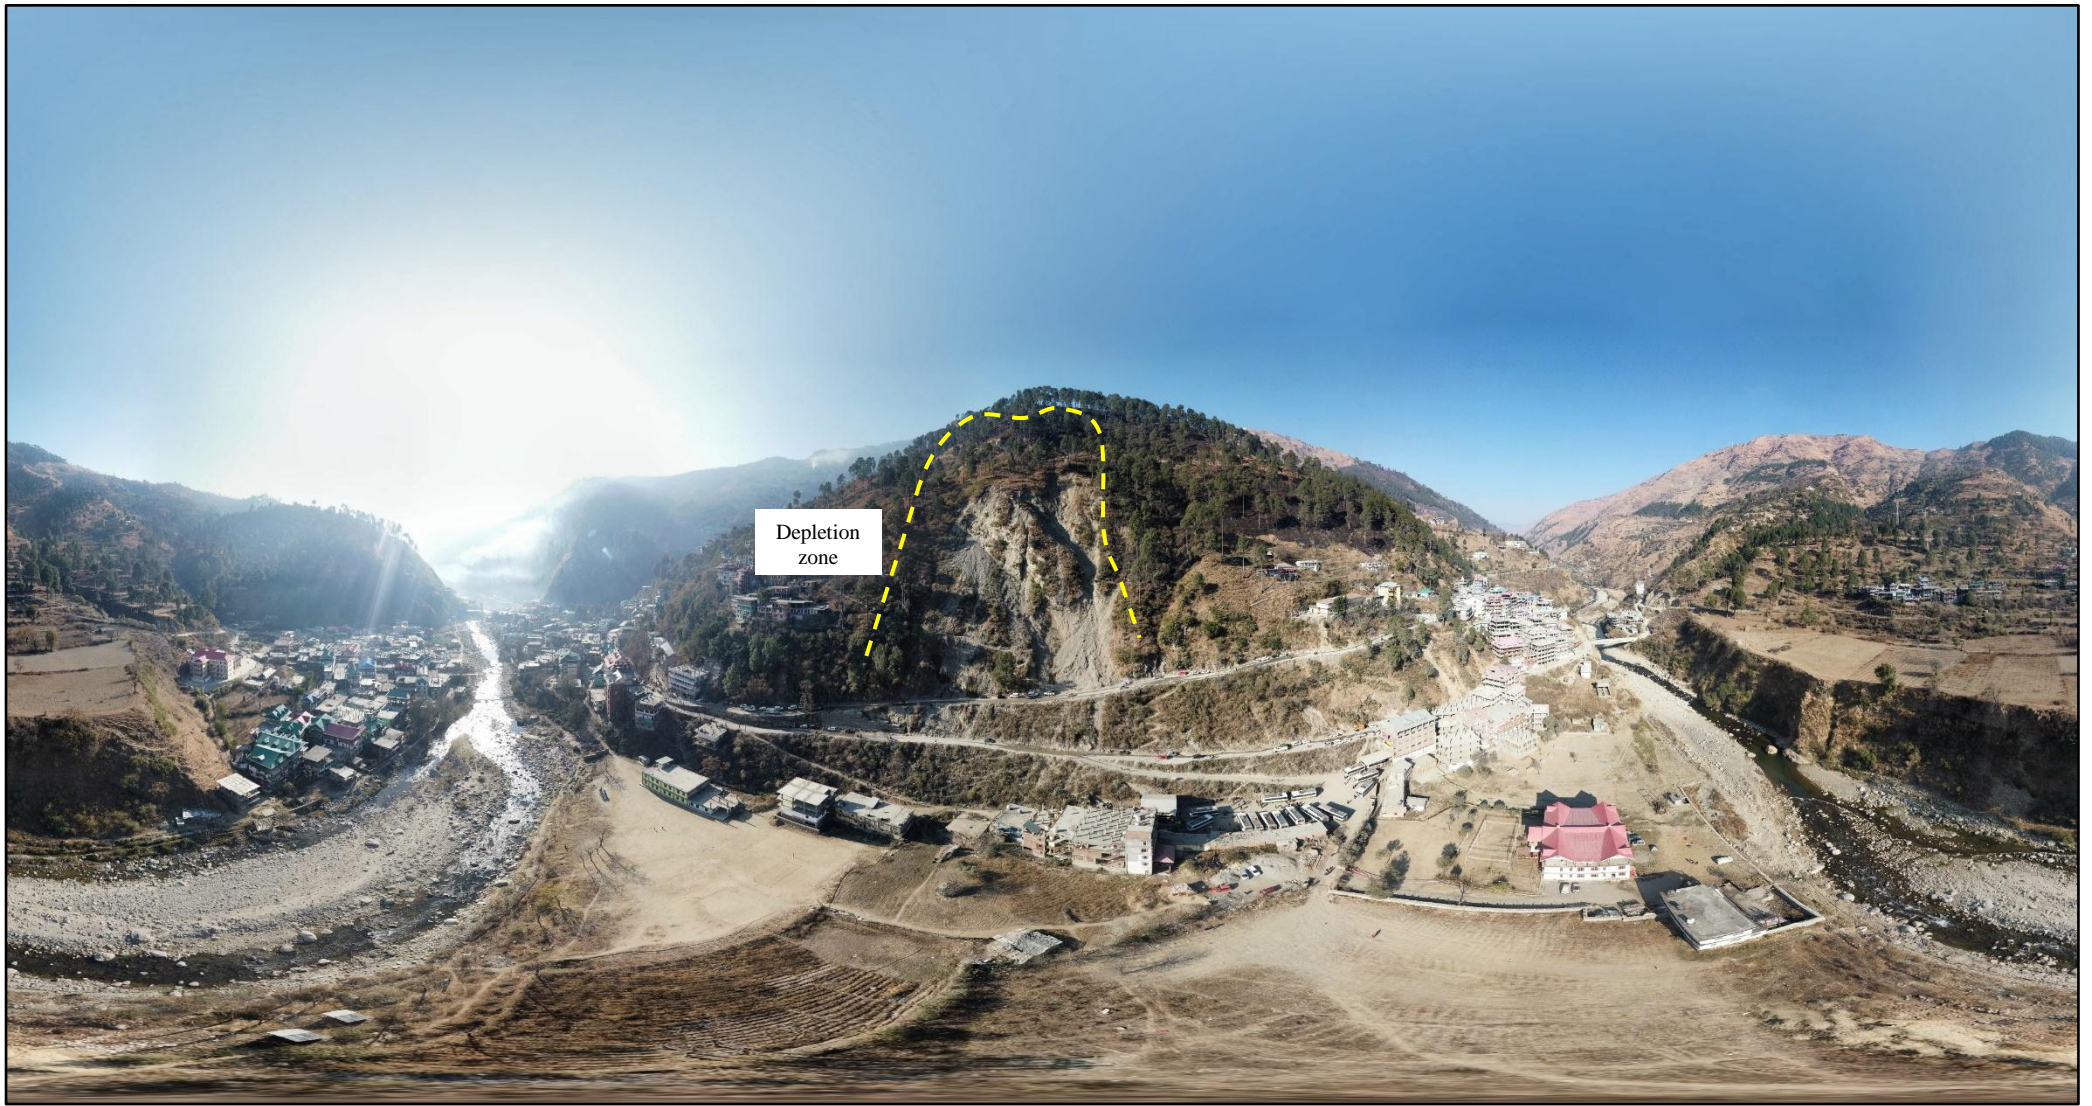
Fig. 23 A panoramic view of PWD rest house, Nerwa landslide site, Shimla district

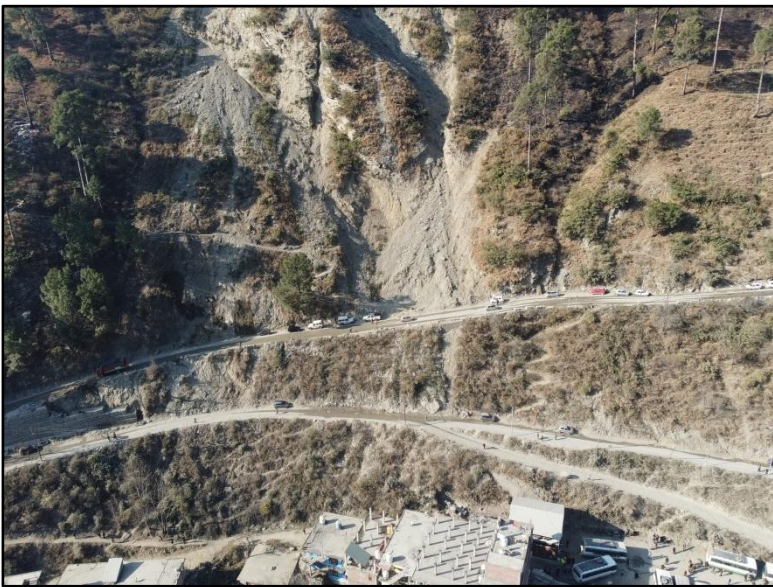
Fig. 25. Structures likely to be affected by Landslide

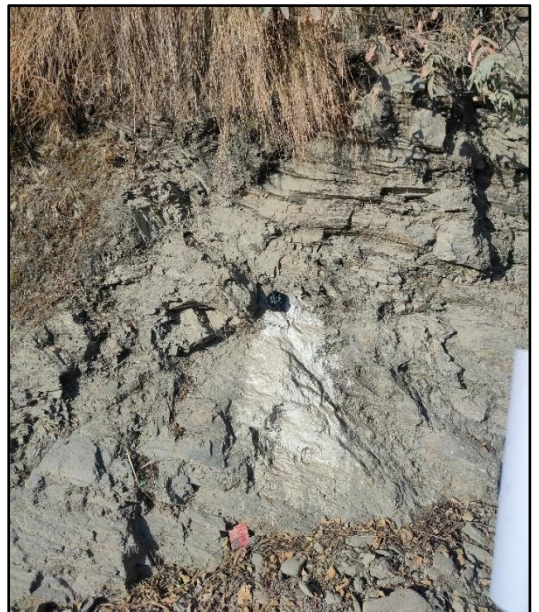
From a geological perspective, the site is situated within the Lesser Himalayas and is part of the Jutogh Group. This region is characterized by metamorphic rocks such as schist, phyllites, slates and quartzite. Specifically, the landslide area is dominated by phyllite, which is highly deformed, jointed and faulted, adding to the site's vulnerability. The phyllite rock mass near the HPPWD guest house displays three sets of discontinuity planes (J0, J1, and J2) and is subject to folding, faulting and shearing (**Fig.26**). The slope faces 070⁰ N with varying angles of 44°, 30°, and 70°, further contributing to the complexity and instability of the geological structure. These technical aspects of the site's geology play a crucial role in understanding and addressing the landslide risks.

Fig. 26. Discontinuity planes and geological features of Phyllite rock mass

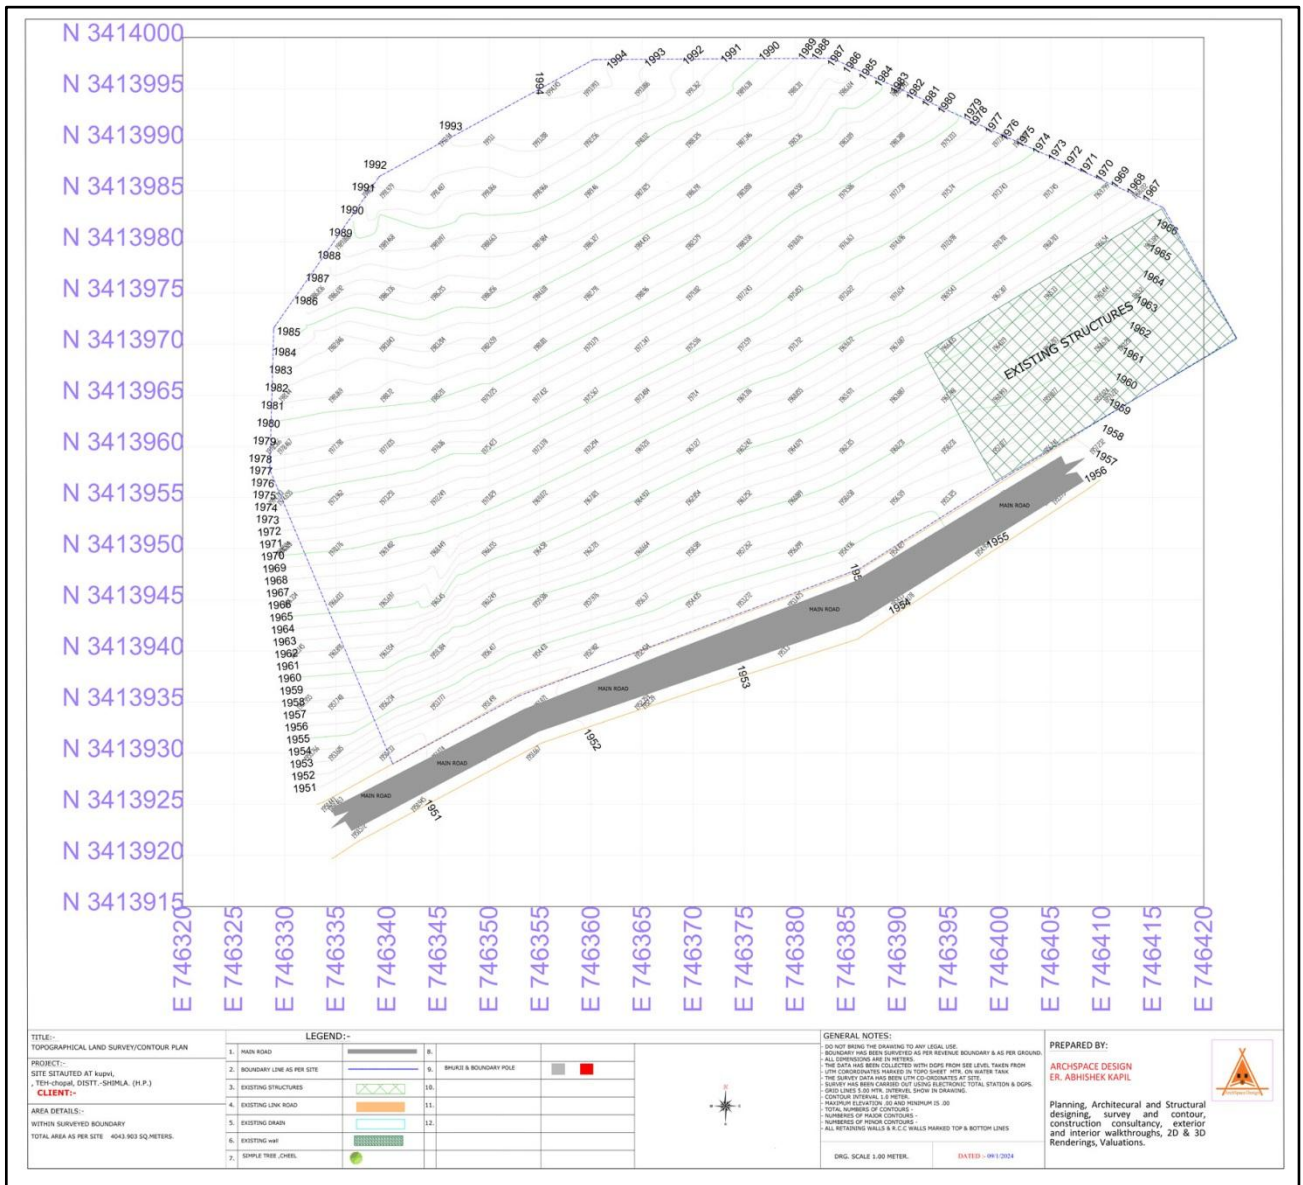
Fig. 27 portrays the contour map of the near police station Kupvi, landslide. The contour map of the landslide site, featuring 1-meter interval contours, reveals a moderate topographic profile, indicating a moderate susceptibility to slope failure. **Fig. 28 and 29** depict the panoramic view and a field photograph of the site, respectively. **Fig. 29** also highlights the structures and agricultural land affected by the landslide above the road, as well as those likely to be affected by its reactivation below the road in the future. Geologically, the area forms a part of the Lesser Himalayas, characterized by rocks such as phyllites, carbonaceous phyllites, and schists belonging to the Jutogh Group. The schist rock exposed near the site is notably fractured and deformed (**Fig. 30**), with three sets of joint planes (J_0 , J_1 , and J_2) weakening the slope. The site's current dry groundwater conditions and the visible tension cracks near the crown suggest a potential for reactivation under heavy and prolonged rainfall. This geological setting indicates a partially stable slope, evidenced by some weed growth, but remains vulnerable to future rainfall events.

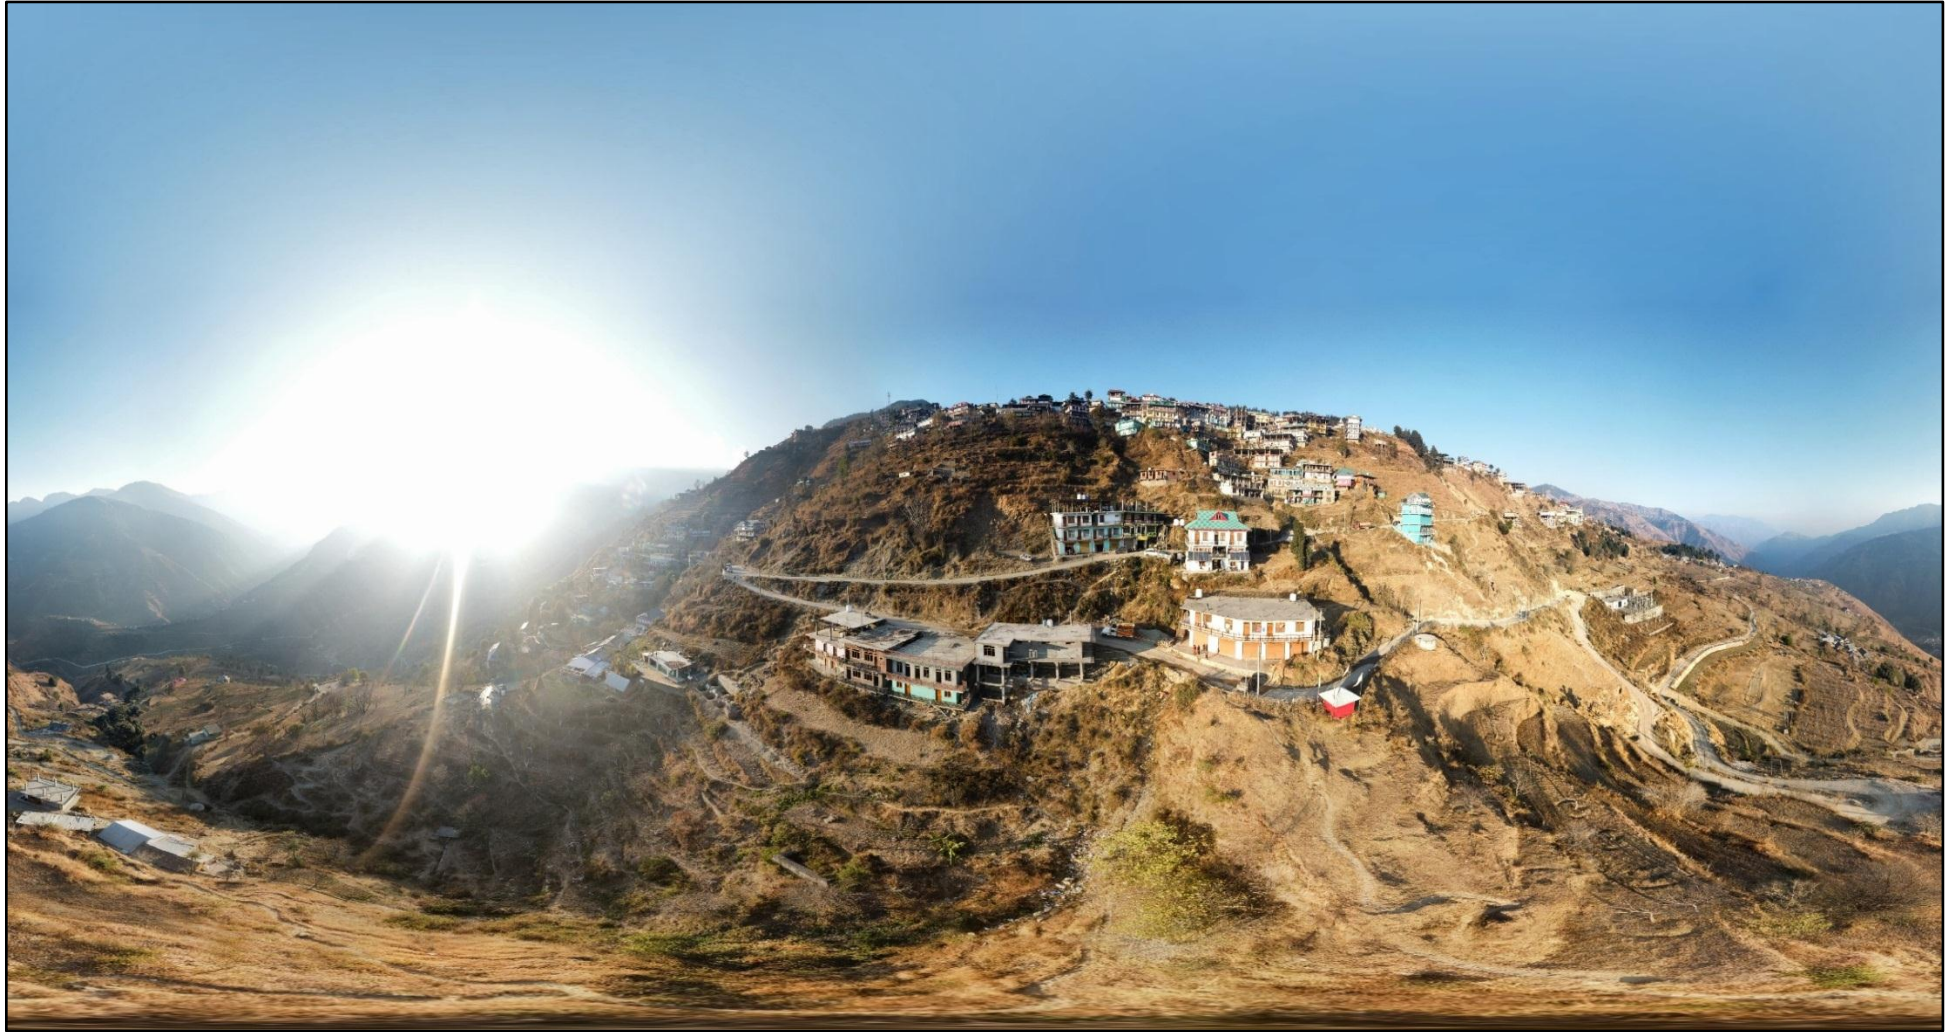
Fig. 28. A panoramic view of Near Police Station, Kupvi landslide site, Shimla district

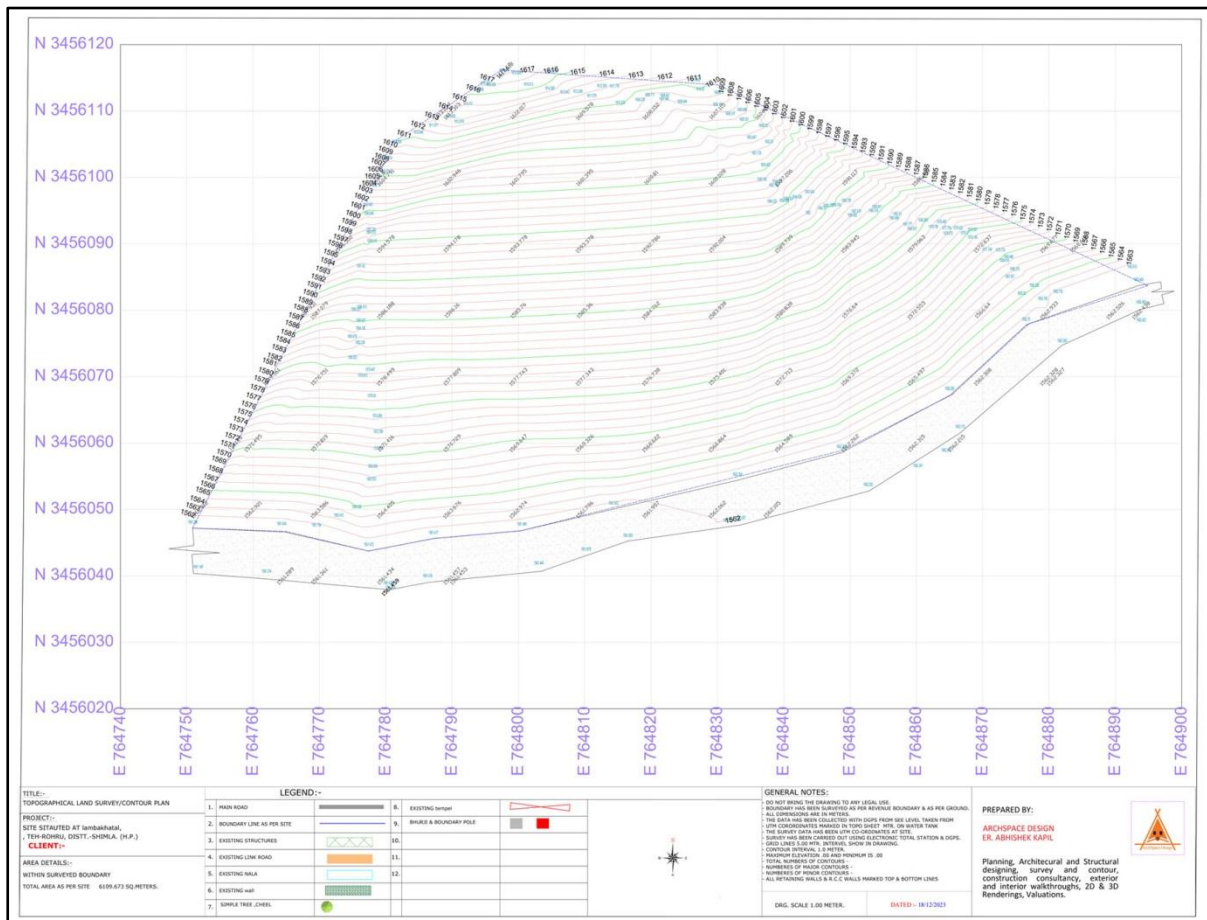
Fig. 31 portrays the contour map of Lambakhatal landslide. The contour map of the landslide site, with 1-meter interval contours, shows a steep topographic profile, indicating a high susceptibility to slope failure. **Fig. 32** and **Fig. 33** depict the panoramic view and a field photograph of the site, respectively. The field investigation reveals the structures and

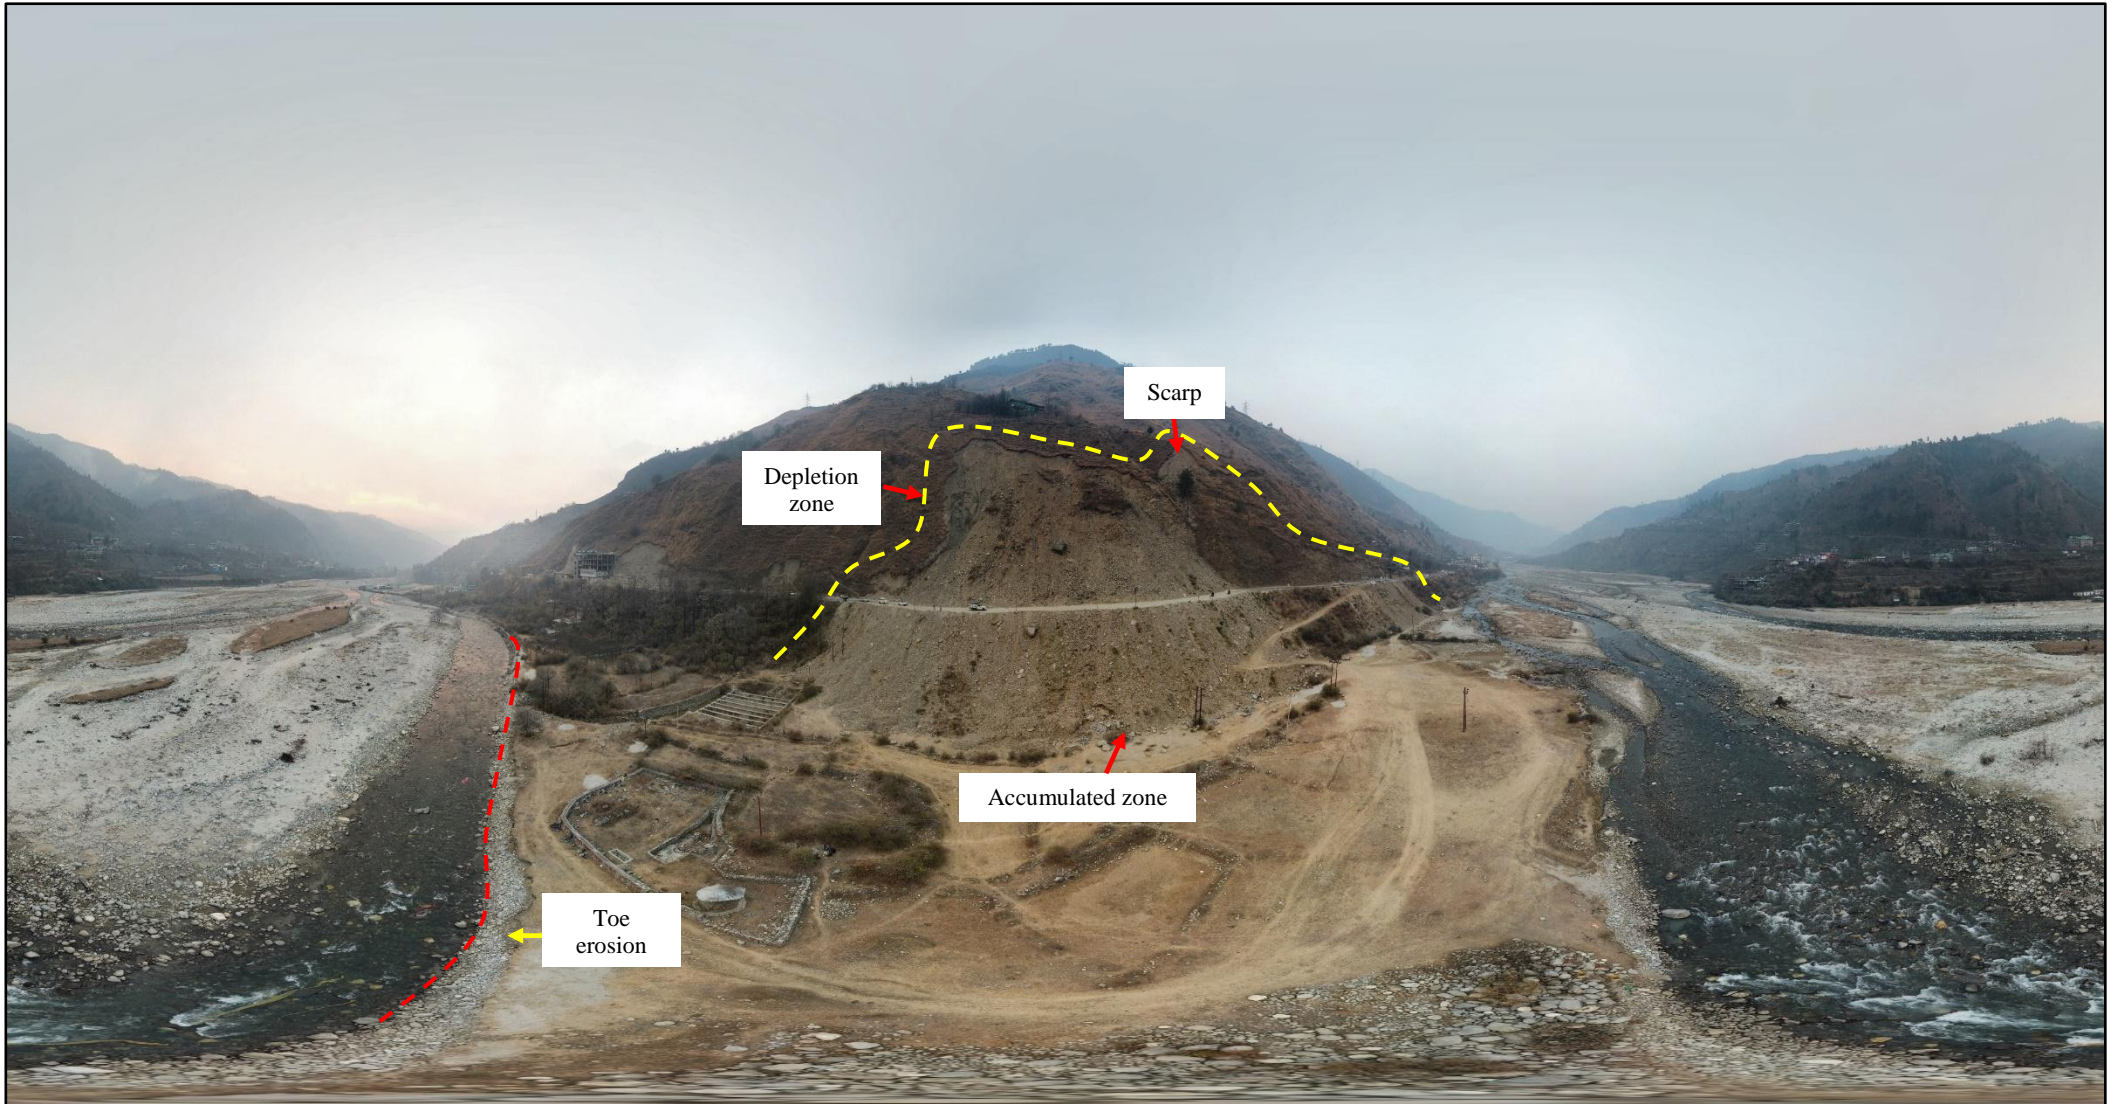
Fig. 32. A panoramic view of Lambakhatal, Rohru landslide site, Shimla district

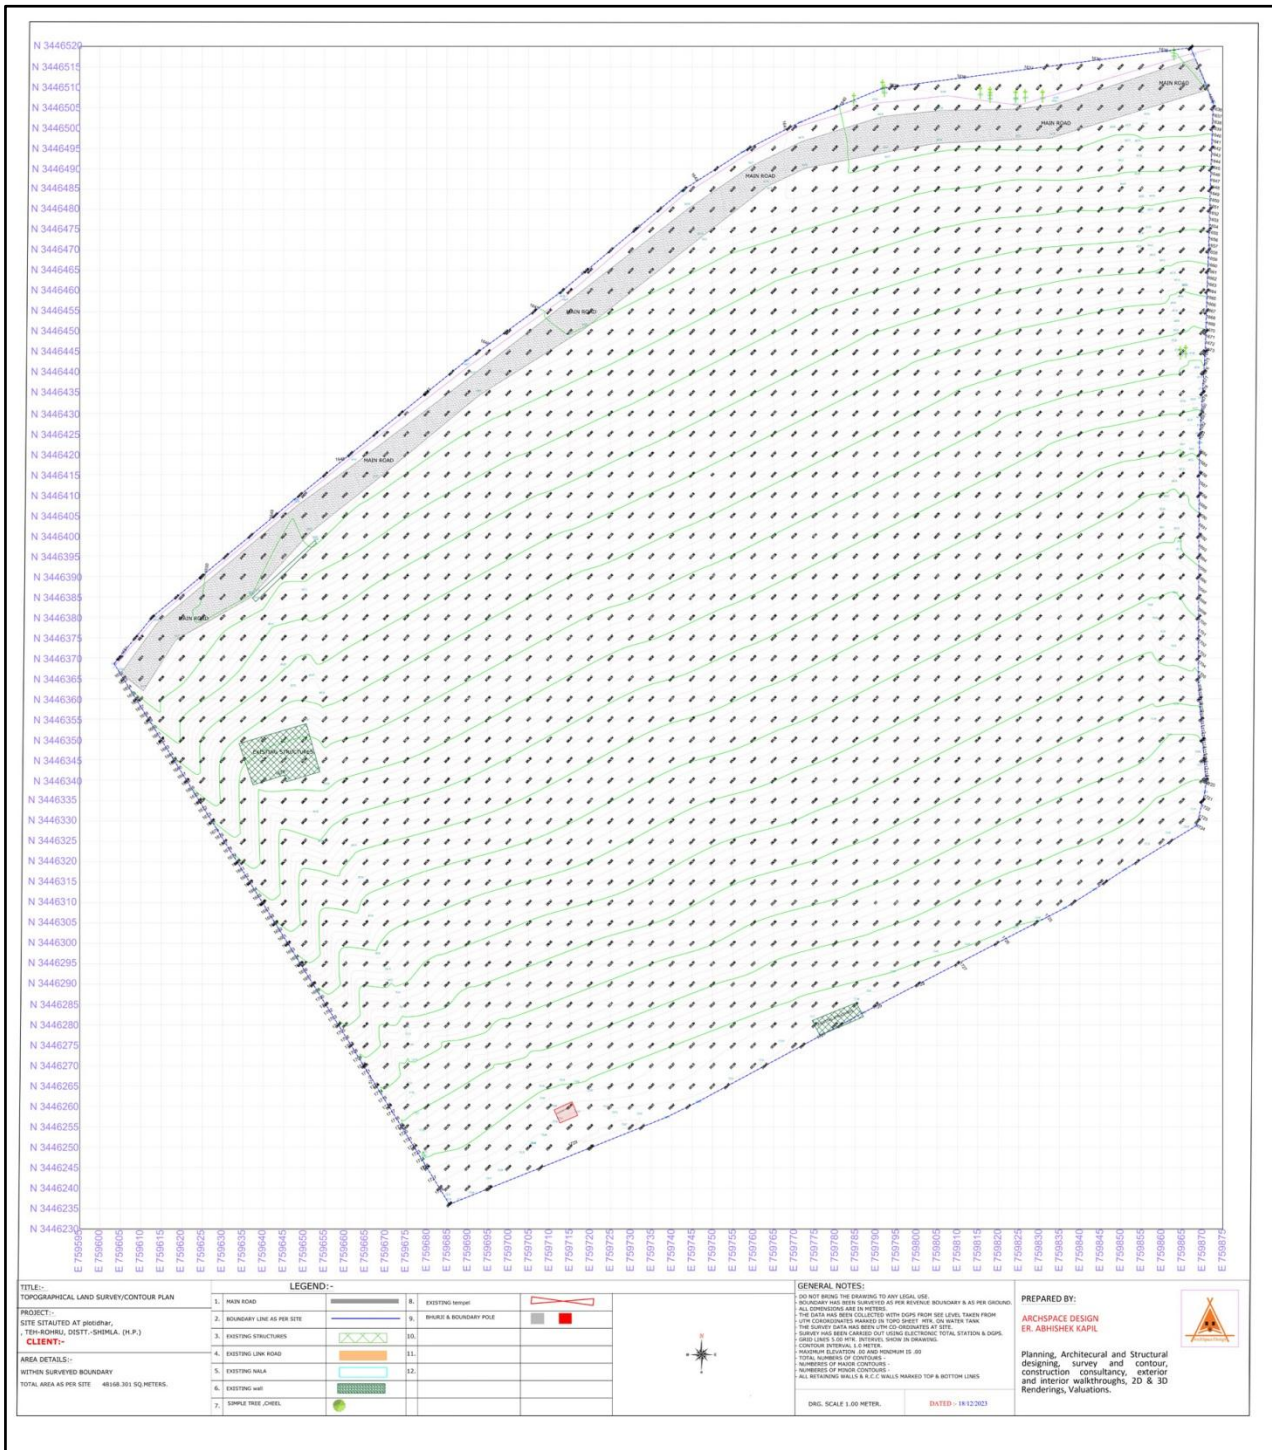
Fig. 34 shows the contour map of the Plouthidhar landslide, with 1-meter interval contours, indicating a moderate to steep susceptibility to slope failure, which is adequate to the village's land subsidence issue. **Fig. 35** and **Fig. 36** depict the panoramic view and a field photograph of the site, respectively. The field investigation highlights the buildings and horticultural land affected by the landslide subsidence. The issue is expected to worsen during future monsoons if left unaddressed. It was observed during the field visit and discussion with locals that poor drainage, characterized by damp to wet conditions **(Fig. 38)**, coupled with heavy rainfall, is contributing to the land subsidence and slope instability in the village.

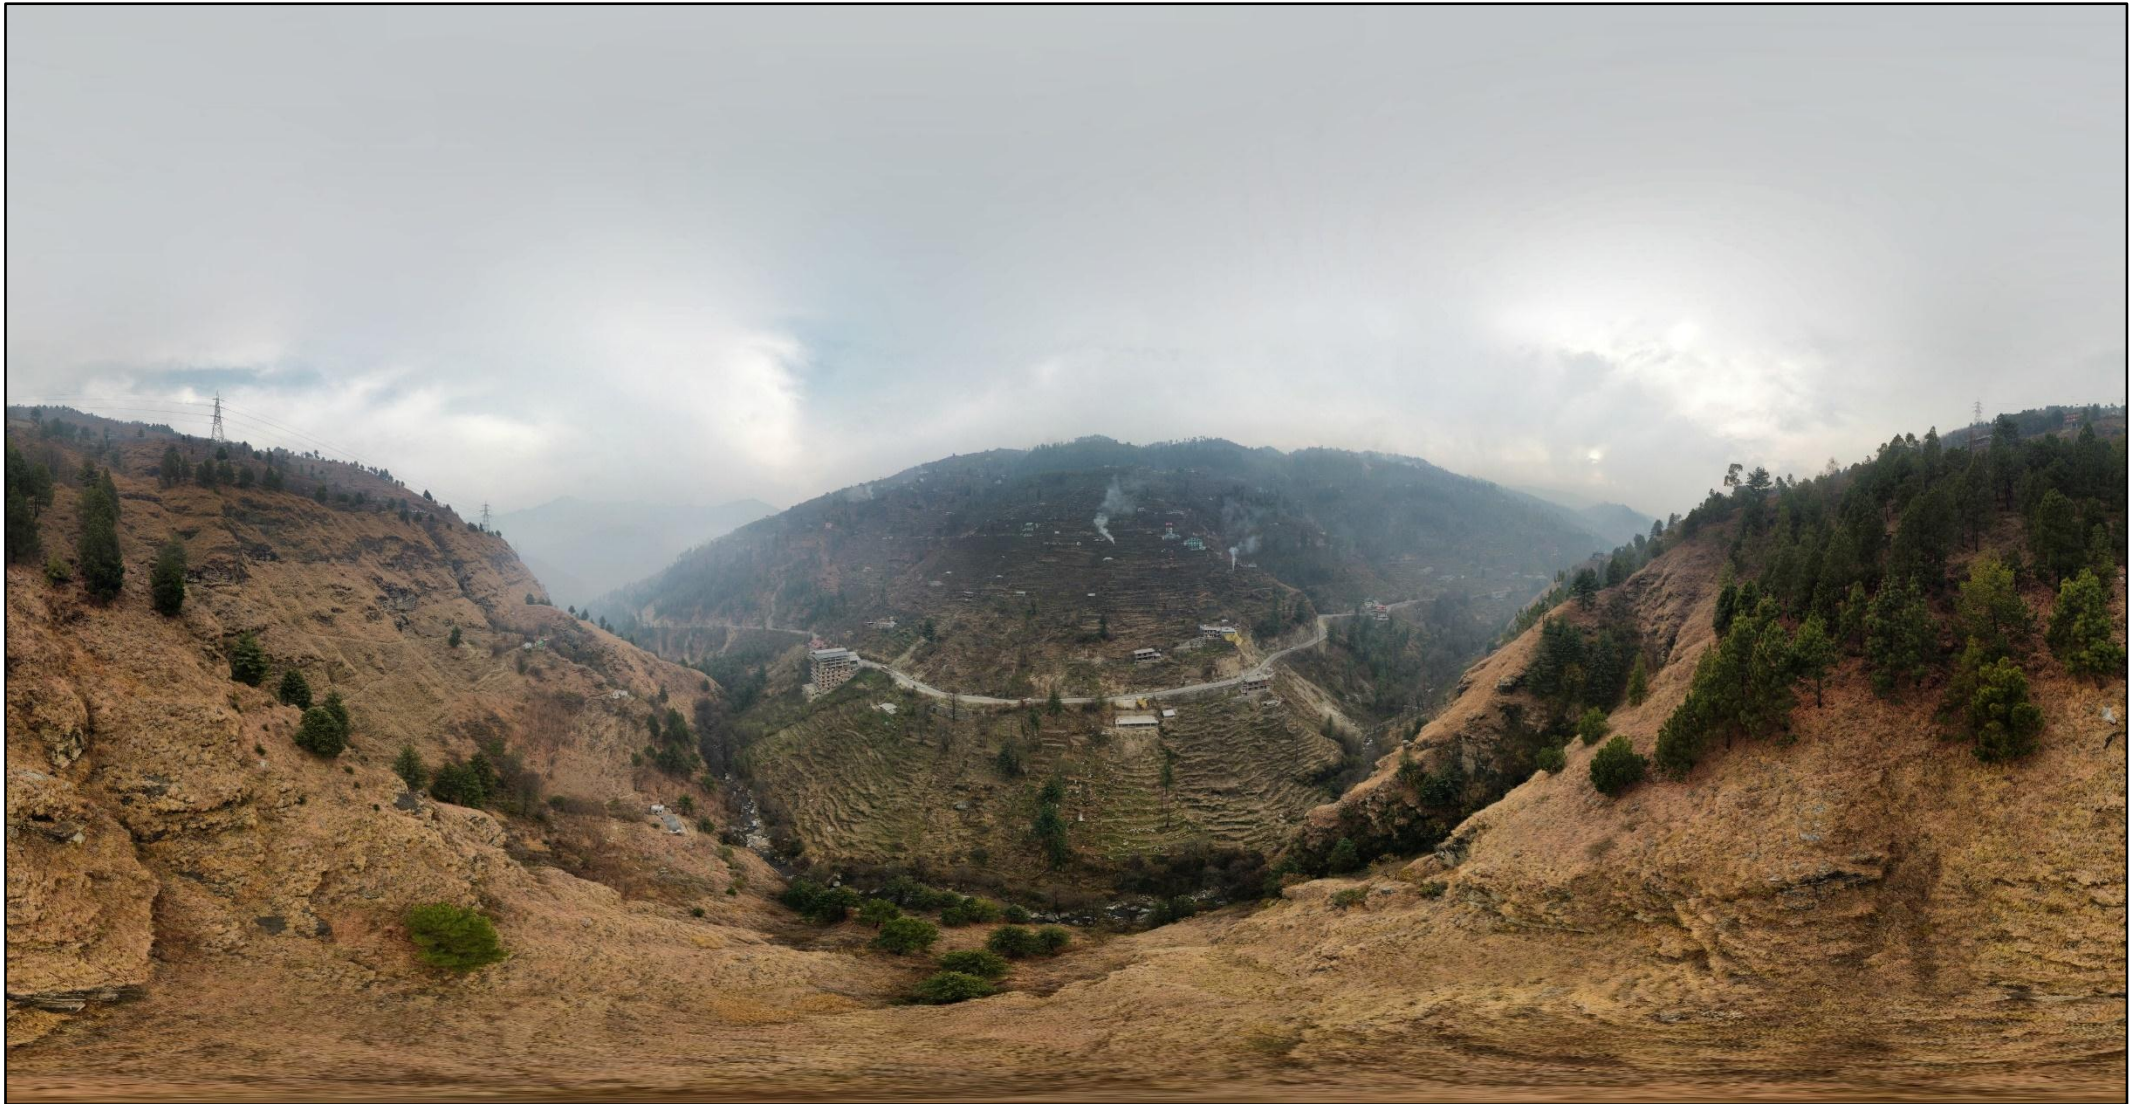
Fig. 35. A panoramic view of Ploutidhar, Jubbal landslide site, Shimla district

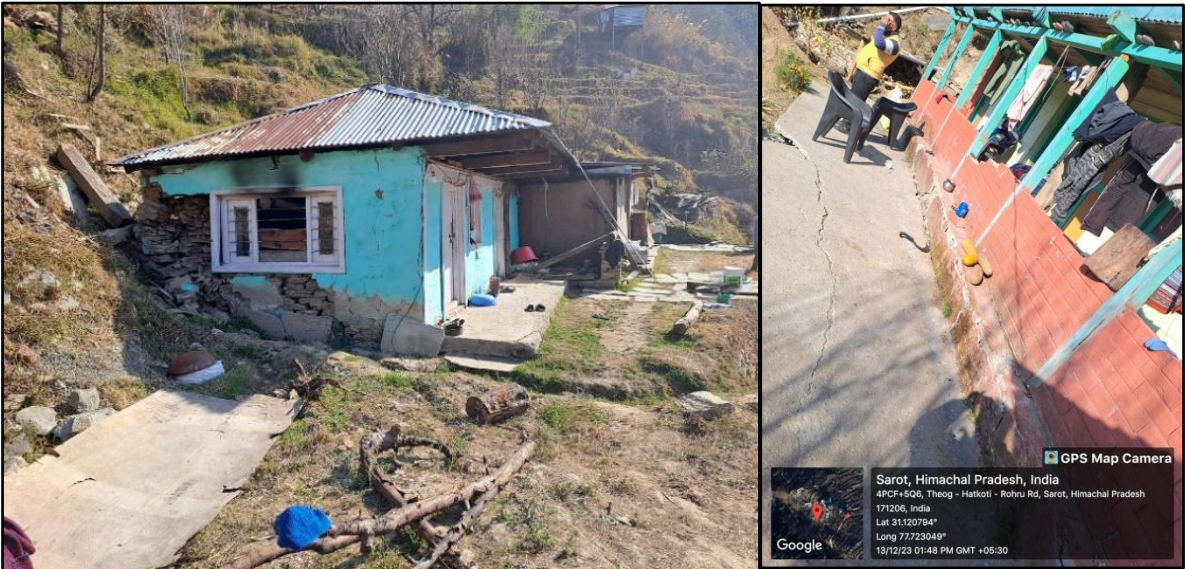
(Fig.37). Approximately 50 Bigha land, hosting apple orchards with 1500 trees (including Apple, Apricot, and Devdar varieties), is at risk of subsiding **(Fig.39)**. Compensation has already been disbursed, with Rs 1.3 Lakhs provided to each of the 18 families for complete damage and Rs 1 Lakh to partially affected families. Beyond the economic ramifications, the village grapples with psychological challenges arising from the potential collapse and gradual subsidence of residences.

Fig. 37. Houses Affected by Land Subsidence in Plotidhar

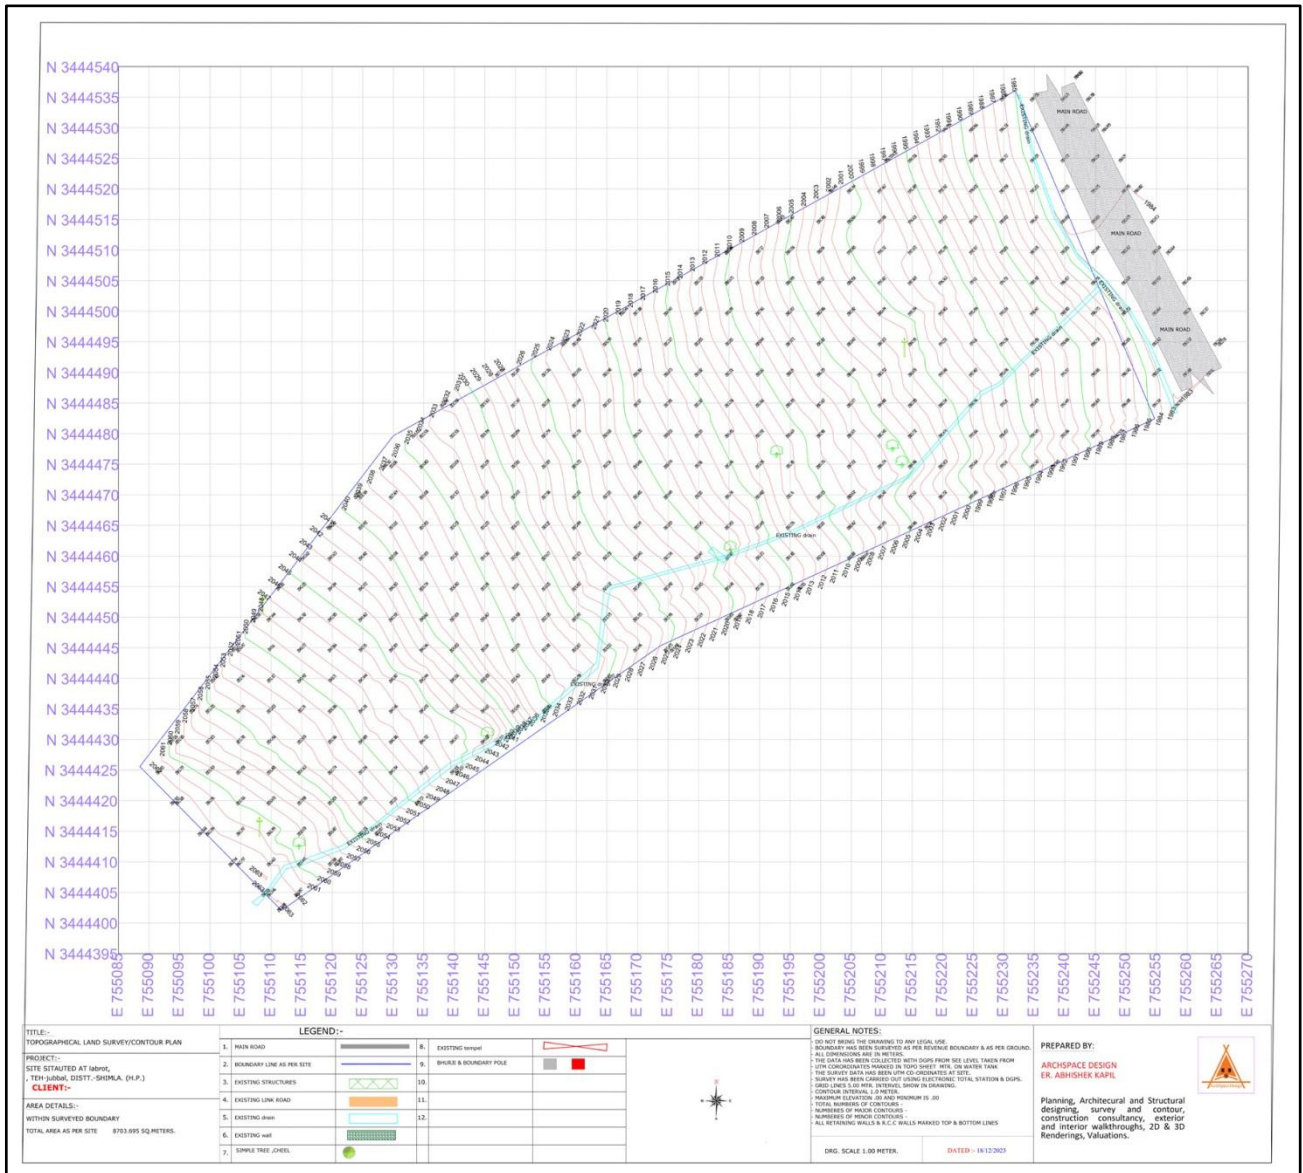
Fig. 40 shows the contour map of Labrot, a village experiencing land subsidence, with 1-meter interval contours indicating a moderate to steep susceptibility to slope failure, which is critical to the village's land subsidence issue. **Fig. 41** and **Fig. 42** depict the panoramic view and a field photograph of the site, respectively. A small land subsidence/landslip incident has also occurred on the Labrot village link road connecting to the NH-705. A protection wall has now been erected to support upslope structures and mitigate the impact of landslides (**Fig. 44**). The field investigation highlights the buildings (**Fig. 43**) and horticultural land affected by the landslide subsidence. If left unaddressed, the issue is expected to worsen during future monsoons. Poor drainage, characterized by damp to wet conditions, coupled with heavy rainfall, is contributing to the land subsidence and slope instability in Labrot village, as observed during the field visit and discussions with locals.
