**PRELIMINARY REPORT ON THE ASSESSMENT OF
LANDSLIDE SITES IN SHIMLA DISTRICT,
HIMACHAL PRADESH**

**Submitted
to
STATE DISASTER MANAGEMENT AUTHORITY
GOVERNMENT OF HIMACHAL PRADESH, SHIMLA**

February-2024

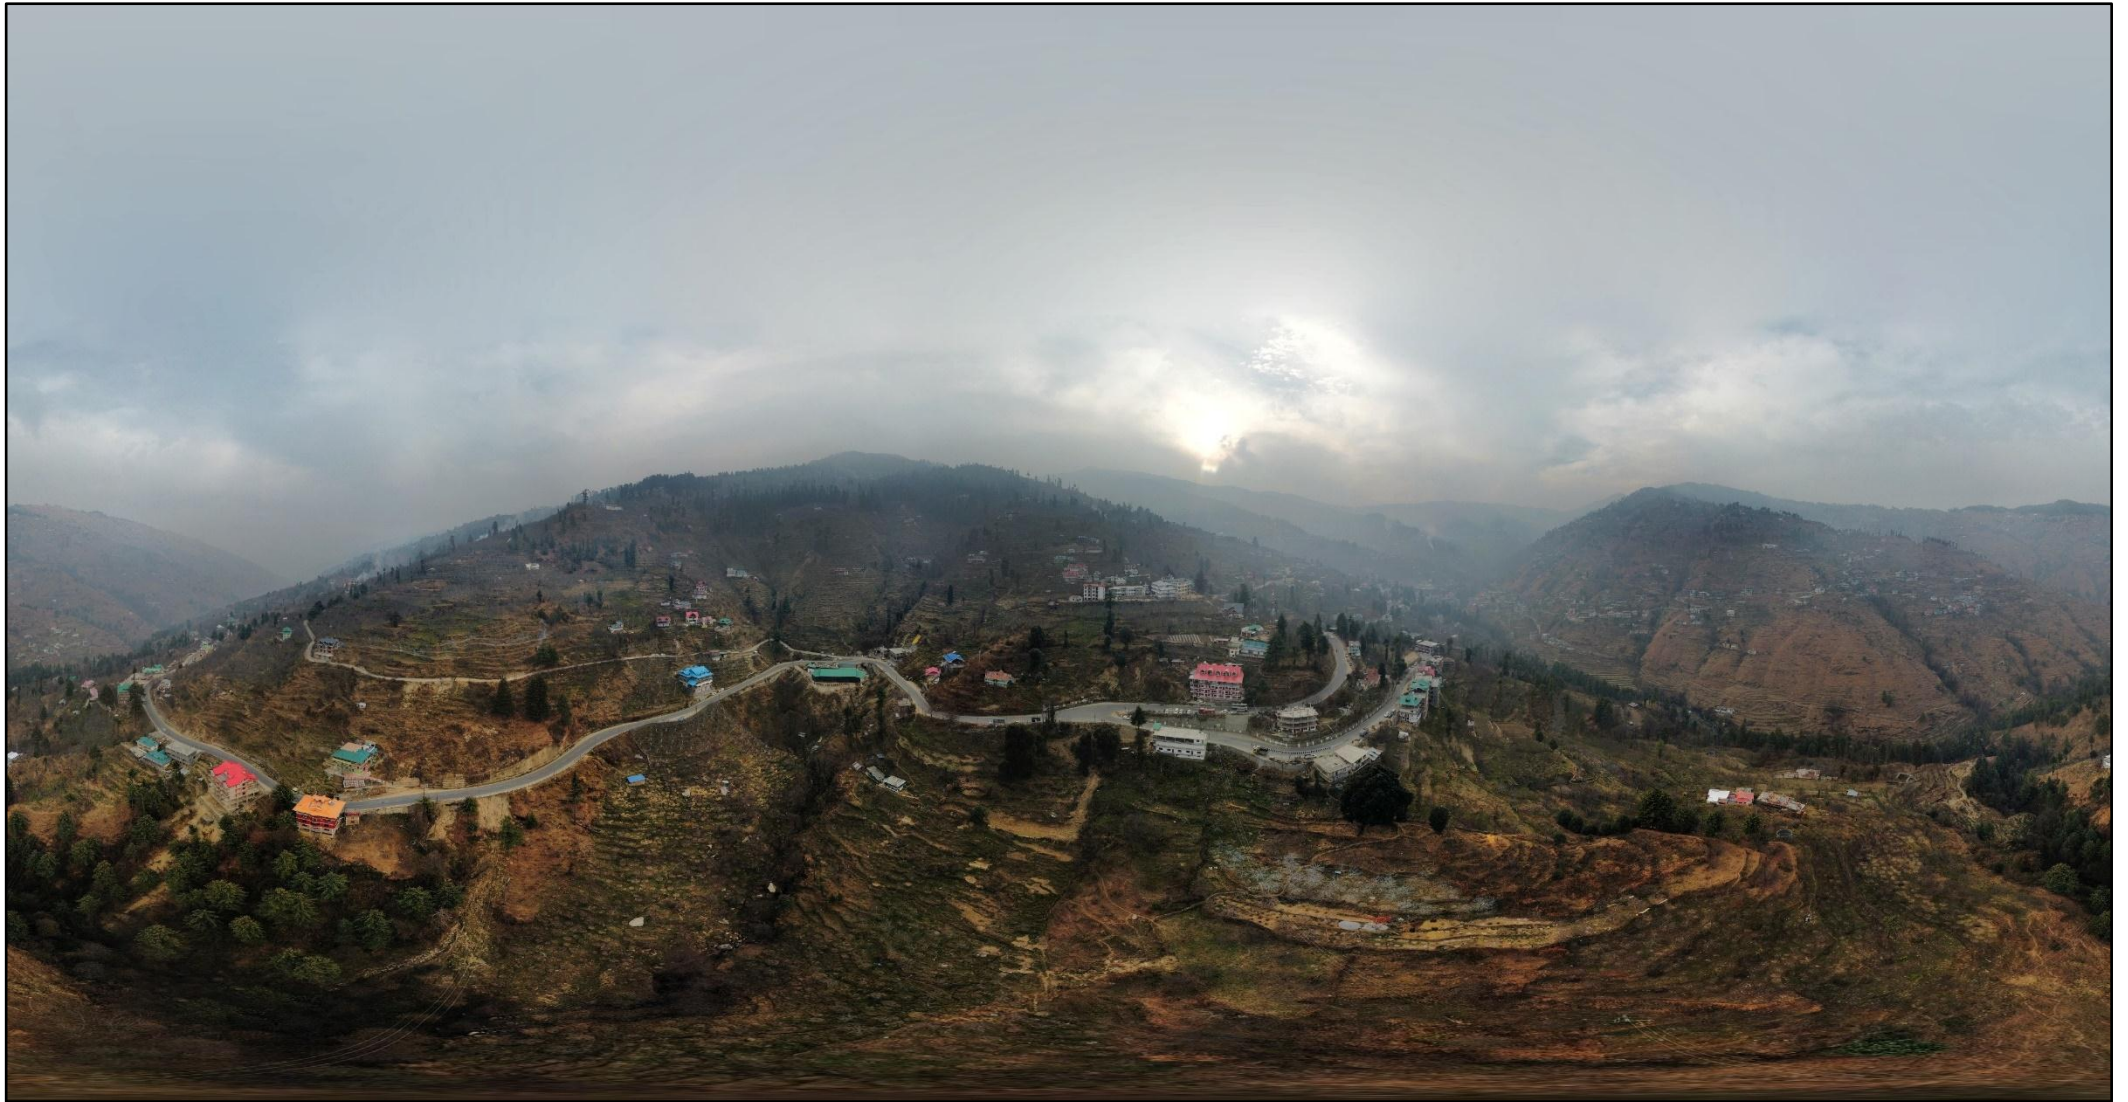
Fig. 41. A panoramic view of Labrot, Jubbal landslide site, Shimla district

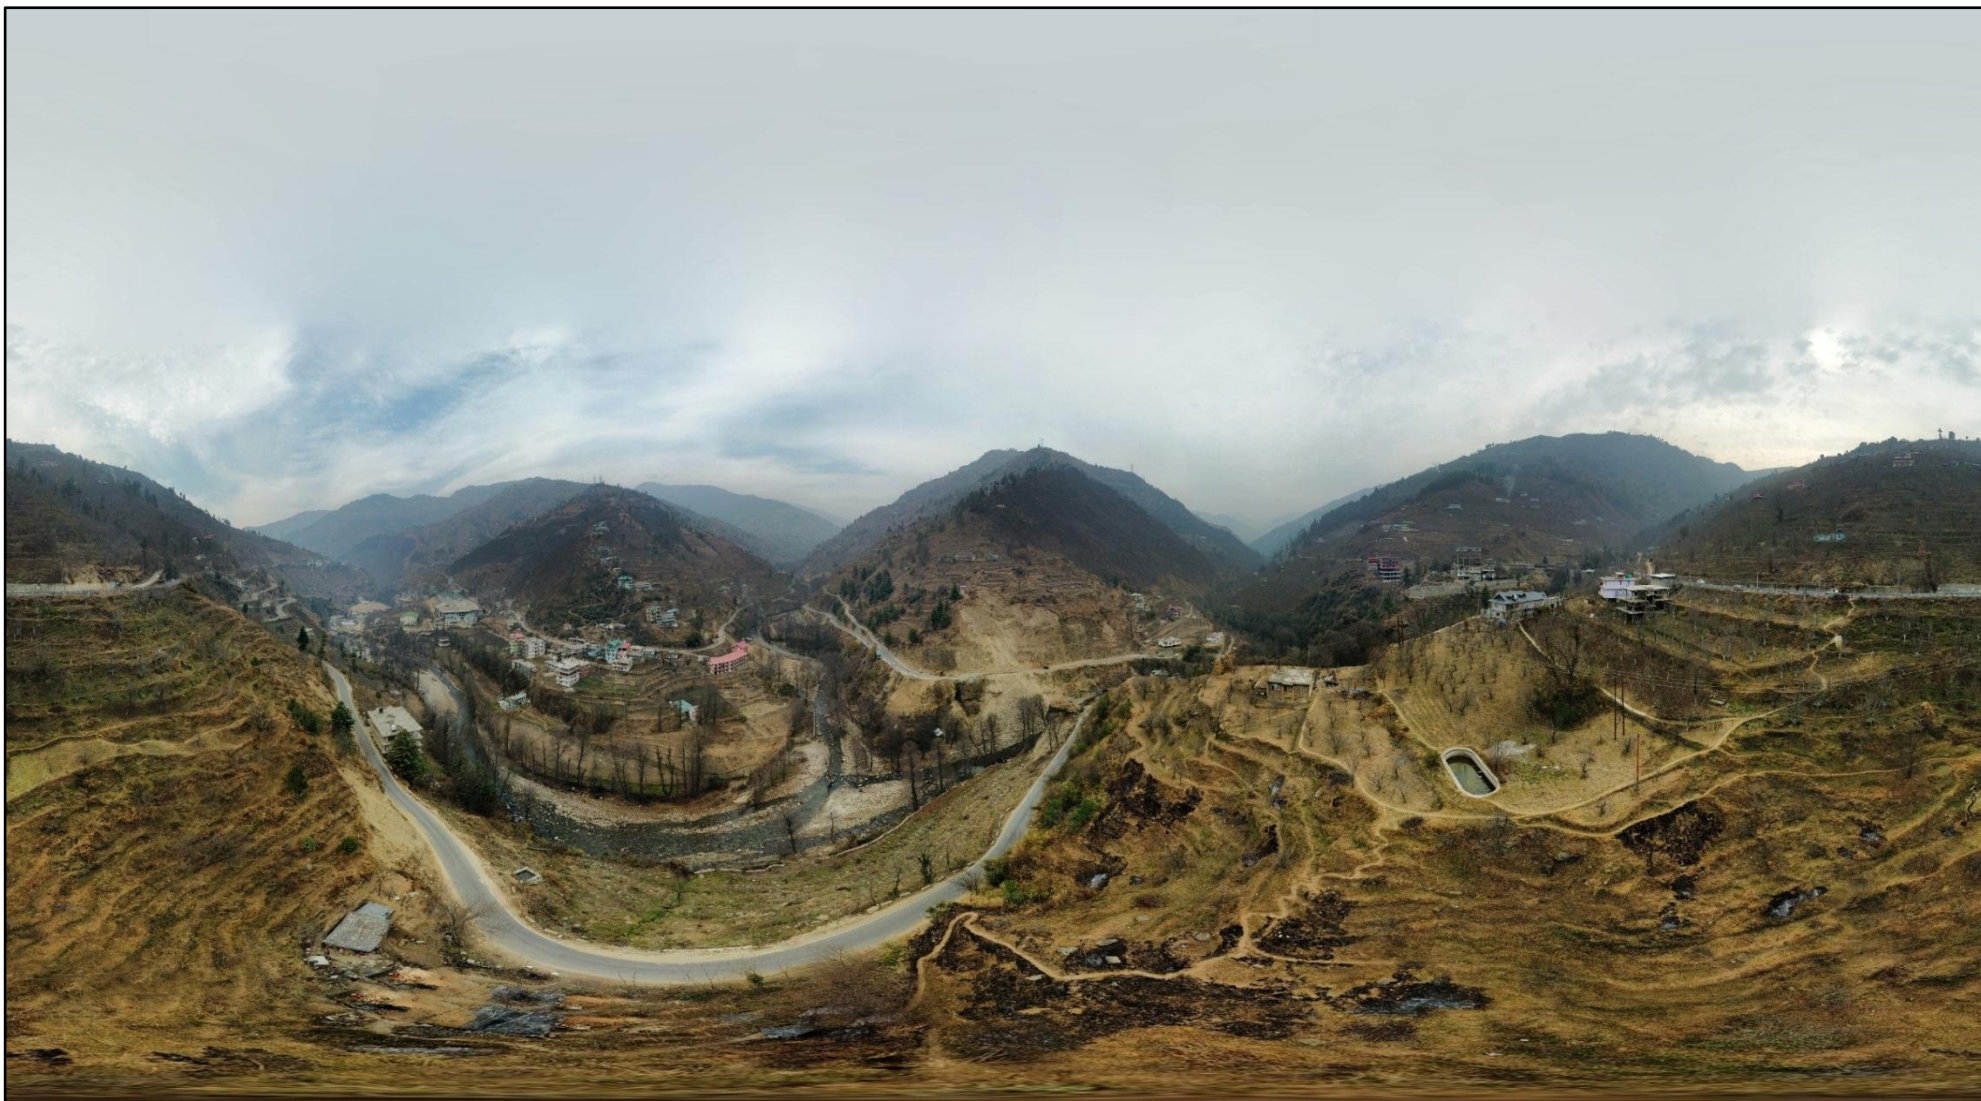
Fig. 46. A panoramic view of Titrikyar, Kotkhai landslide site, Shimla district

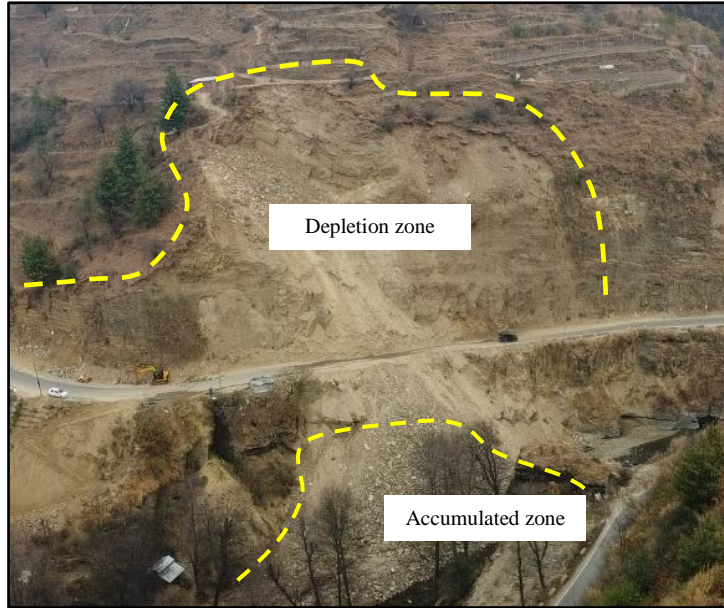
Fig. 47. Titrikyar landslide showing depletion and accumulation zone of the site

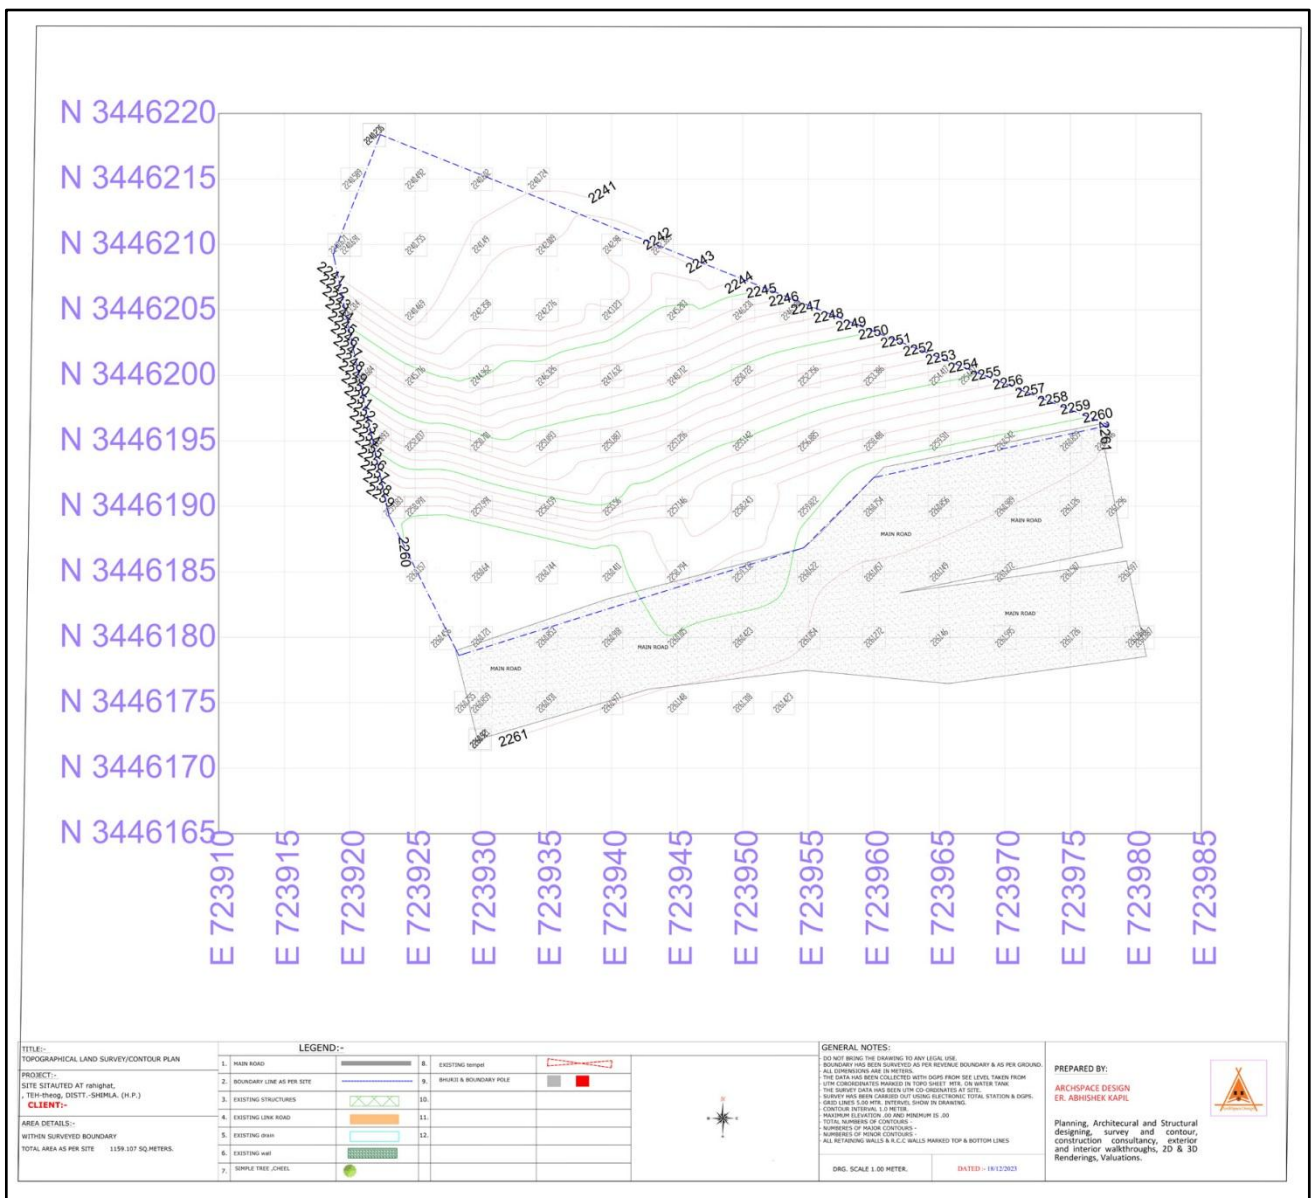
Fig. 50 shows the contour pattern of the Rahighat-Kiyartu Road landslide site, with 1-meter interval contours indicating a steep to very steep slope prone to failure, which is crucial for understanding the landslide. **Fig. 51** and **Fig. 52** show a panoramic view and a field photograph of the site, respectively. The field investigation reveals the impact on vegetal cover, remnants of a damaged retaining wall (**Fig. 53**) due to the landslide, and damp underground conditions caused by the area's inadequate drainage system, which contributed to the said landslide. The site is affected by debris failure due to excessive rainfall.

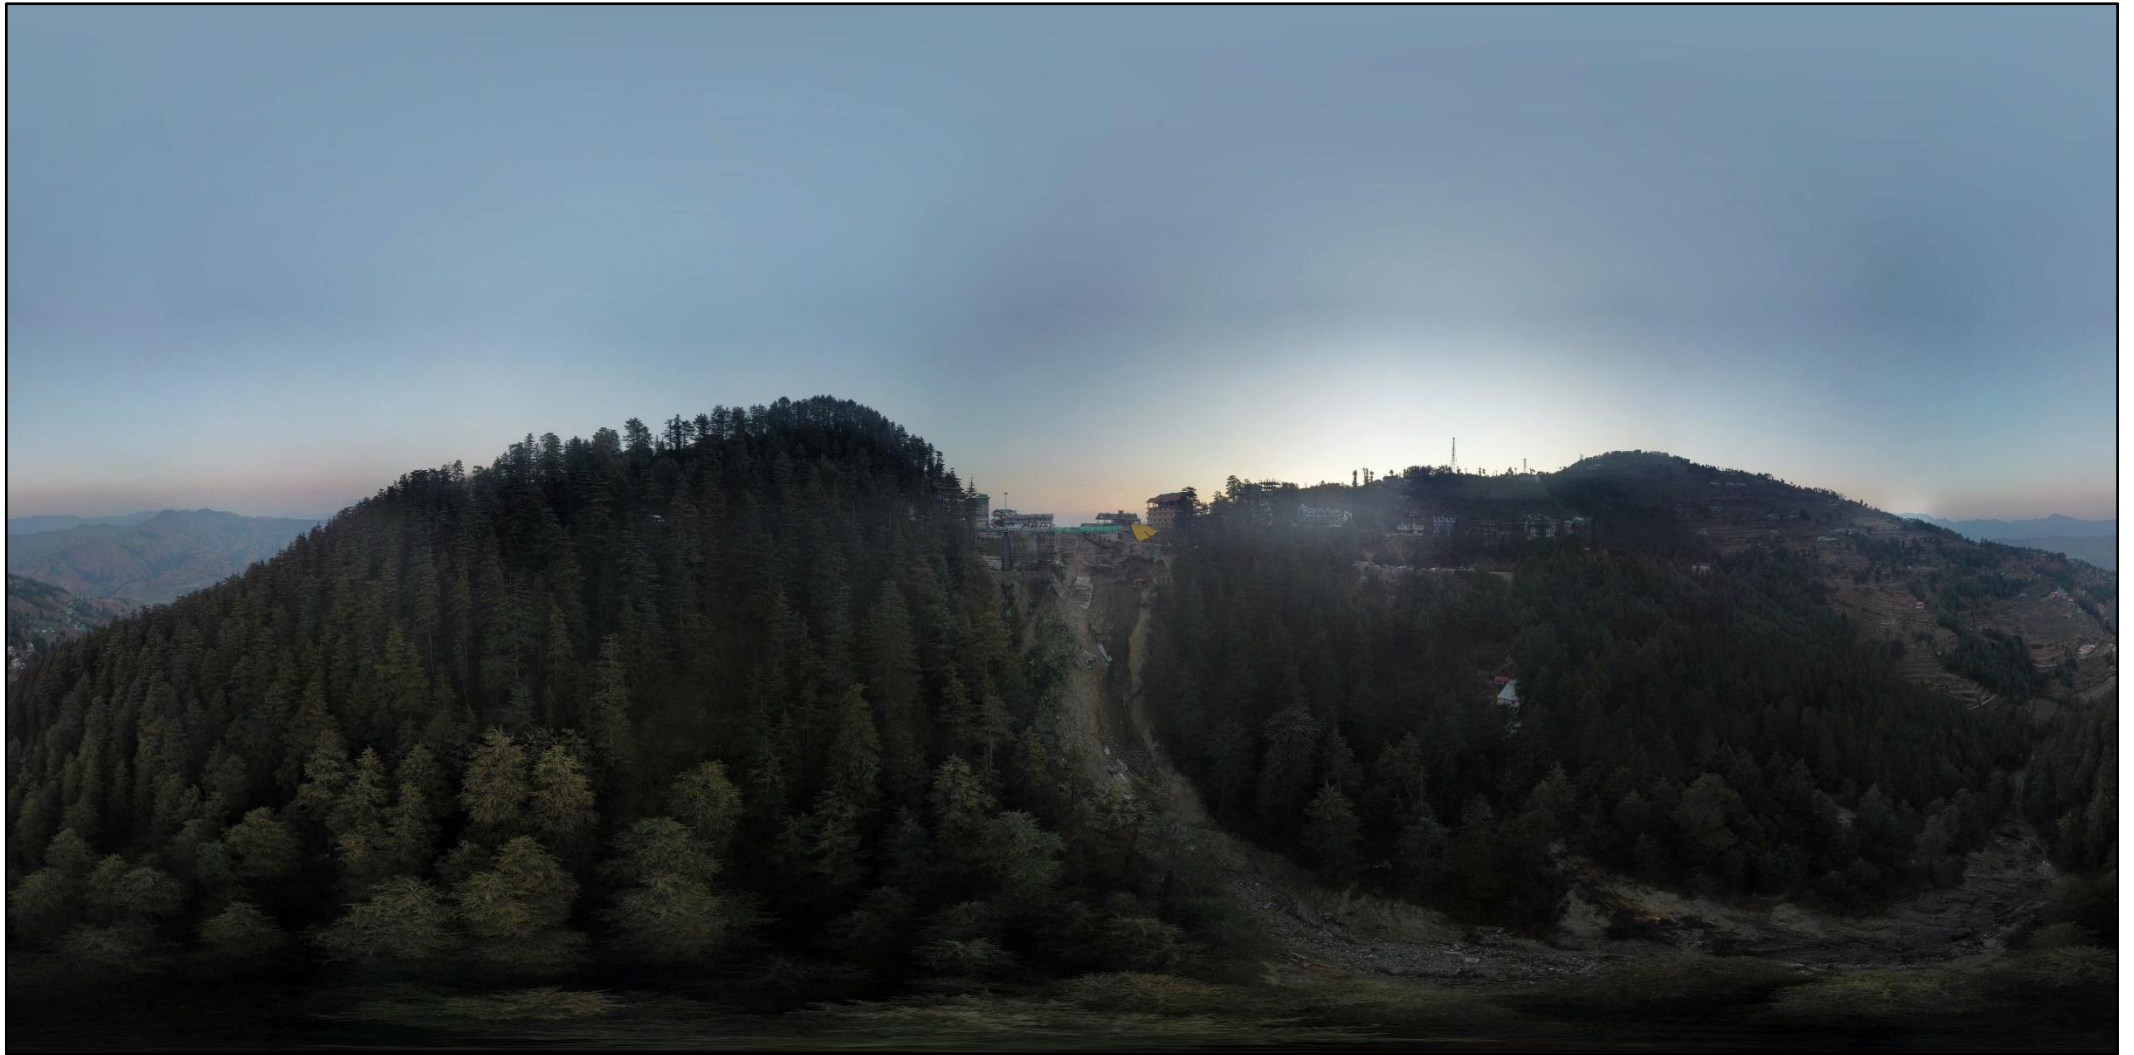
Fig. 51 A panoramic view of Rahighat Kyartu Link Road, Theog landslide site, Shimla district

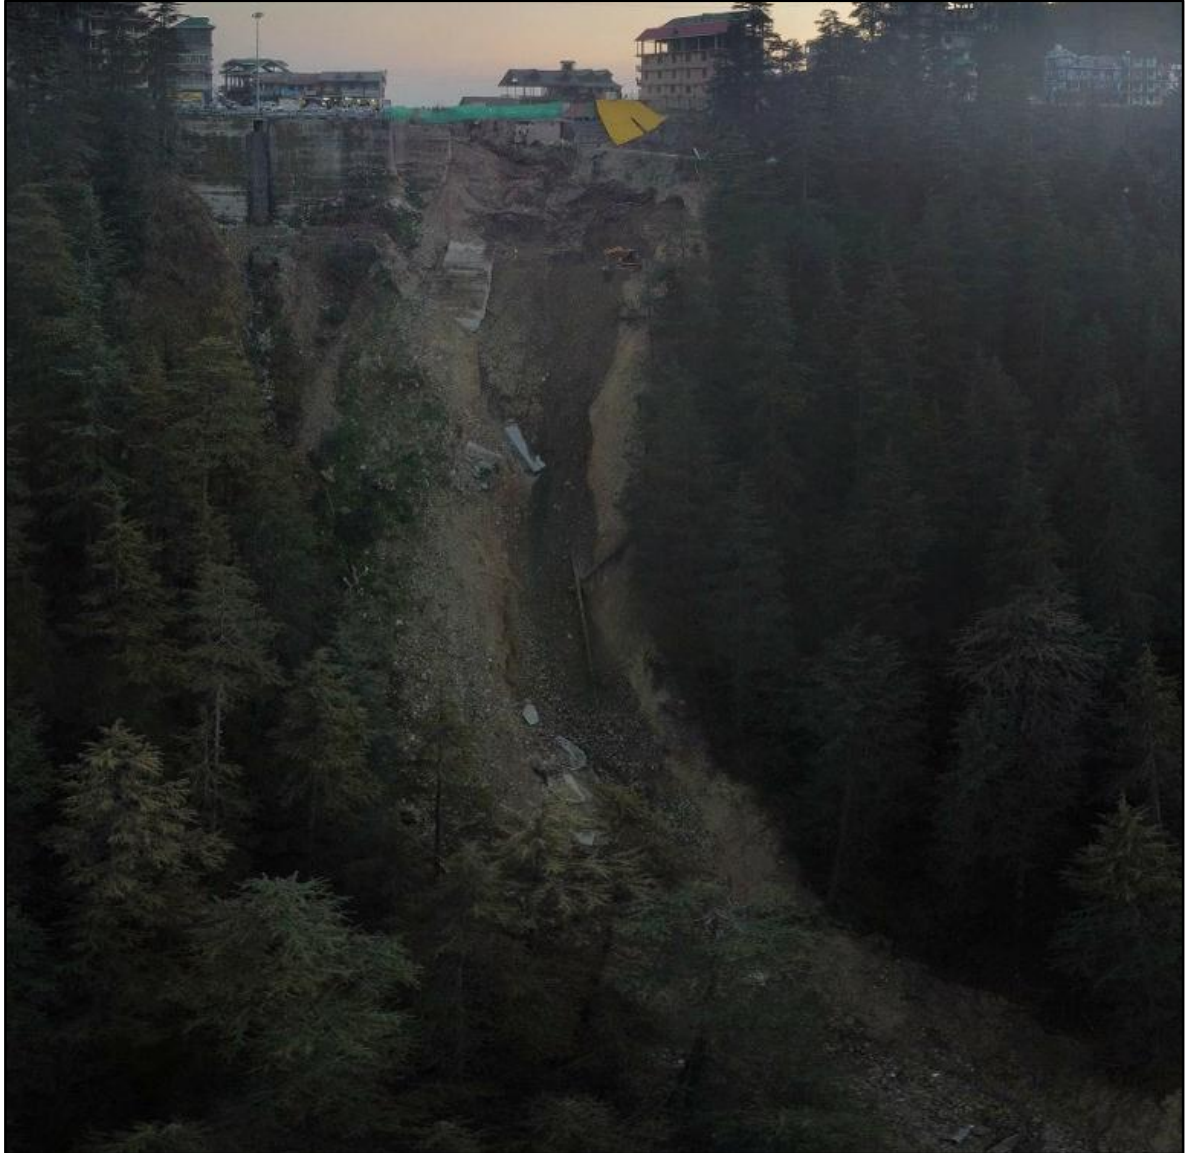
Fig. 52. Field photograph of Rahighat Kyartu Link Road, Theog landslide site, Shimla

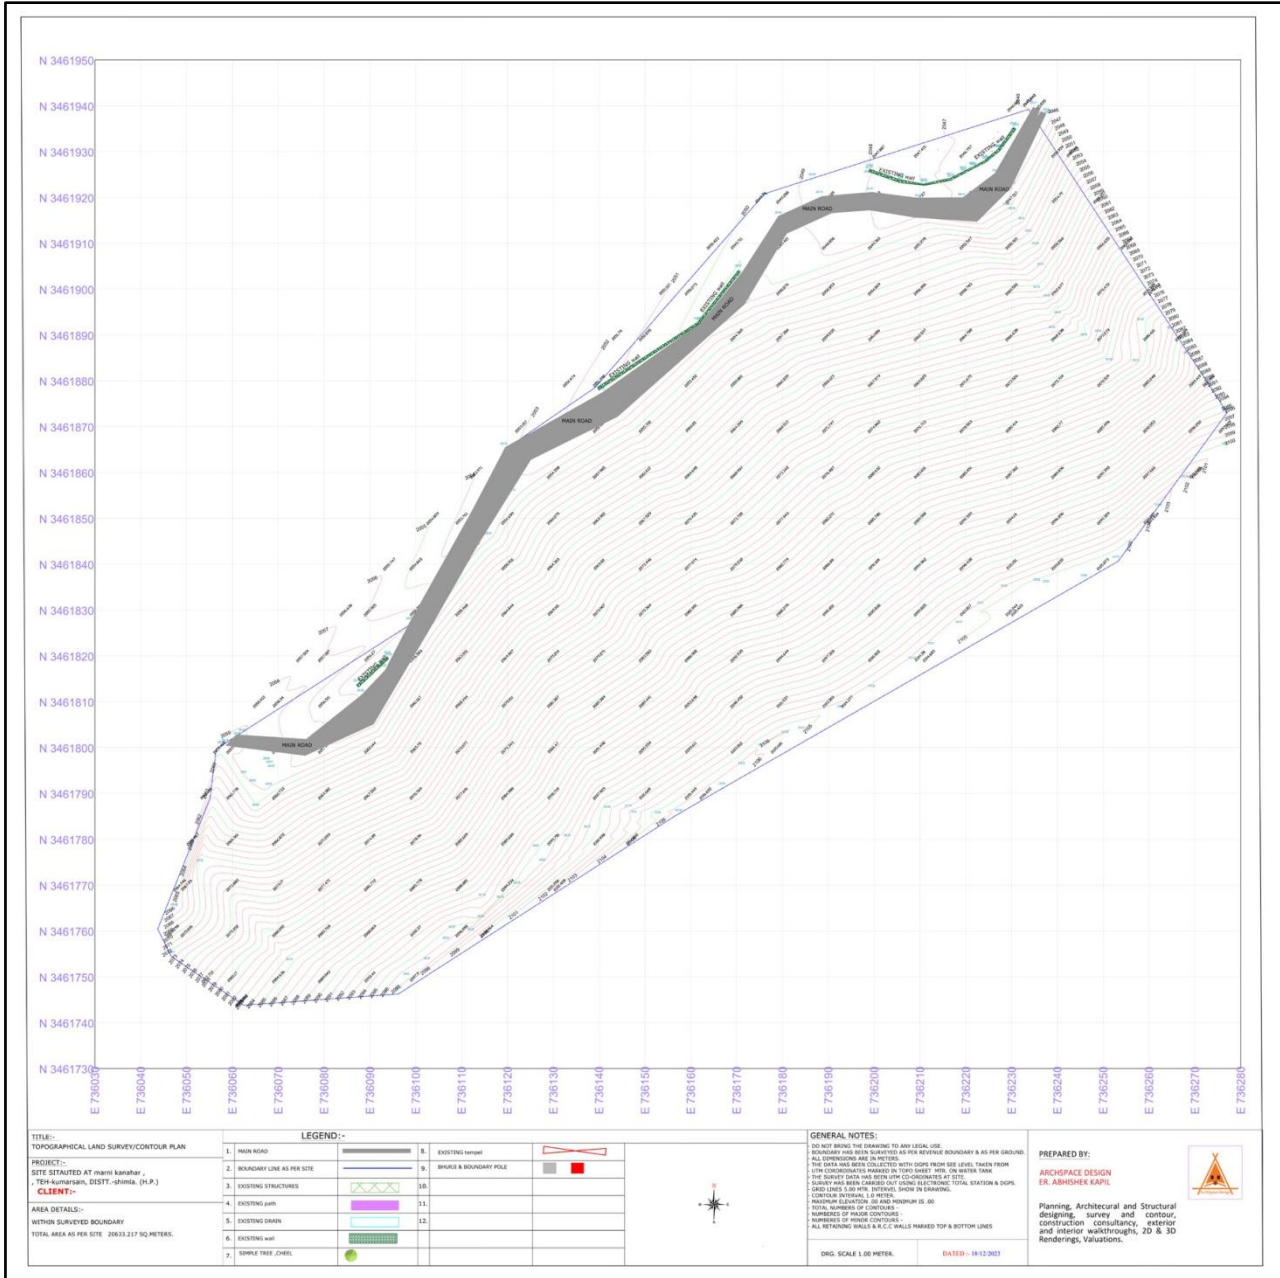
Fig. 54 portrays the contour map of Marni-Kanahar landslide, a site characterized by ongoing land subsidence, with 1-meter interval contours indicating a moderate to steep slope susceptible to failure, crucial to understand slope destabilization process. **Fig. 55** and **Fig. 56** present a panoramic view and a field photograph of the site, respectively, with the latter highlighting the depletion zone and threatened apple orchards above the crown of the landslide. **Fig. 57** showcases the debris runout and the protective measure of an RCC protection wall, erected to support upslope structures and mitigate landslide impact. The field investigation identifies cracks measuring about 10 inches to 1 foot (**Fig. 58**) caused by

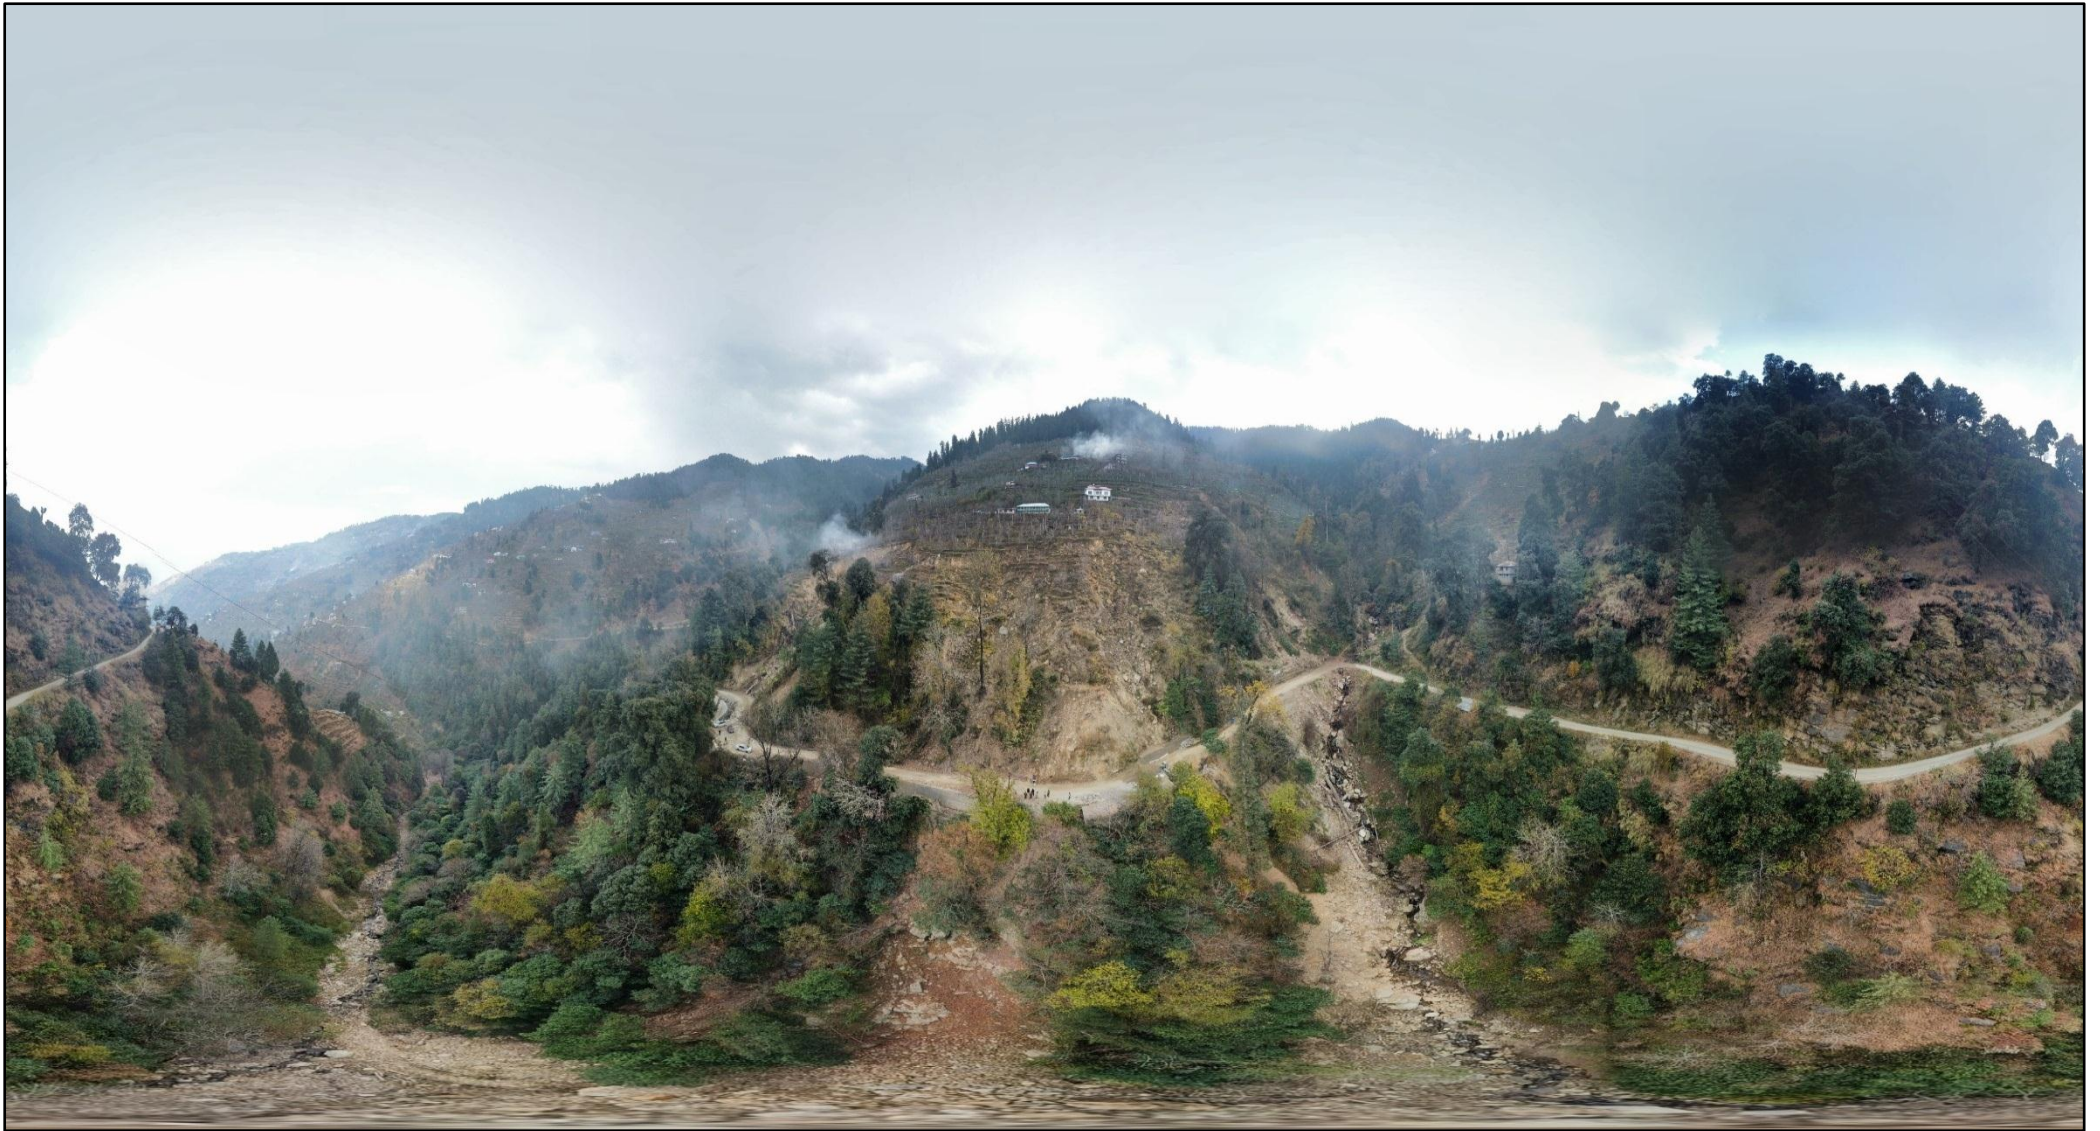
Fig. 55. A panoramic view of Marni-Kanhar, Kumarsain landslide site, Shimla district

- The debris translational retrogressive landslide was triggered by prolonged and heavy precipitation during the monsoon.
- The moderate to steep slope of the area makes it susceptible to slope failure
- The rocks in the area, belonging to the Rampur Group, have undergone severe deformation and are highly fractured, contributing to the instability of the slope.

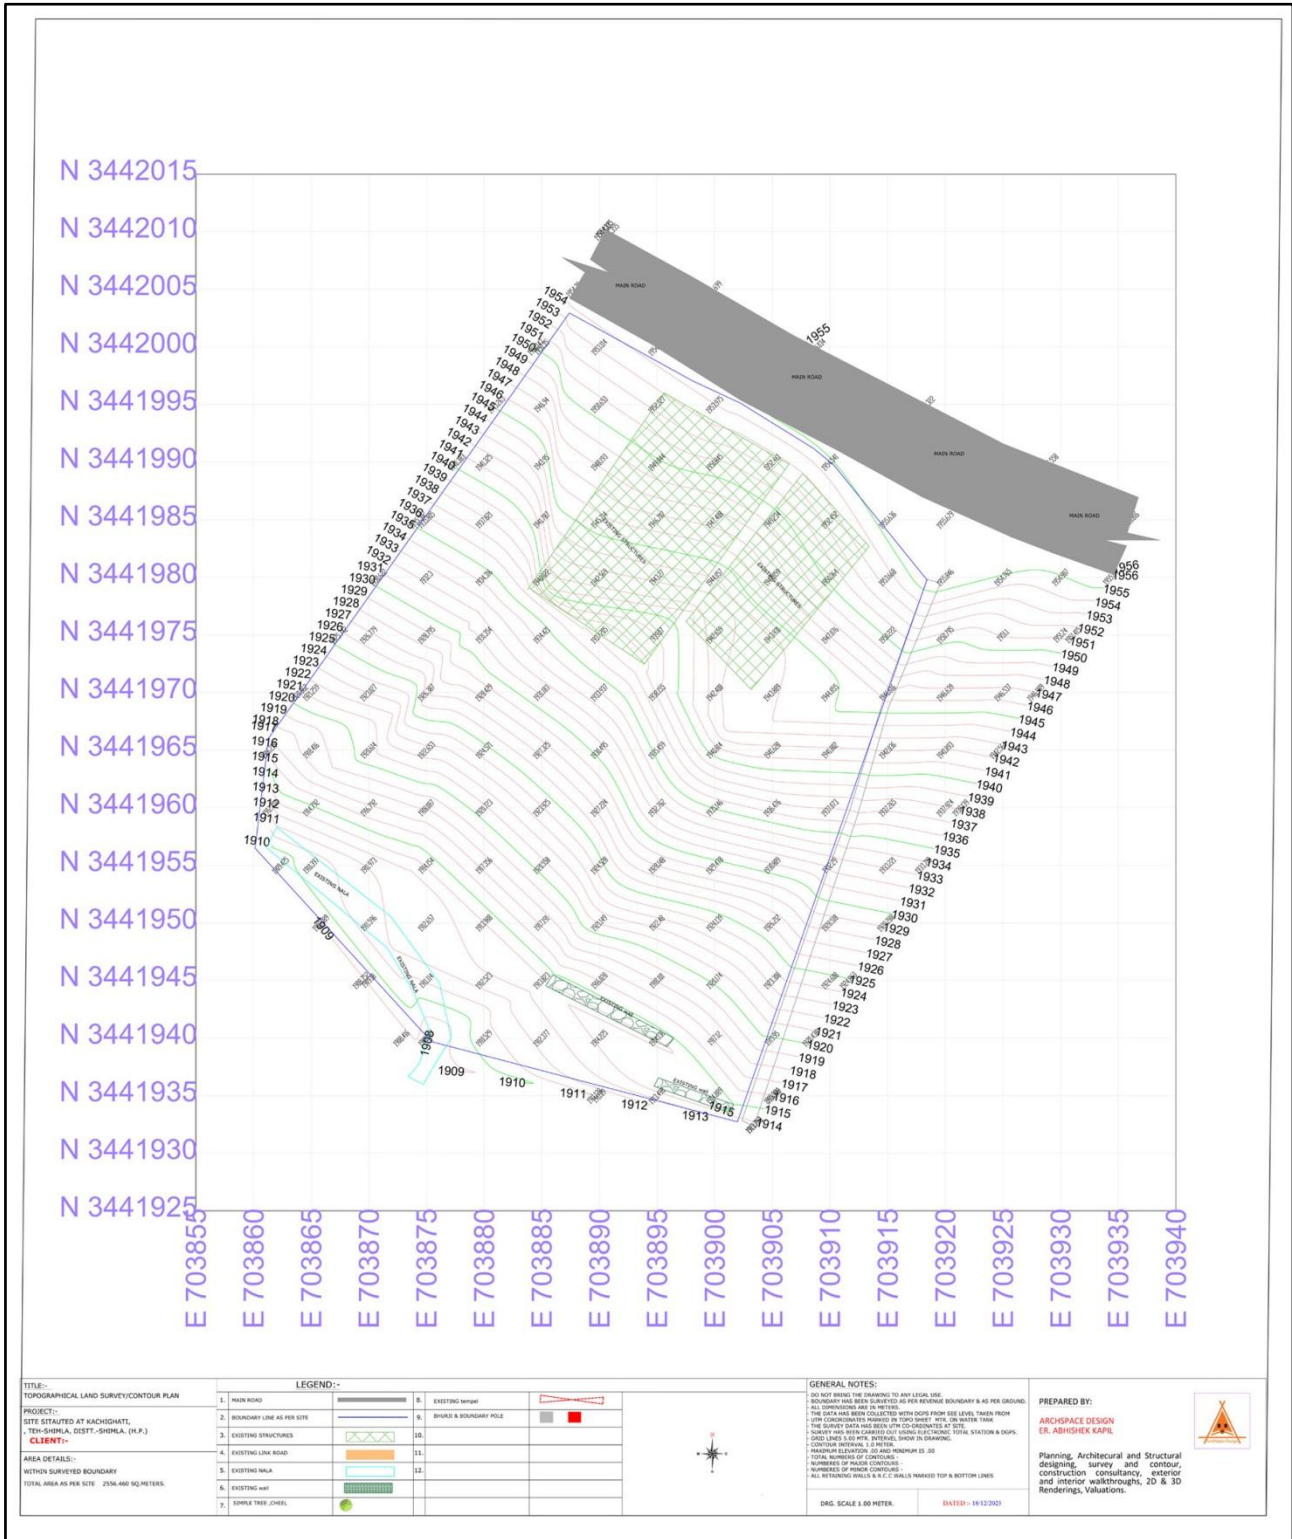
Fig. 60 depicts the contour map of the Kachighati landslide, with 1-meter intervals indicating a steep to very steep slope susceptibility to failure, critical to the landslip of the site. **Fig. 61** and **Fig. 62** present the panoramic view and a field photograph of the site, respectively. **Fig. 62** also shows the remnants of the affected buildings.

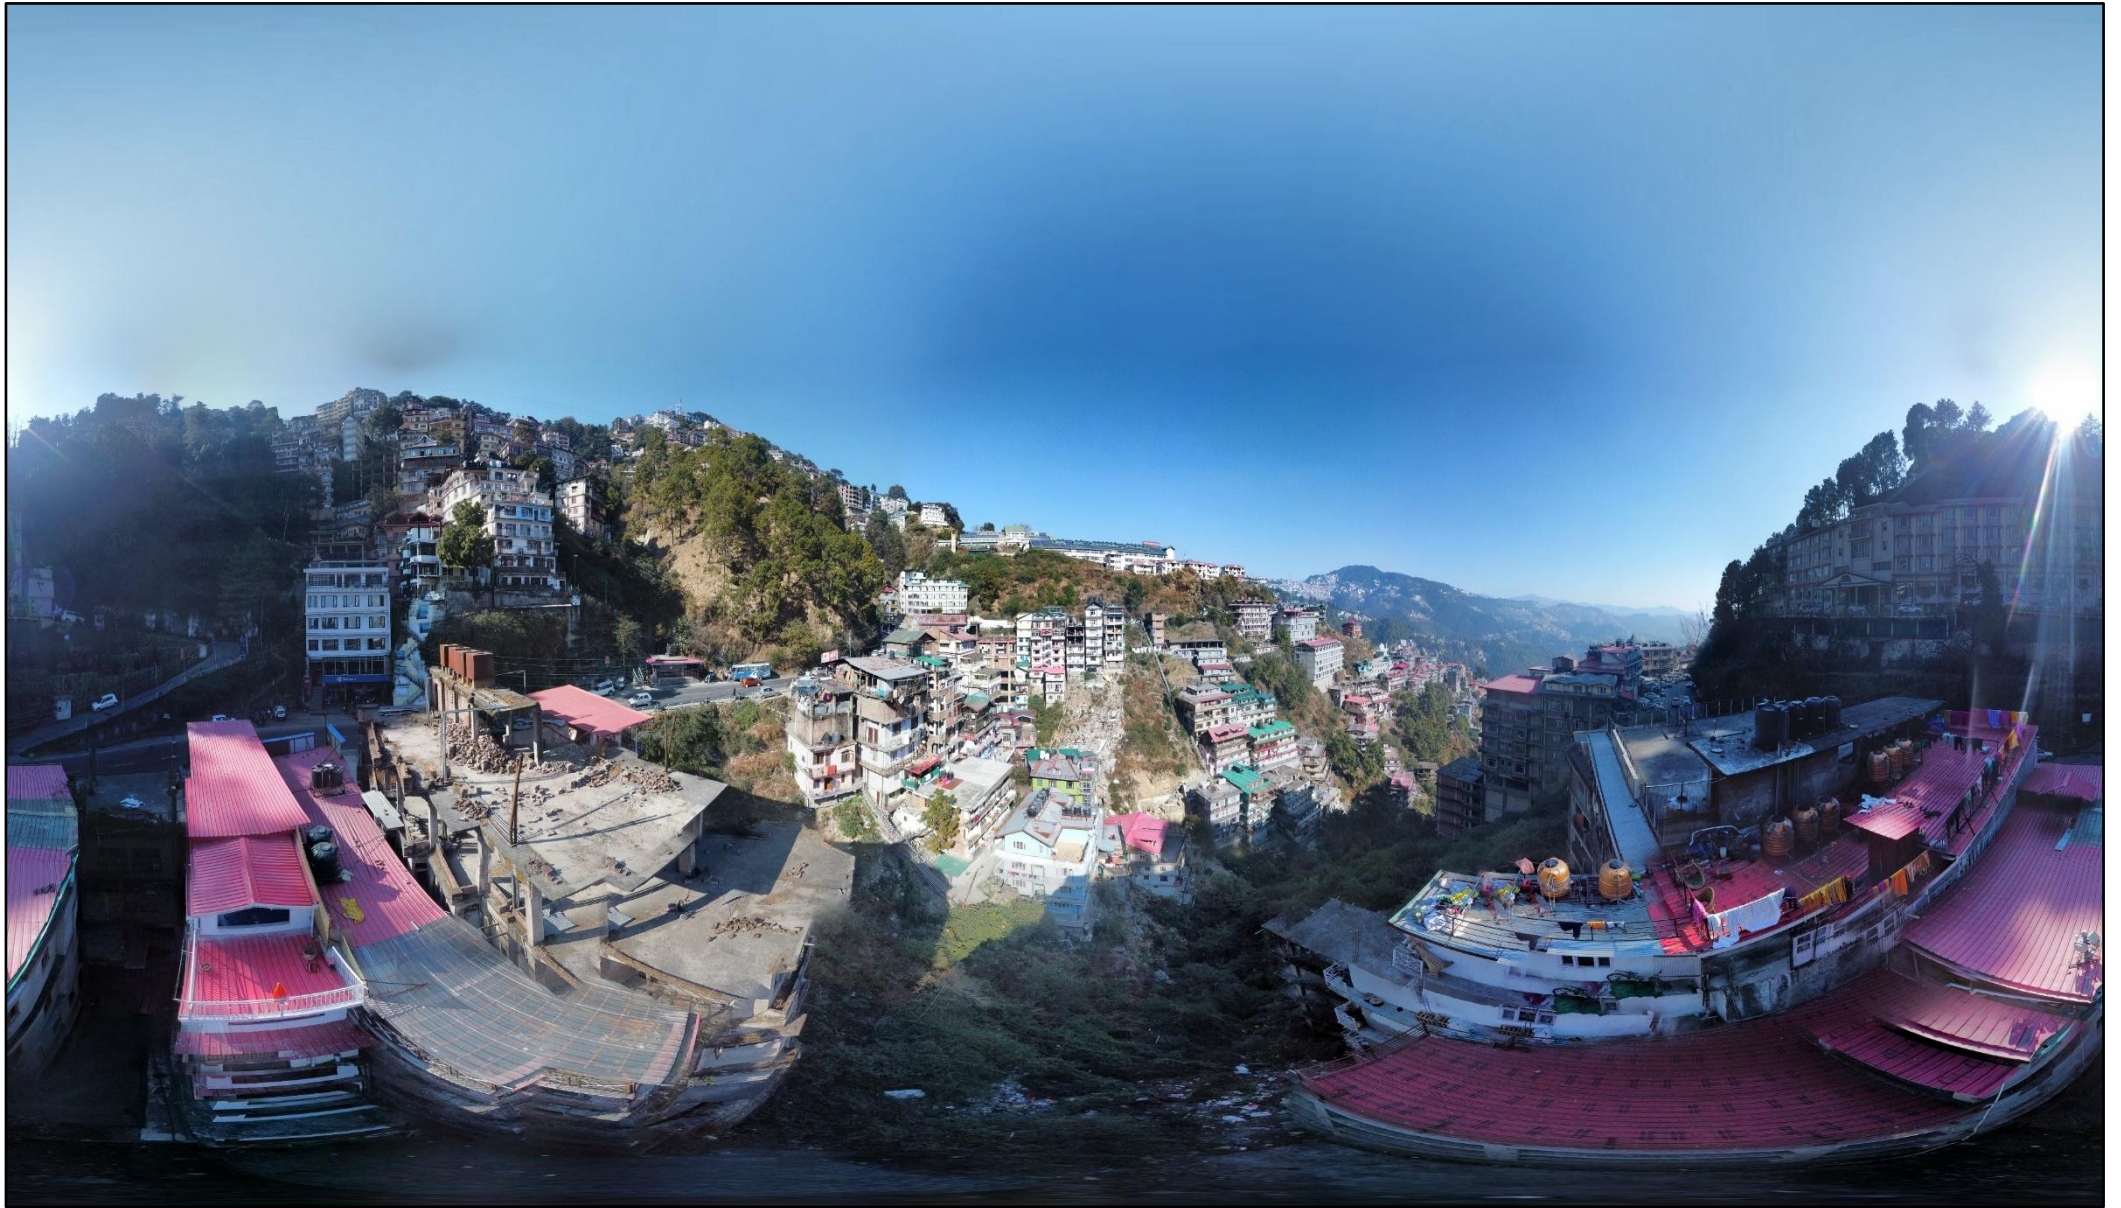
Geologically, this area is part of the Jutogh Group, characterized by rocks such as Phyllites, Carbonaceous Phyllites, Schist and Quartzite. The predominant rock type in the area is schist. The building affected by the landslide was about 30 years old, and the slope is extremely steep, with an angle of 60° to 70° . The soil type is silty sand with rock fragments. The failure was mainly caused by the steep slope, continuous rainfall and potentially unscientific building foundation design. The steep slope and unconsolidated soil mass likely underwent saturation due to rain, leading to increased pore water pressure and the subsequent failure. During the field visit, it was observed that lots of weeds have grown on the upper slope, indicating that the slope is currently stable and not active.

Fig. 61. A panoramic view of Kachighati, Shimla landslide site, Shimla district

- The landslide was primarily triggered by the steep slope, continuous rainfall and possibly the unscientific design of the high-rise building's foundation.
- The combination of the steep slope and the unconsolidated soil mass likely led to saturation from rainwater, increasing pore water pressure and resulting in the landslide.

- Given the seismic sensitivity of the zone, construction should not exceed a slope angle of 45° .
- Given the fragile lithological setup and steep slope, buildings in the area should be limited to two-and-a-half stories.
- Municipal Council Authorities and the Town and Country Planning Department should enforce building bylaws to prevent future violations in the vicinity of the city.
- Due to the fragile lithology, thorough geotechnical investigations are necessary before any construction in the Kachighati area.

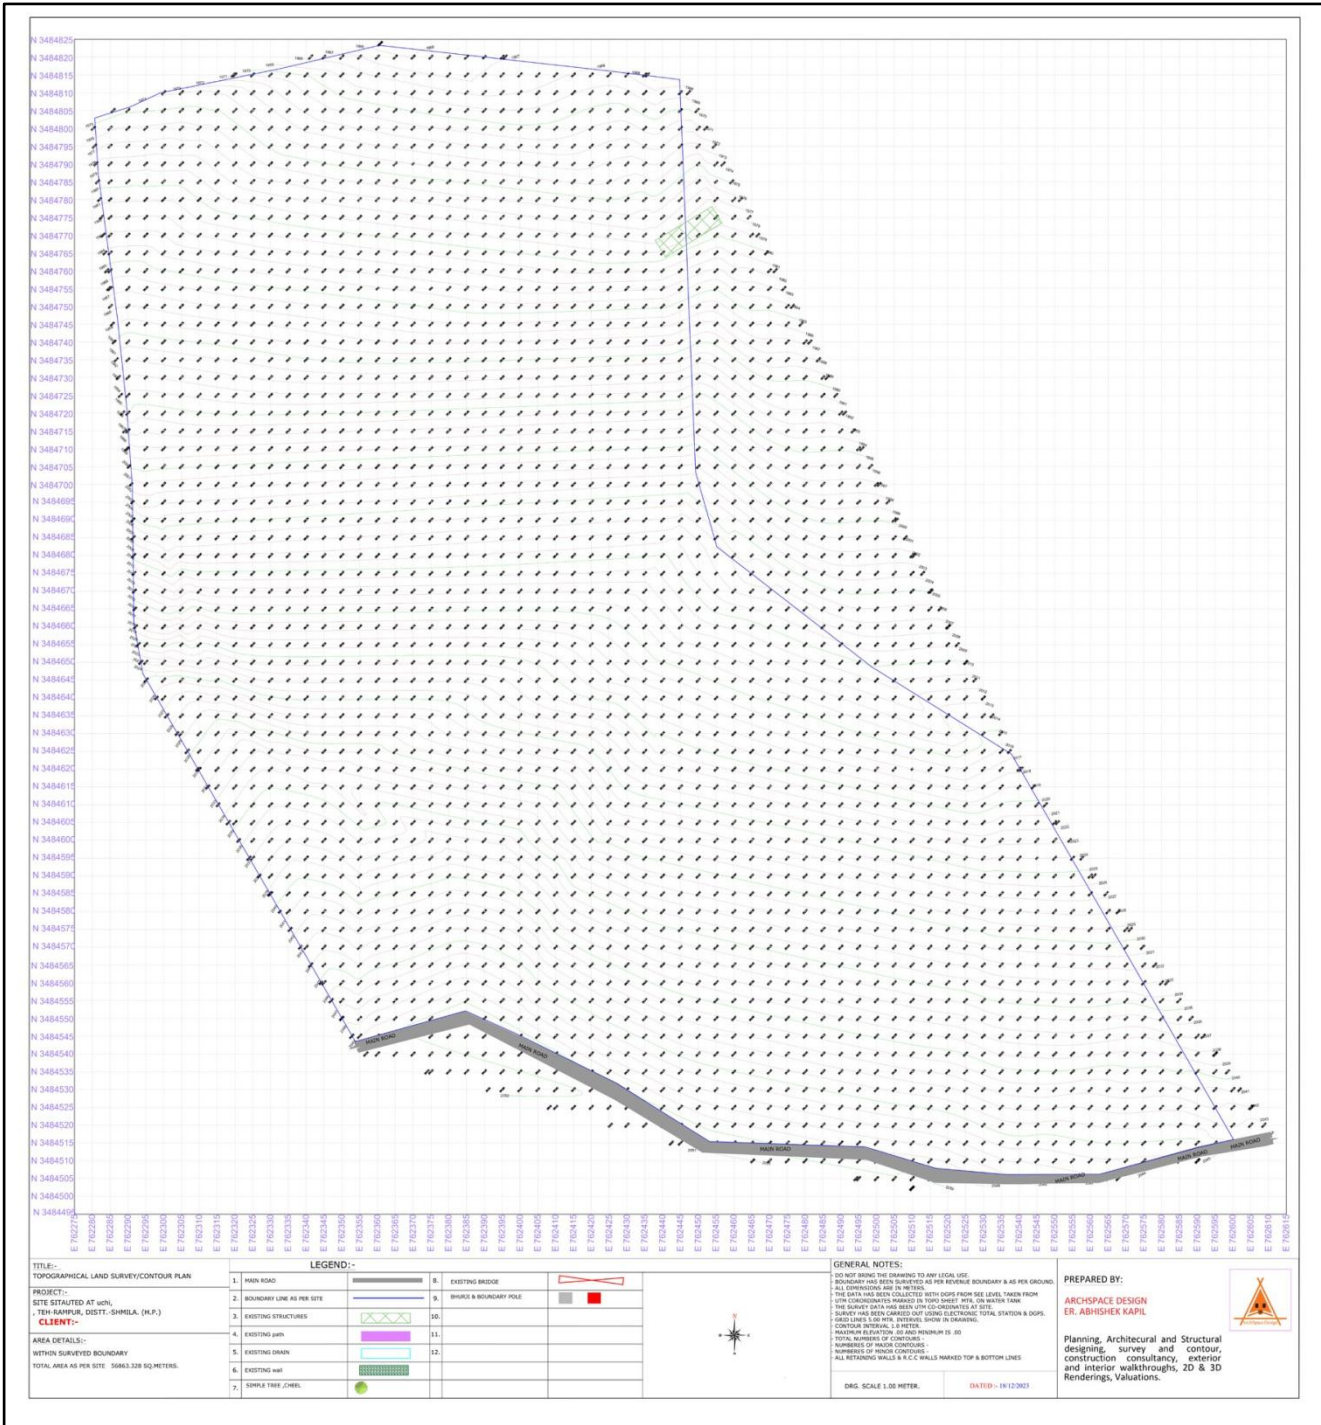
Fig. 63 shows the contour map of Uchi, a village experiencing land subsidence, with 1-meter interval contours indicating a moderate to steep slope liable to slope failure, which is critical to the village's land subsidence issue. **Fig. 64** and **Fig. 65** depict the panoramic view and a field photograph of the site, respectively. **Fig. 66** depicts the development of tension cracks on the floor of a house affected by land subsidence in the village. **Fig. 67** shows evident tension cracks on the floor and walls of residential structures, indicating sinking of the structure and land subsidence in the area. Besides, cracks are visible in a village temple, serving as a mark of ongoing sinking landmass (**Fig. 68**). Locals also noted that some tree roots are spreading out in the village. A surprising phenomenon of trunk hollowing and widening of a mighty oak tree due to root spread caused by land subsidence was observed during the field visit (**Fig. 69**). The field investigation reveals the impact of the landslide
