**PRELIMINARY REPORT ON THE ASSESSMENT OF
LANDSLIDE SITES IN SHIMLA DISTRICT,
HIMACHAL PRADESH**

**Submitted
to
STATE DISASTER MANAGEMENT AUTHORITY
GOVERNMENT OF HIMACHAL PRADESH, SHIMLA**

February-2024

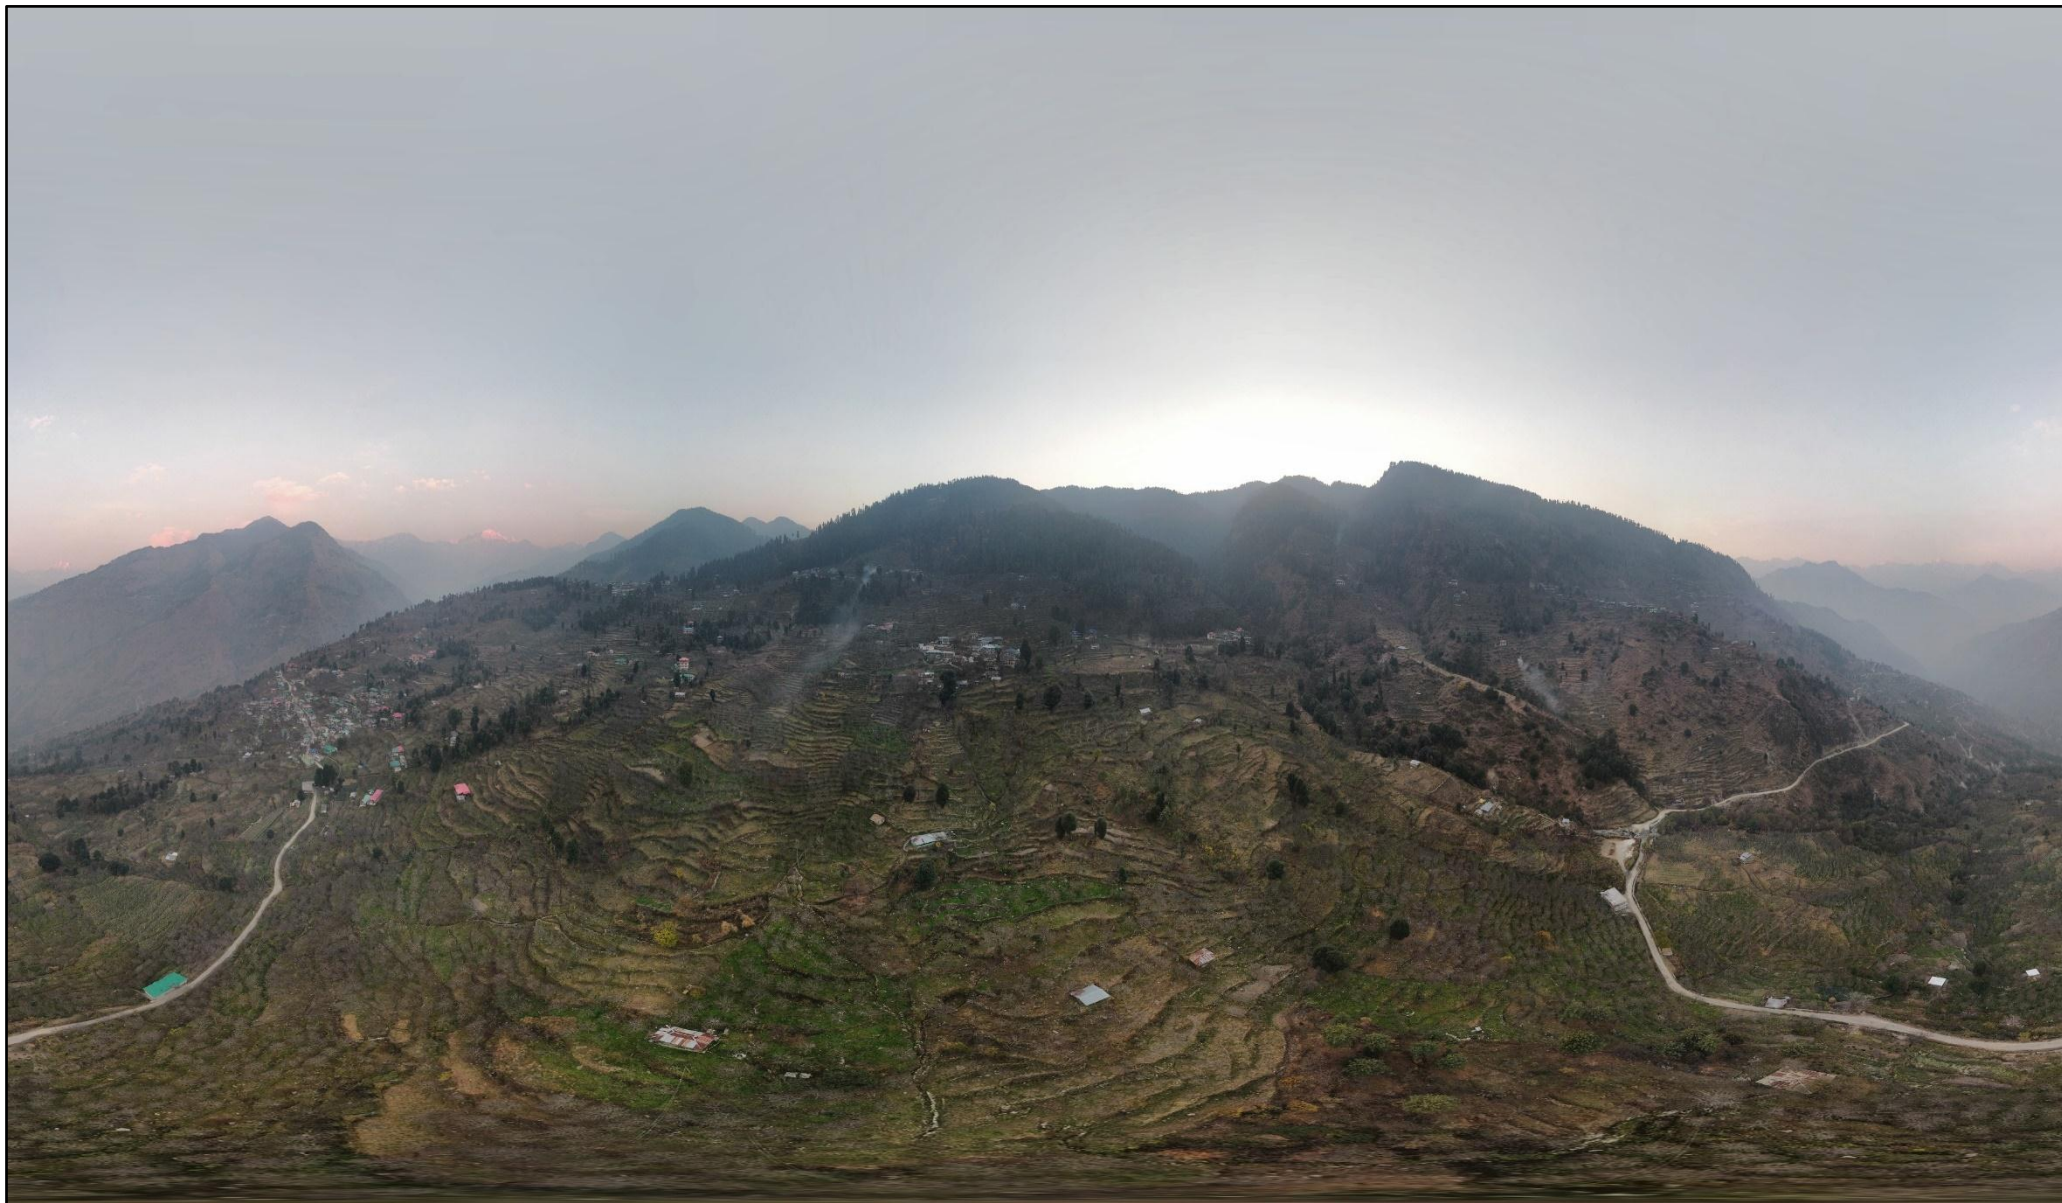
subsidence on buildings and horticultural land. Without intervention, the situation is expected to deteriorate during future monsoons. Poor drainage, leading to damp to wet conditions, combined with heavy rainfall, is contributing to the land subsidence and slope instability in Uchi village, as observed during discussions with locals and the field visit.

Fig. 64. A panoramic view of Uchi, Rampur landslide site, Shimla district

- The causes of landslide and subsidence in the Uchi village include heavy rainfall, drainage problem and a slope angle ranging from 25° to 60°.
- Water entering the slope through tension cracks during precipitation increases its instability. The current & ongoing land subsidence is triggered by heavy precipitation and existing damp ground conditions.
- The proximity of the village to the Main Thrust and its impact on the rocks and terrain cannot be ignored. The site's high moisture content of about 26% indicates a greater susceptibility to soil detachment.

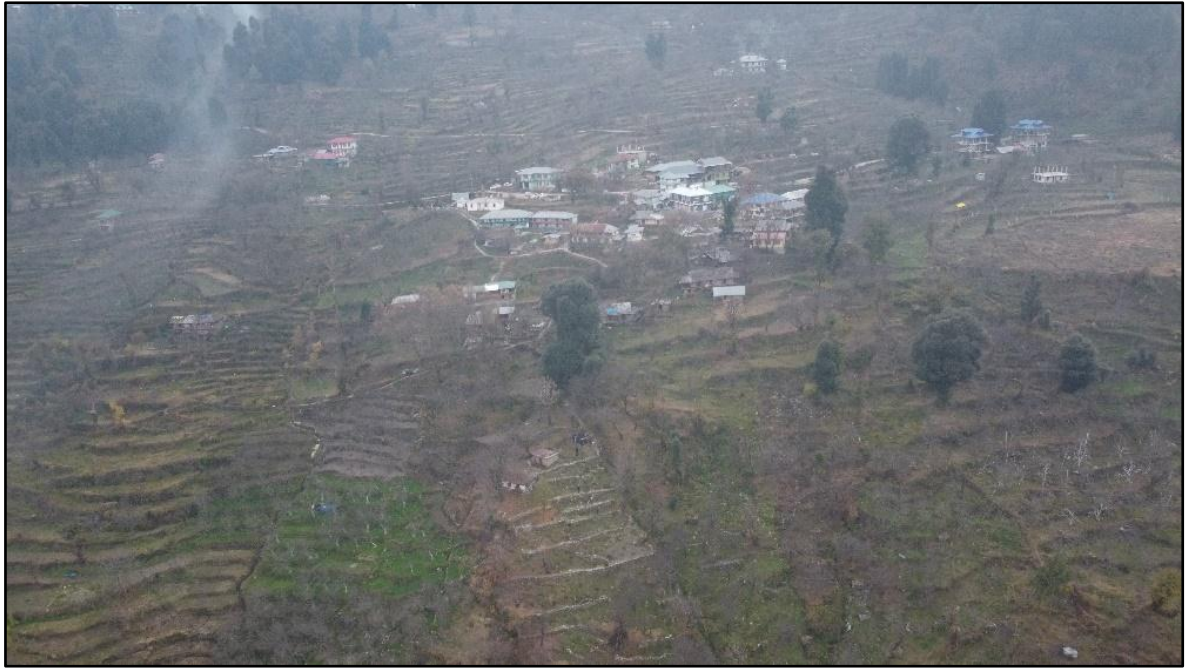
Based on laboratory observations, the grain size analysis of the Uchi soil indicates that this site contains 40% silt content, while sand accounts for approximately one-third of the total. Clay content is reported at only 3% of the total. The site has a higher moisture content of about 26%, indicating a greater susceptibility to soil detachment (**Table 1**). It falls into the non-plastic class with small dry density values. In terms of shear parameters, the site exhibits low cohesion.

Fig. 65. Field photograph

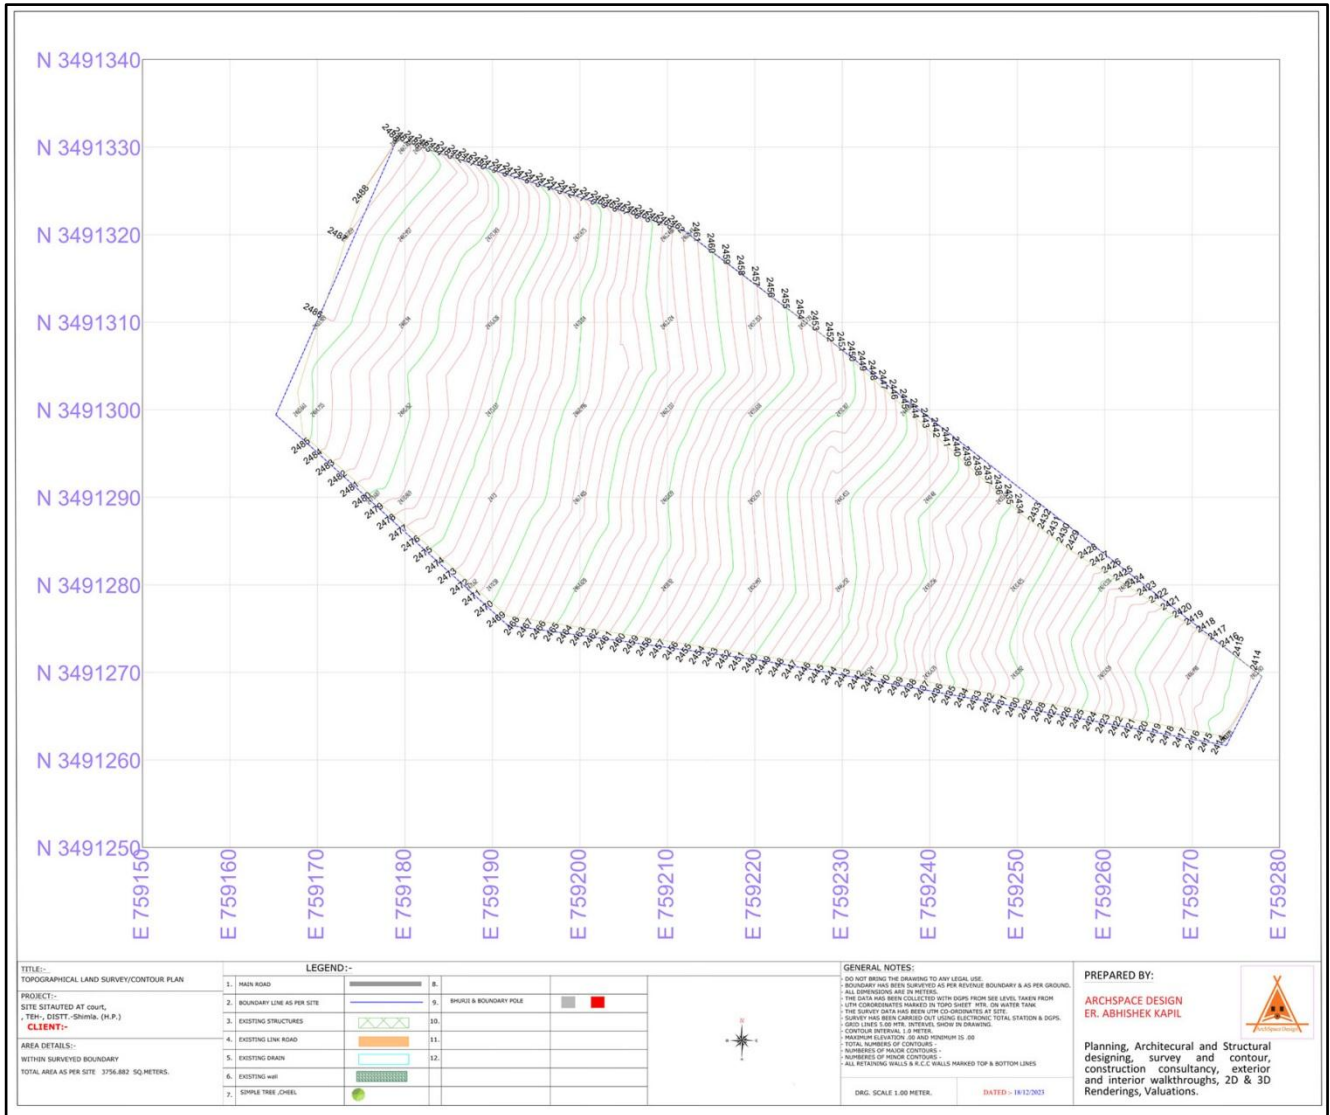
Fig. 70 shows the contour map of Kot, a village experiencing land slide and subsidence issue, with 1-meter interval contours indicating a steep slope susceptibility to slope failure. **Fig. 71** and **Fig. 72** depict the panoramic view and a field photograph of the site, respectively. **Fig. 72** shows the sinking area and houses at risk. **Fig. 73** illustrates the extent of the landslide's impact with debris runout material. **Fig. 74** provides a closer look at the debris runout material. **Fig. 75** depicts cracks in apple orchards caused by subsidence.

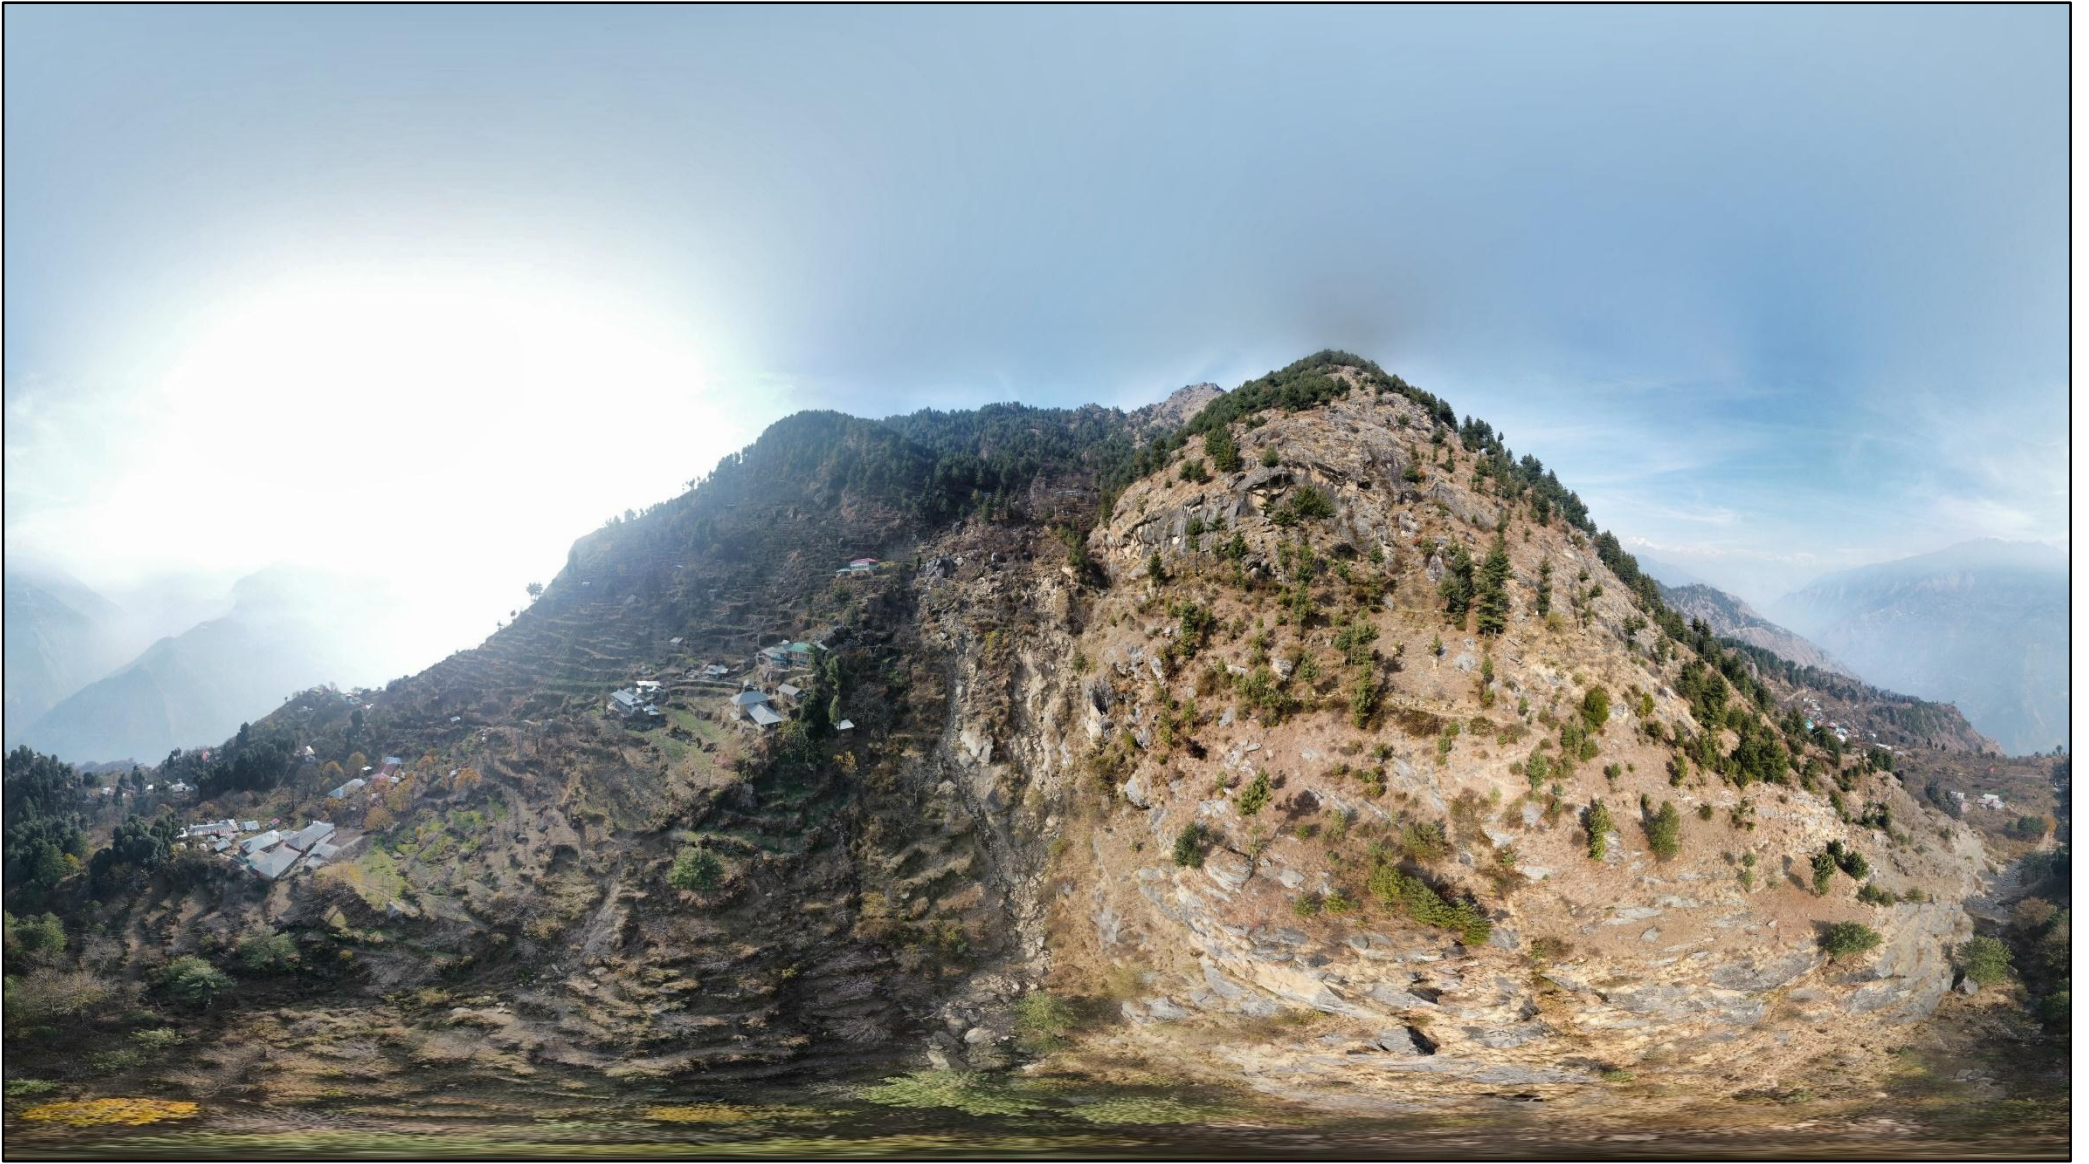
Geologically, the area is formed by the rocks of J-WGC forming part of Lesser Himalayan Crystalline bounded by Munsiri thrust (MT) or Main Central Thrust- I (MCT-I) in the south at Jhakri and Kullu thrust (KT) in the North at Karcham. J-WGC is comprises chiefly of a variety of gneisses and schists. Though the area is not very far from MT the effect on rocks and terrain cannot be neglected. This site is formed by the debris and rock blocks of gneiss and augen gneiss. As per the local people, this site was used to be natural water drainage got buried by approximately 30 years old rock fall event and water flows below the debris in the rainy season. This landslide is rainfall induced triggered in monsoon season due to heavy precipitation. Water between the rocky surface and debris provides the ramp to the overlying debris. Groundwater condition on failed slope at crown is damp while at toe it is flowing.

Fig. 71. A panoramic view of Kot, Rampur landslide site, Shimla district

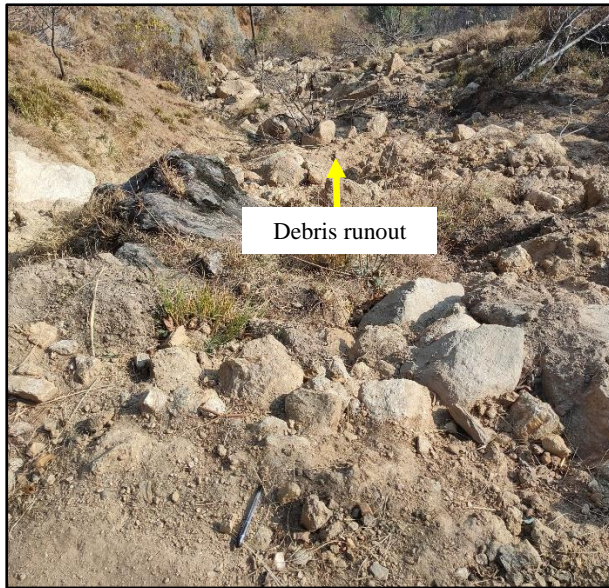
Fig. 74. Debris run out material

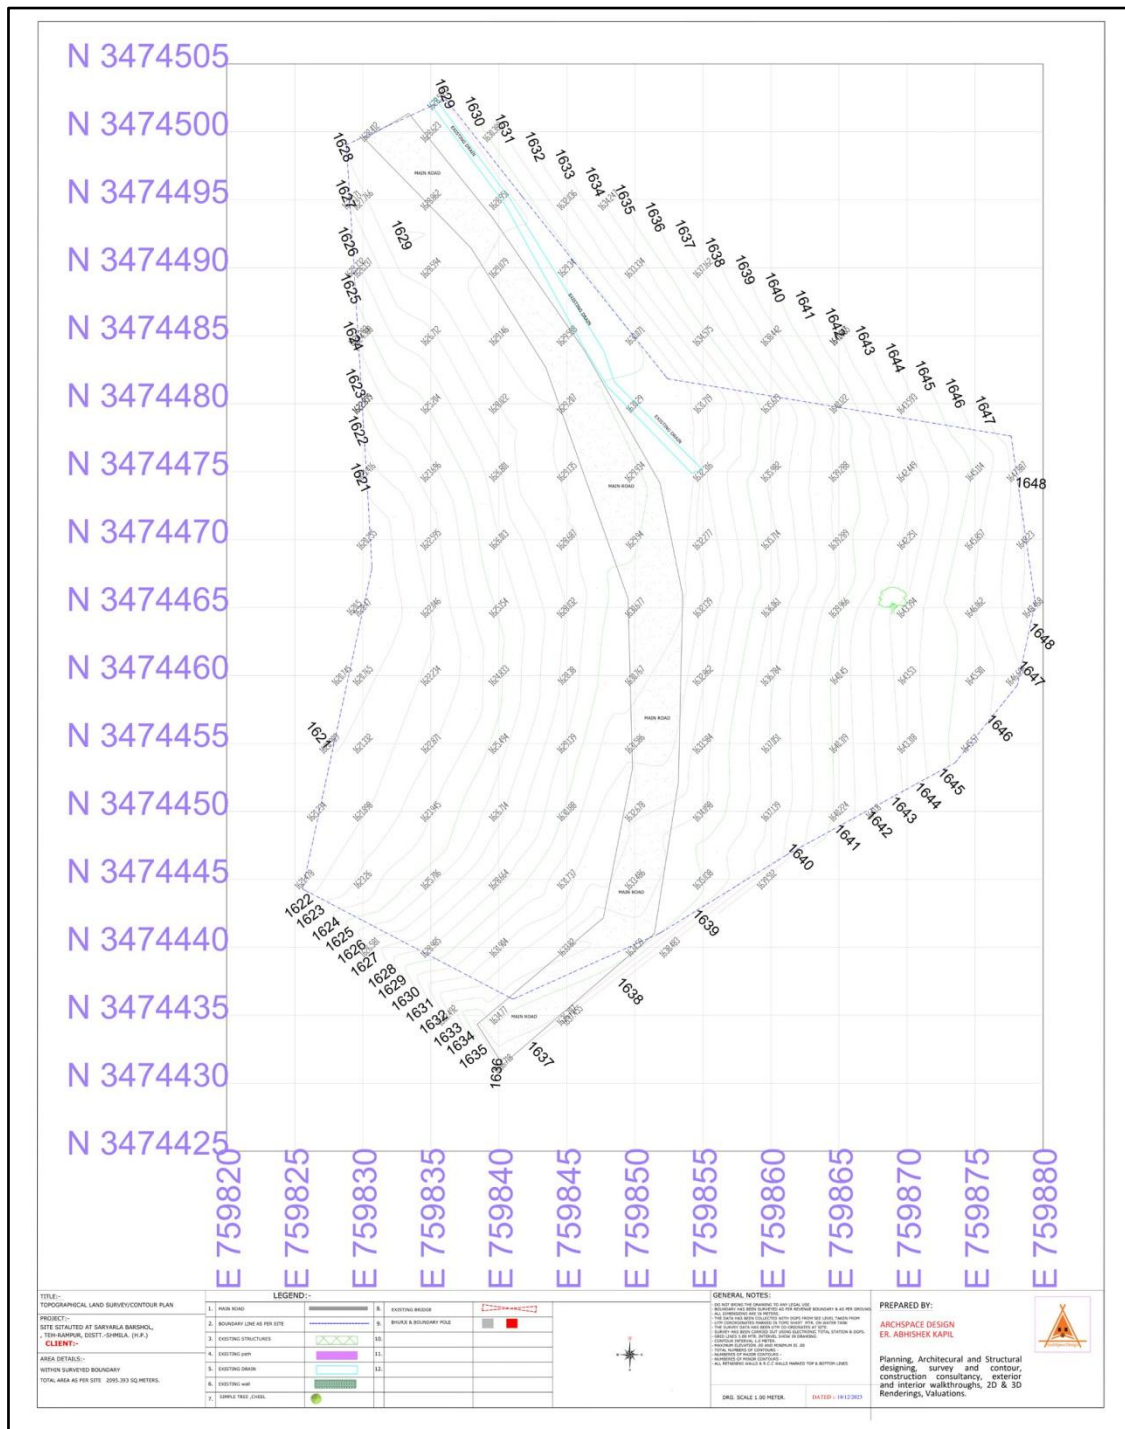
Fig. 76

The Saryarla-Barshol landslide initially occurred in 2005 and was reactivated in July 2023 due to heavy rainfall. The landslide site falls in the Survey of India toposheets 53E/11 at 1:50,000 scale. It is a small translational landslide. During this event, the old road subsided and the waist wall collapsed. This landslide disrupted the road connectivity of Taklech village, which has a population of about 1000 persons in approximately 200 families located above the crown of the site. The entire village of Taklech is at risk of future damage, with about 7 bigha of land susceptible to damage if proper mitigation measures are not taken. During the monsoon, 8-10 houses were vacated. The PWD rest house located above the road is also at risk of being impacted in the future. **Fig. 76** shows a contour map of Saryarla-Barshol, a village prone to landslide, shows a moderate to steep slope, crucial for understanding the landslide disaster. **Fig. 77** and **Fig. 78** offer a panoramic view and a field photograph, with the latter revealing debris flow and deposition zones.

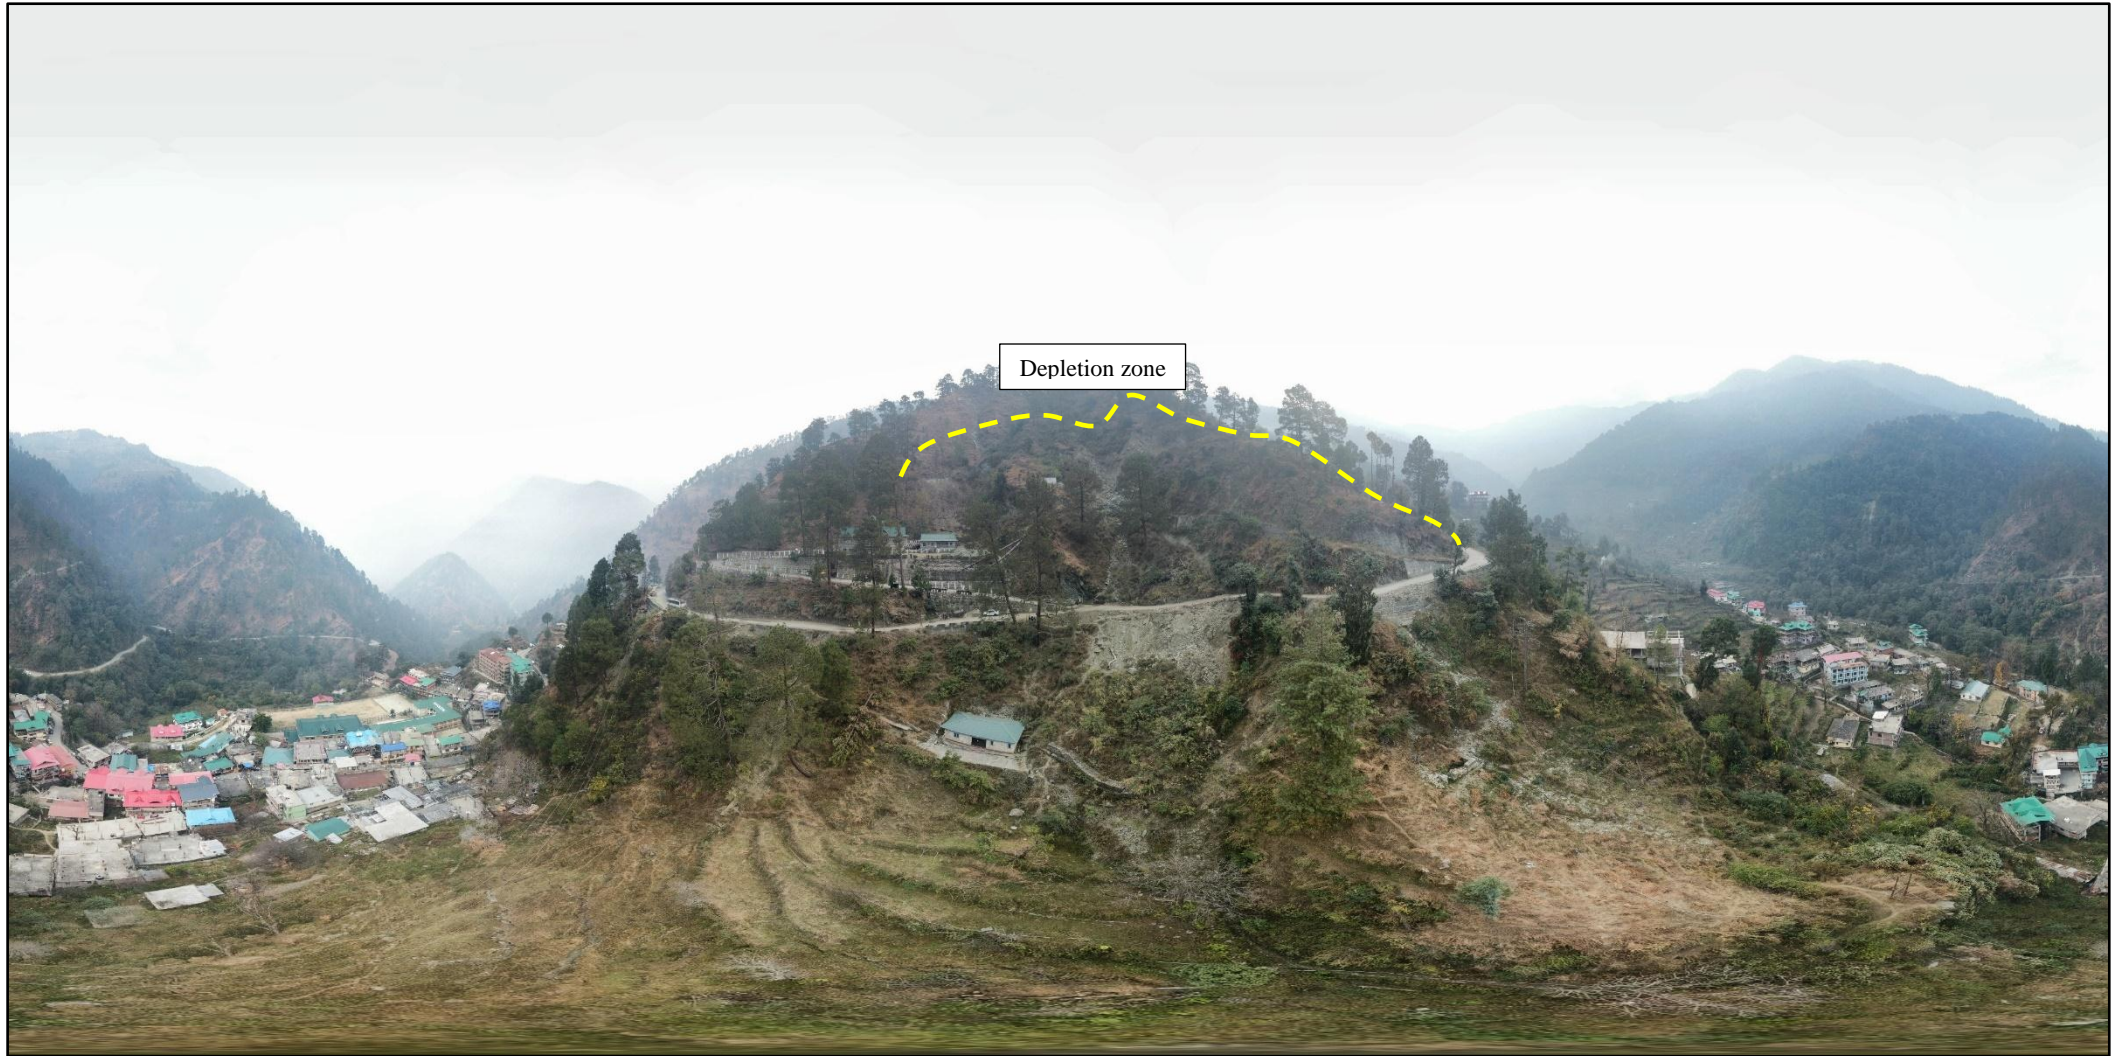
Groundwater conditions on the slope are damp. The main reason for this landslide is heavy rainfall and poor drainage management. Road subsidence also occurred downhill, and the slope at the lower end is very steep, positively correlating with J_1 . This lower slope is kinematically unstable. The burst wall on the slope was damaged during the last landslide. Rainfall on the lower slope acted as a crucial factor in the slope's disruption.

Fig. 77. A panoramic view of Saryarla-Barshol, Rampur landslide site, Shimla district
