## Landslide Compendium of Northwestern Himalayas

विशेष प्रकाशन संख्या 107  
SPECIAL PUBLICATION No. 107

भारतीय भूवैज्ञानिक सर्वेक्षण  
GEOLOGICAL SURVEY OF INDIA

कोलकाता, 2016  
**Kolkata, 2016**

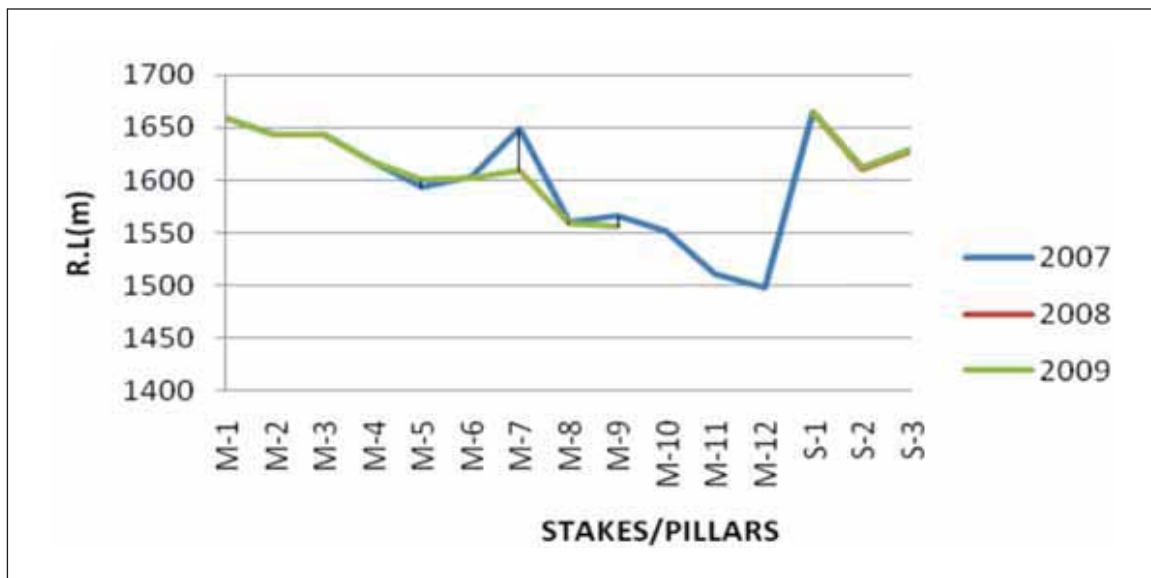
Fig. 3.23. Ground displacement curve obtained using monitoring of stakes/pillars at Surbee landslide zone.

few places. A total of 12 stakes/pillars were installed on both flanks of the Surbee landslide for geodetic monitoring of ground movement using Total Station (Kumar and Sharma, 2011). The surface movement of the stakes planted within the slide body shows insignificant cumulative movement of the order of less than 1 cm in 3 years as monitored between 2007 and 2009 (Fig. 3.23).

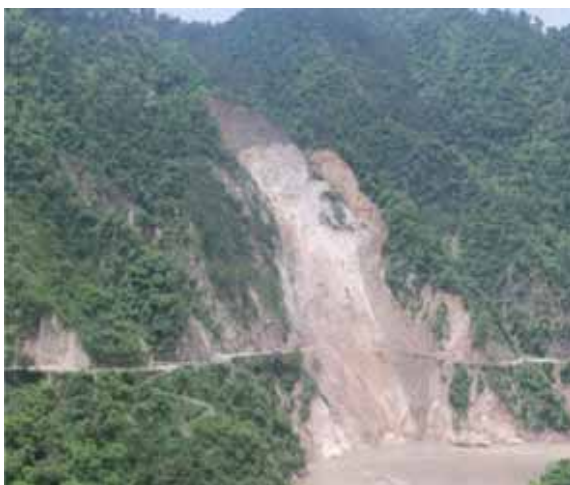
**Sirohbagar (Kaliyasaur) Landslide near Srinagar (Pauri Garhwal)**

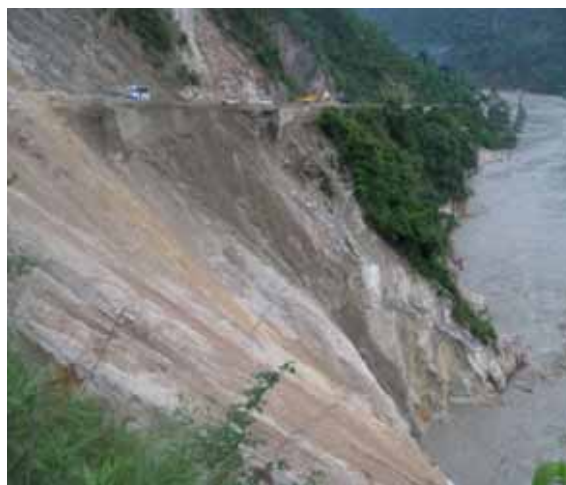
**Lower part of Sirohbagar (Kaliyasaur) Landslide near Srinagar (Pauri Garhwal)**

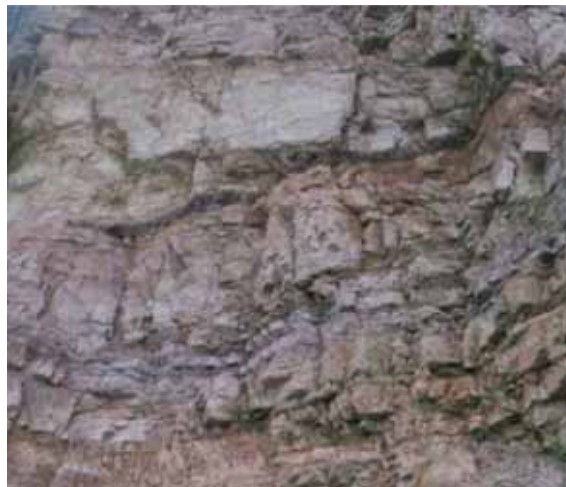
**Quartzites of Garhwal Group at Sirohbagar (Kaliyasaur) Landslide**

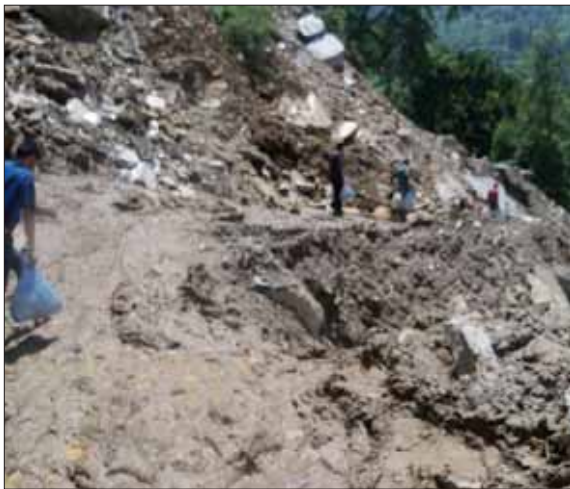
**Composite Landslide at Phata, 6 km for Guptkashi**

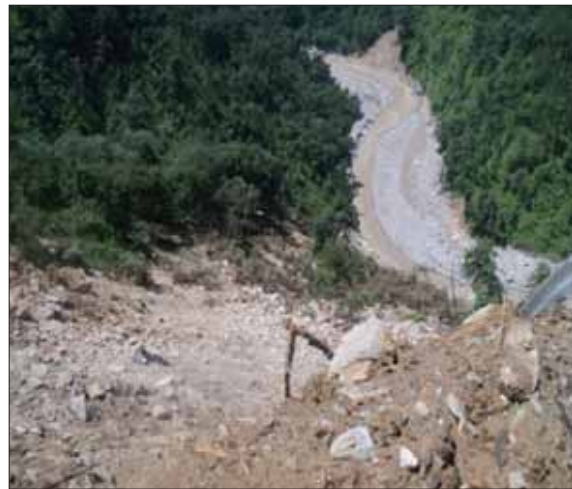
**Too Erosion by Mandakini, Phata Landslide**

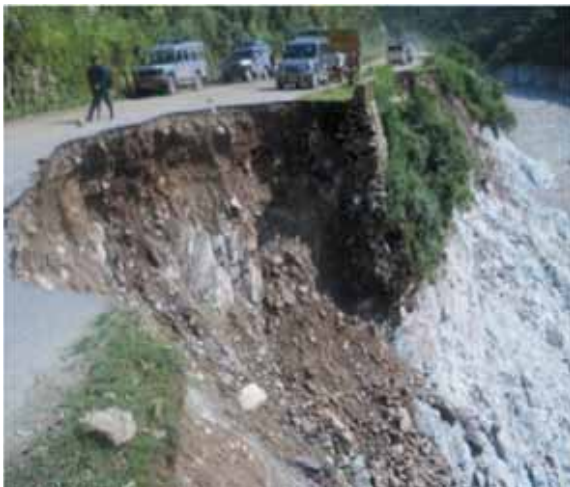
**Road Breach in RBM Near Naulapani  
(Tilwara-Rudraprayag)**

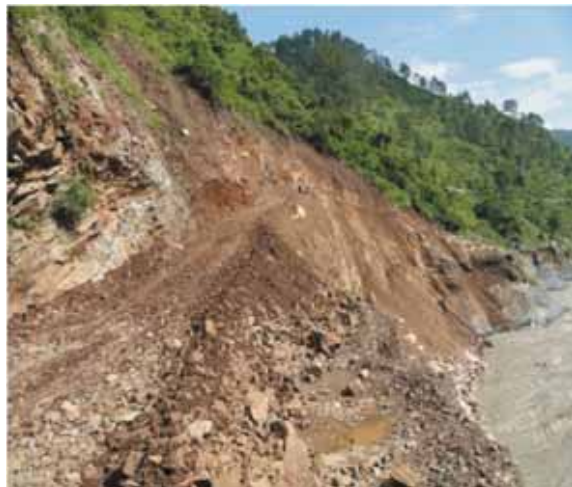
**Slide in RBM at Naulapani (Tilwara-Rudraprayag)**

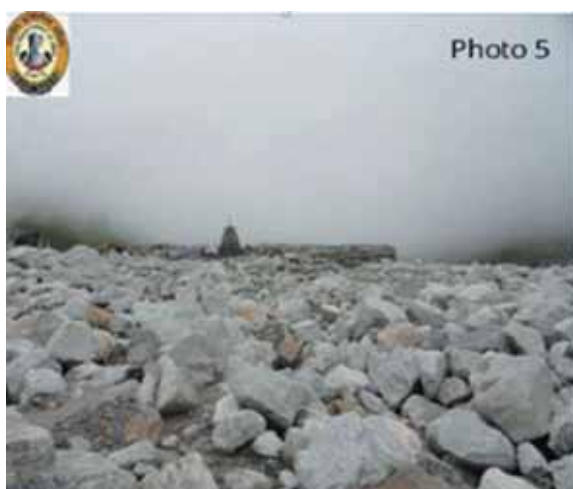
Heap of boulders at the rear side of the temple

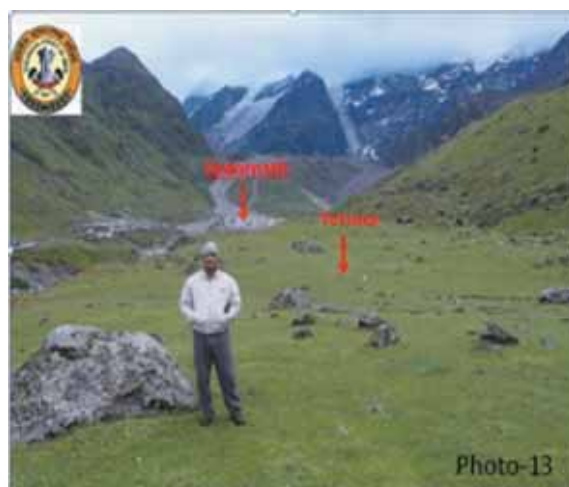
View of Terrace about 1 km down stream of Kedarnath Temple, assessed safer for future developmental activities
