**A NOTE ON PRELIMINARY POST-DISASTER STUDY OF GROUND CRACKS  
AND SUBSIDENCE IN LINDOOR VILLAGE, LAHAUL AND SPITI DISTRICT,  
HIMACHAL PRADESH**

Toposheet Numbers Nos.: 52D/14

Christy Tom, Geologist and Siddhartha Jang Thapa, Geologist  
Geological Survey of India, Northern Region

दिसंबर/ December, 2023

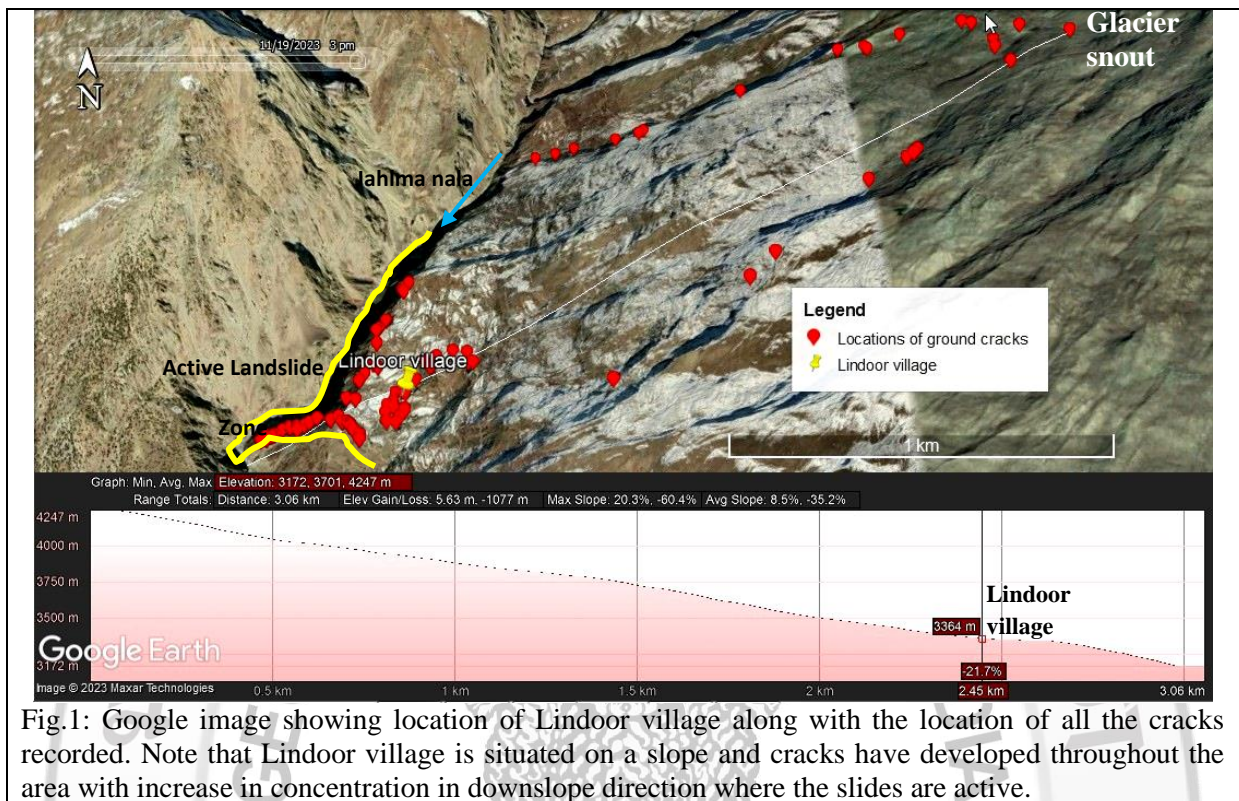
Fig.1: Google image showing location of Lindoor village along with the location of all the cracks recorded. Note that Lindoor village is situated on a slope and cracks have developed throughout the area with increase in concentration in downslope direction where the slides are active.

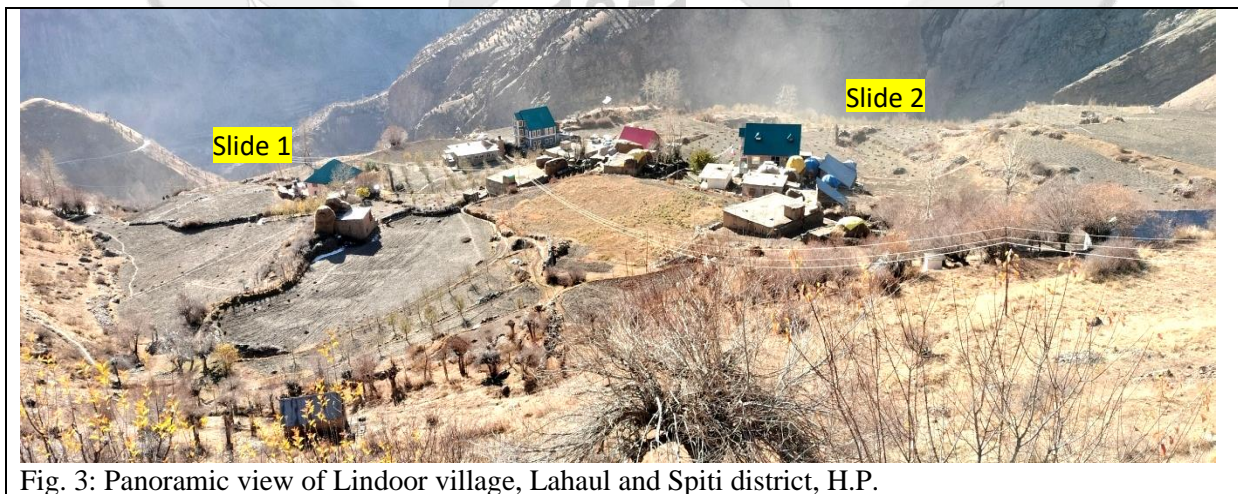
Fig. 3: Panoramic view of Lindoor village, Lahaul and Spiti district, H.P.

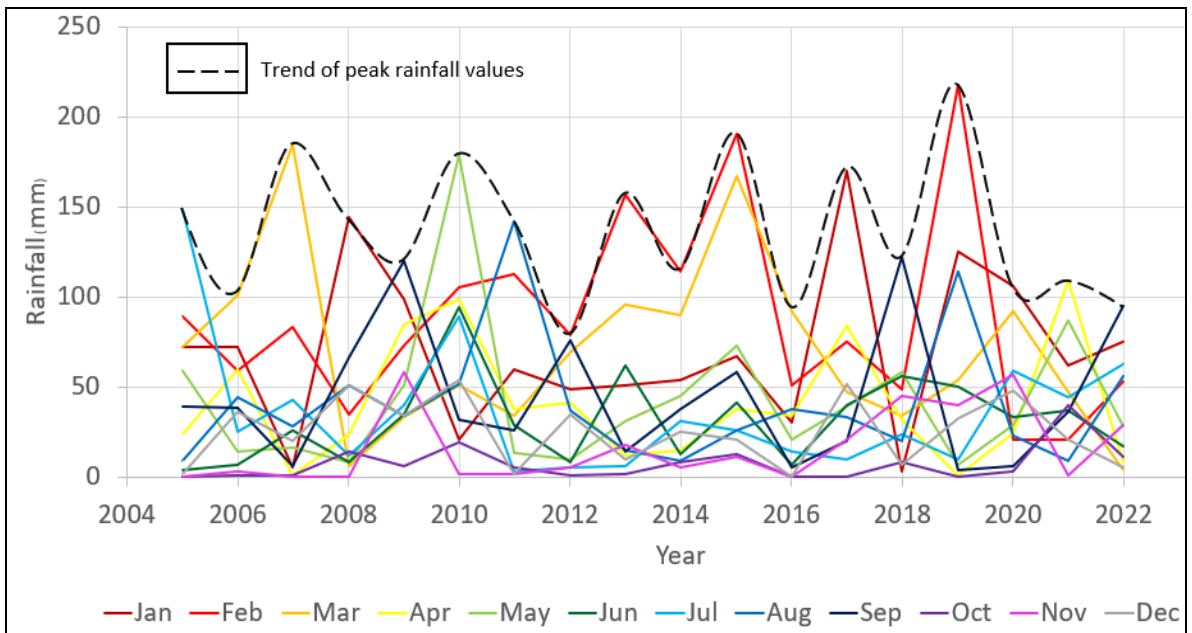
- (3) The available rainfall data (source: IMD) for the period from Jan 2005 to Dec 2022 (Annexure-III) has been analysed. The month-wise rainfall plot for the period is shown in Figure 25. The Annual rainfall (Figure 26) and Monsoonal rainfall ranges from 291.5 mm to 796.5 mm and from 35 mm to 212.9 mm (Figure 27) respectively. In the absence of data on ground deformation and its chronology, correlation of rainfall with ground deformation could not be carried out.

Fig.25: Total monthly rainfall data (mm) of Keylong, Lahaul & Spiti district, HP from 2005-2022.

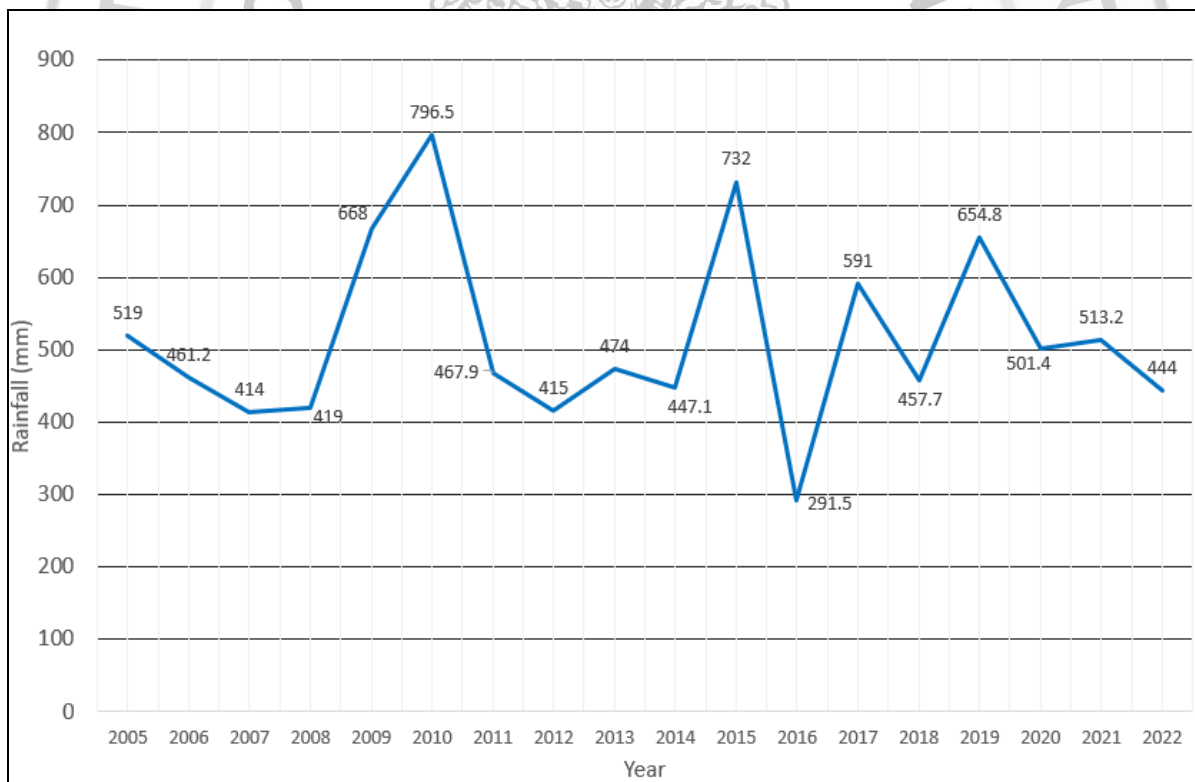
Fig.26: Total annual rainfall data (mm) of Keylong, Lahaul & Spiti district, HP from 2005-2022.

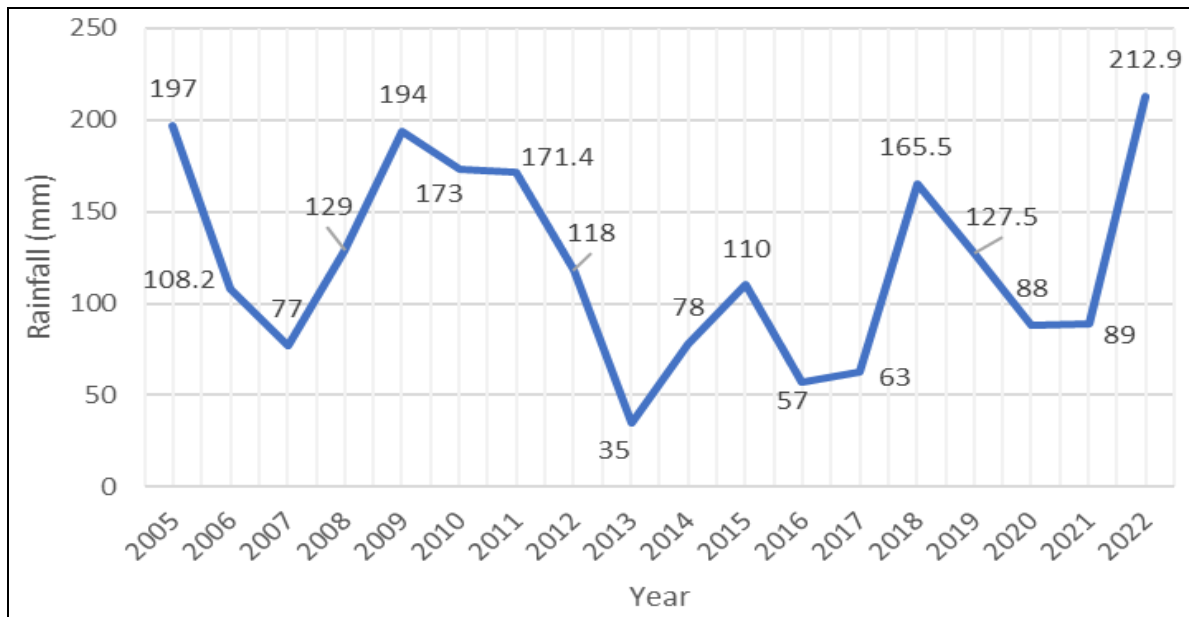
Fig.27: Total monsoonal rainfall data (mm) of Keylong, Lahaul & Spiti district, HP from 2005-2022.

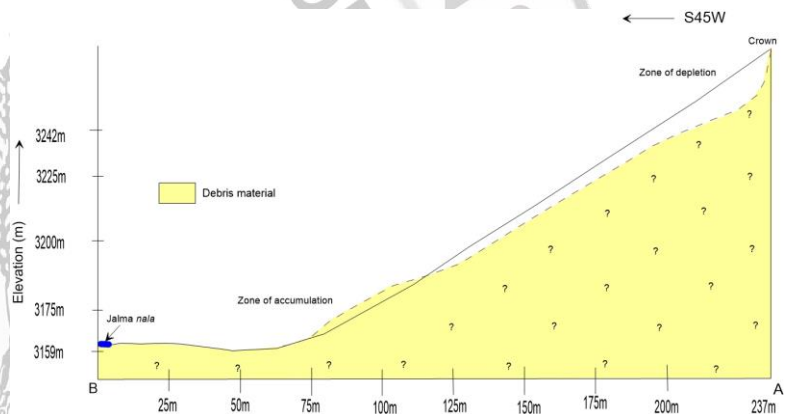
Fig.4: Schematic cross-section of Lindoor Debris/Talus Slide 1, Lahaul & Spiti District.

40	Summary/Abstract	<p>As per the information from the villagers, the slide has been initiated somewhere near the year 2000. Since then, minor overburden sliding has been continuously been occurring but the slide has been majorly reactivated during the month of August 2023. As per media reports, 12 houses have developed cracks and fissures have also developed all over around 200 bighas of land. These reports were confirmed during the ground visit and found that these settlements are present ~300 m above the crown of the slide. The reasons could be attributed to the following: increased pore-water pressure in the debris/talus material possibly brought on by seepage of water (streamlet coming/flowing down) from upper slopes and <i>Kuhl/nala</i> passing all over the village areas used for water supply and irrigation purposes causing the ingress of water above the slide zone; or thrust/pressure exerted on left bank slopes comprising of debris material and resulting toe erosion by <i>Jahlma nala</i>.</p>

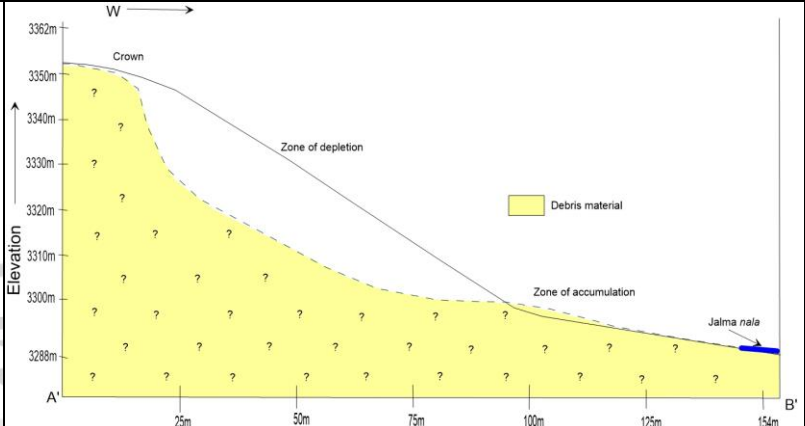
<p>Fig.3: Schematic cross-section of Lindoor Debris/Talus Slide 2, Lahaul &amp; Spiti District with seepage of water.</p>
40	Summary/Abstract	<p>As per the information from the villagers, the slide has been initiated somewhere near the year 2000. Since then, minor overburden sliding and fall has been continuously been occurring but the slide has been majorly reactivated during the month of August 2023. According to the villagers, blasting was carried out at the toe of the slide/fall zone for river water channelization by villagers of other villages. The blasting has been stopped after appeal by the villagers of Lindoor. As per media reports, 12 houses have developed cracks and fissures have also developed all over around 200 bighas of land. These reports were confirmed during the ground visit and found that these settlements are present ~250 m above the crown of the slide. The reasons could be attributed to the following: increased pore-water pressure in the debris/talus material possibly brought on by seepage of water (streamlet coming/flowing down) from upper slopes and <i>Kuhl/nala</i> passing all over the village areas used for water supply and irrigation purposes causing the ingress of water above the slide zone; or thrust/pressure exerted on left bank slopes comprising of debris material and resulting toe erosion by <i>Jahlma nala</i>.</p>
