**A site visit report on Short and Long term mitigation measures for
landslides and land subsidence across Sirmaur district in the state of
Himachal Pradesh**

**Submitted to
Himachal Pradesh State Disaster Management Authority (HPSDMA)
Himachal Pradesh**

**Submitted by
Geotechnical Engineering and Geo-Hazard Group
CSIR-Central Building Research Institute
Roorkee-247667, Uttarakhand**

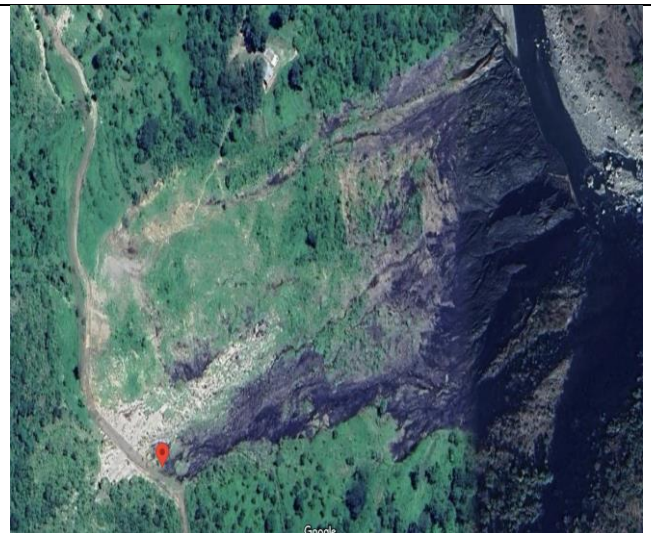
Lana Rauna site, Neri Nawar Panchayat, Pachhad Subdivision (road passing through slide zone)

Lana Rauna site, Neri Nawan panchayat, Pachhad subdivision	Height of slope around 100 m high on hill side and 400 m on valley side.	Width of site is approximately 800 m	Steep slope between 60° to 75° on both hill and valley sides	30°48'02.9"N, 77°15'36.2"E	Highly disintegrated rock mass and major presence of fines materials	Chronic from last 25-30 years	Low shear strength of strata, Water ingress in slope during rains and inadequate drainage, Toe cutting by Giri river during rains	Anchors, grouting Bioengineering, Geosynthetic retaining structures to arrest slope movement. Rock fall barriers for rock fall protection. Building condition survey (BCS) for nearby affected structures. Provision of drainage holes, drainage paths, culverts etc. River training works on valley side. Continuous monitoring & relocation and emergency evacuation plans	B.2
Chunnar site, Neri Nawan panchayat, Pachhad subdivision	Height of slope around 1000 m high on hill side and 5-10 m on valley side.	Width of site is approximately 1500 m		30°46'31.6"N, 77°17'48.3"E	Debris & Talus on hill side, Highly disintegrated rock mass and major presence of fines materials	Not chronic, from last 5-10 years	Low shear strength of strata, Water ingress in slope during rains and inadequate drainage, Toe cutting by Giri river during rains	Anchors, grouting Bioengineering, retaining structures to arrest slope movement. Rock fall barriers for rock fall protection. Building condition survey (BCS) for nearby affected structures. Provision of drainage holes, drainage paths, culverts etc. River training works on valley side. Continuous monitoring of slope & relocation and emergency evacuation plans	B.3

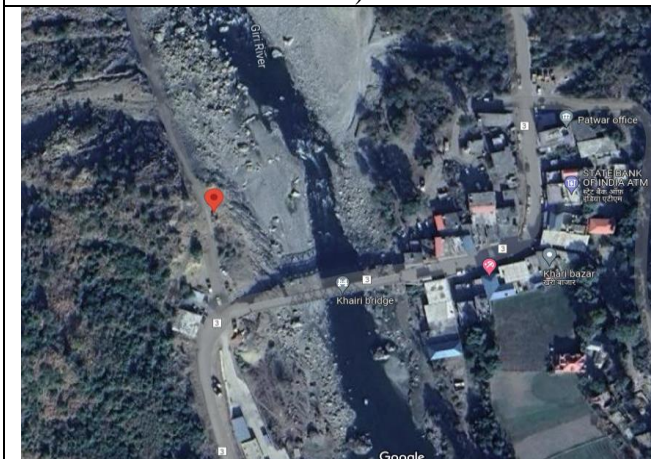
Chunnar site, Neri Nawar panchayat, Pachhad subdivision (road passing through slide zone)

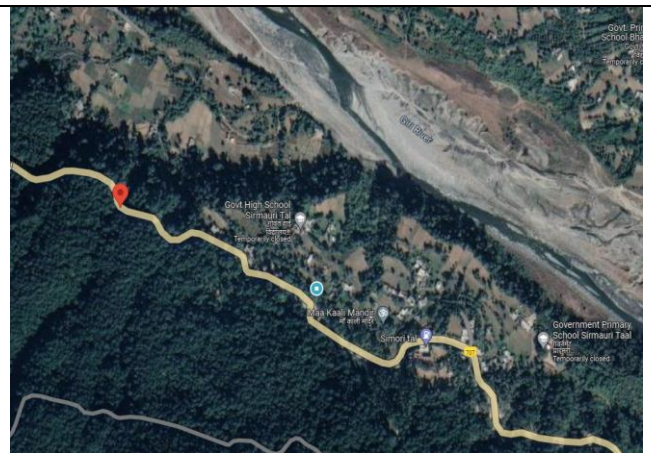
Katchi Dhang NH-707 site, Village Sirmauri Tal, Paonta Sahib Subdivision (Chainage km 14+165), instability in major road passing through slide

<p>Katchi Dhang NH-707 site, Muglawala Kartarpur Panchayat, Village Sirmauri Tal, Paonta Sahib Subdivision (Chainage km 14+165)</p>	<p>Height of slope around 30 m on hill side and 70-80 m on valley side.</p>	<p>Width of site is approximately 300 m</p>	<p>Moderately Steep slope between 60° to 75°</p>	<p>30°32'42.1"N, 77°38'45.2"E</p>	<p>Jointed rock mass overlain by soil mix boulder (mostly on hill side), highly sheared rock mass on valley side</p>	<p>Not chronic</p>	<p>Presence of loosened rock joints and debris on hill side slope, water ingress in slope during rains, Toe instability on valley side</p>	<p>Rock nets, Self-drilling anchors (SDA's), Bioengineering, masonry retaining structures to arrest slope movement. Debris fencing near outfall. Provision of drainage holes, drainage paths, culverts etc. along the slide</p>	<p>C.1</p>
<p>Katchi Dhang NH-707 site, Muglawala Kartarpur Panchayat, Village Sirmauri Tal, Paonta Sahib Subdivision</p>	<p>Height of slope around 50 m on hill side and 30 m on valley side.</p>	<p>Width of site is approximately 450 m</p>	<p>Moderate to quite Steep slope between 70° to 80°</p>	<p>30°32'55.0"N, 77°38'19.3"E</p>	<p>Very blocky to highly disintegrated rock mass (mostly on hill side), Debris material on valley side</p>		<p>Presence of highly sheared & disintegrated rock mass and debris on the slope, water ingress in slope during rains, Toe instability on valley side slope caused by river erosion</p>	<p>Rock nets, Self-drilling anchors (SDA's), Bioengineering, masonry retaining structures to arrest slope movement. Provision of drainage holes, drainage paths, culverts etc. along the slide. Provision of river training works for valley side slope</p>	<p>C.2</p>

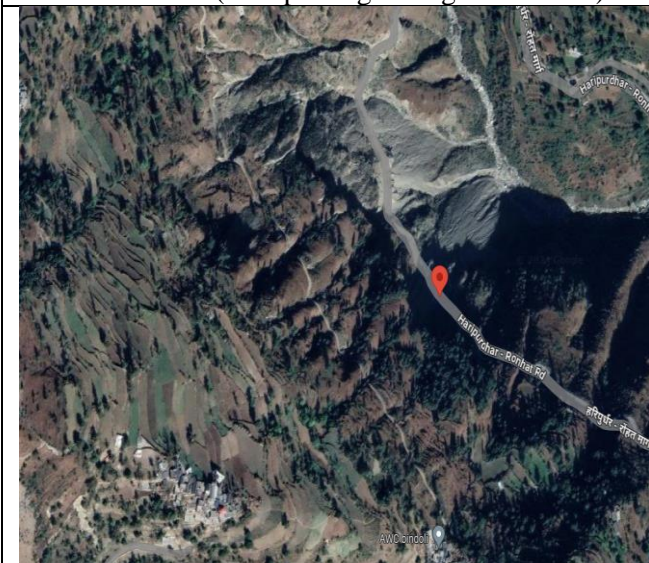
Bindoli site, Ajroli Panchayat, Shillai Subdivision (road section passing through slide & habitation)

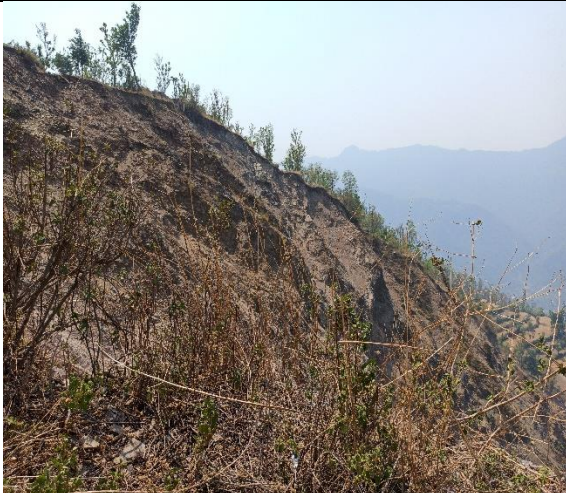
Fig. 2 Disintegrated rock mass and soil fines with boulders in strata

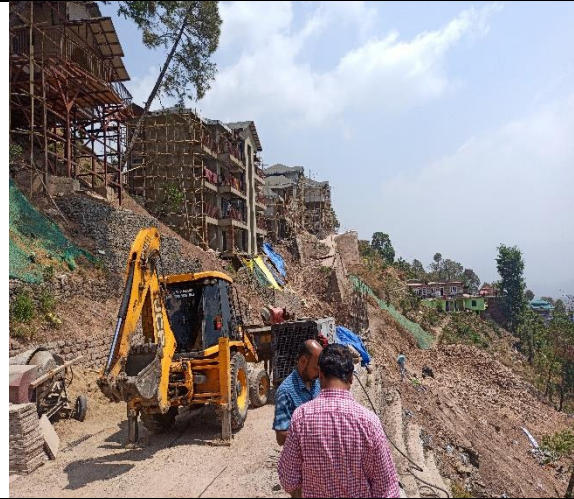
Fig. 2 Both hill and valley side instability and high building loads on slope

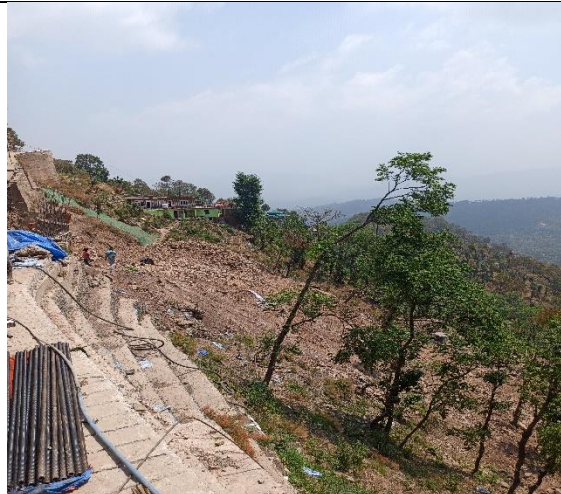
Fig. 3 Buildings present on fringes of slope

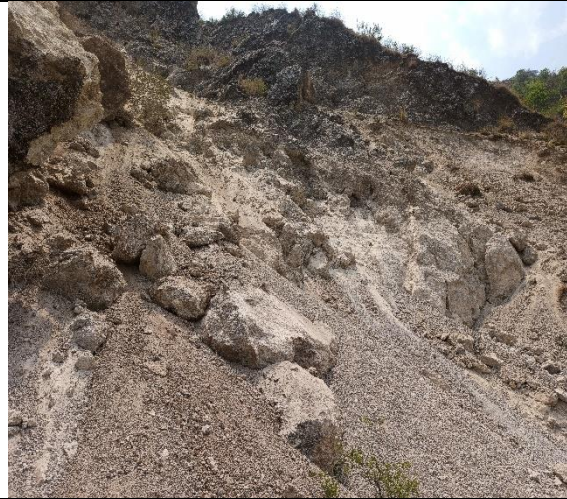
Fig. 2 Significant rock fall potential on hill side slope

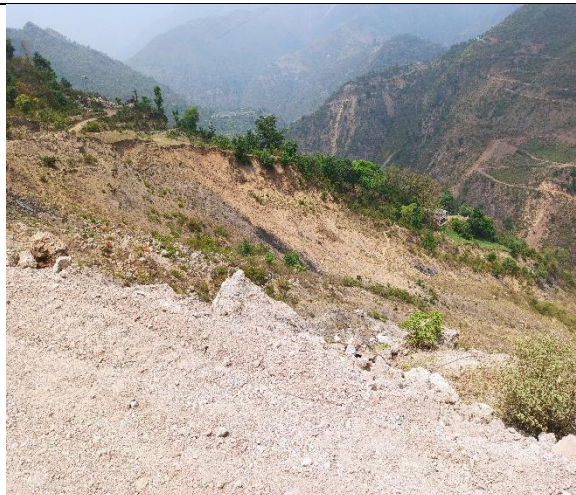
Fig. 6 Instability on valley side affecting infrastructure

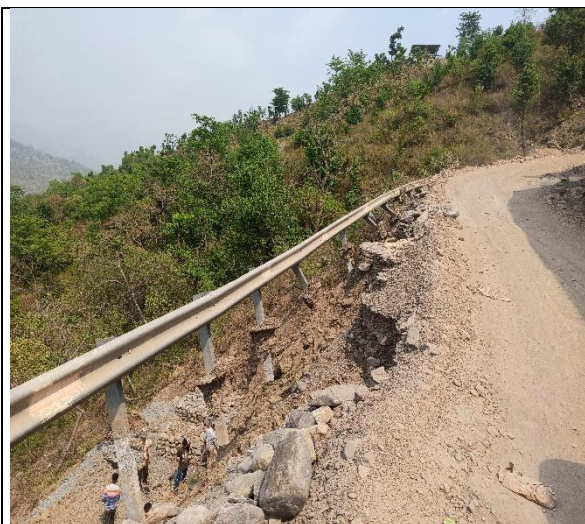
Fig. 3 Fine soil and debris material and erosion of road

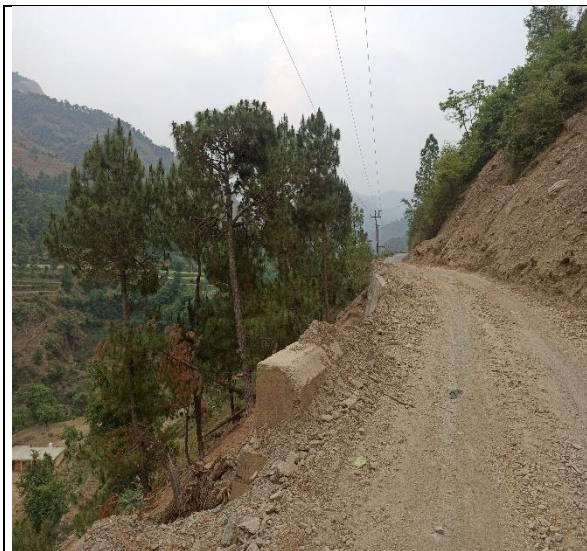
Fig. 3 State highway passing through slide zone & tree tilting indicating ground movement

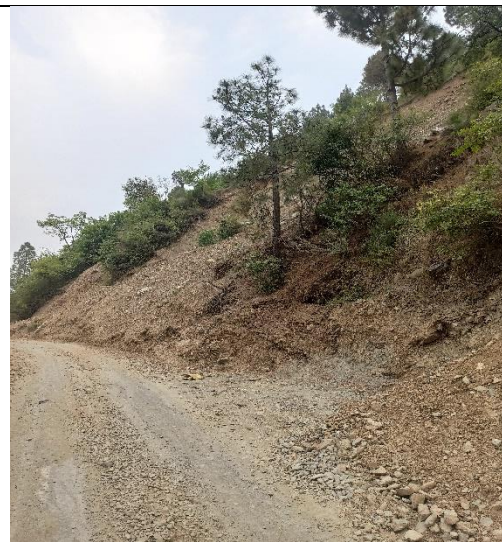
Fig. 4 Large debris overburden and minimum vegetation on hill side slope

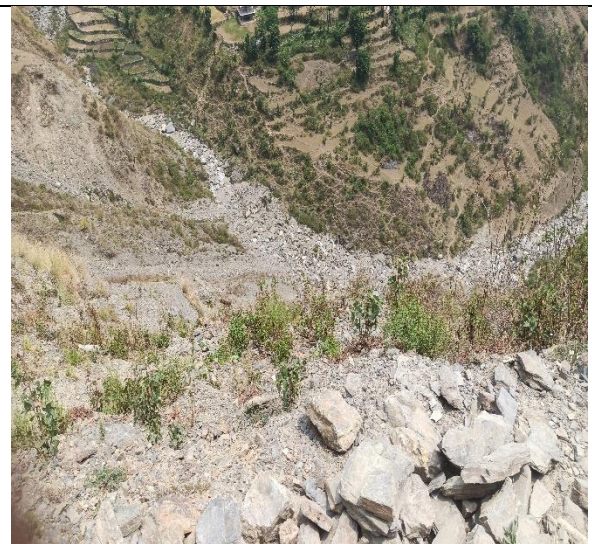
Fig. 2 Debris material visible on valley side slope along with seasonal stream

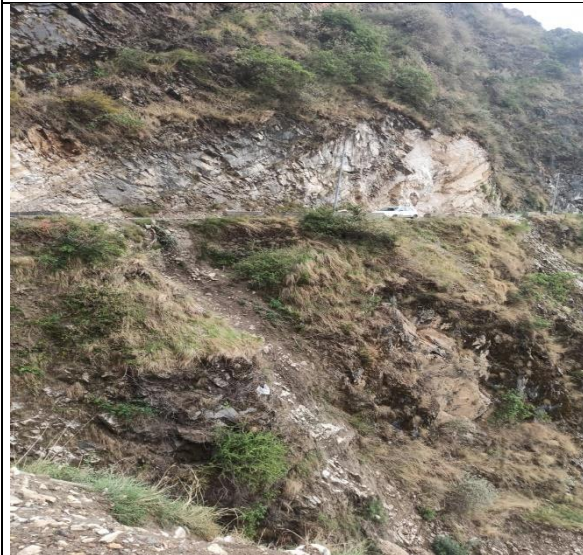
Fig. 3 Steep slope on hill and valley side. Valley side has thin layer of debris underlain by jointed rock mass
