REPORT ON THE PRELIMINARY ASSESSMENT OF LANDSLIDE INCIDENCE AT URNI,
DISTRICT- KINNAUR, HIMACHAL PRADESH

Item Code: NR/PHP/2014/041 /076
(Field Season: 2014 -15)

By
Rahul Vadakkedath, Geologist
and
A Ramesh Kumar, Geologist

Engineering Geology Division

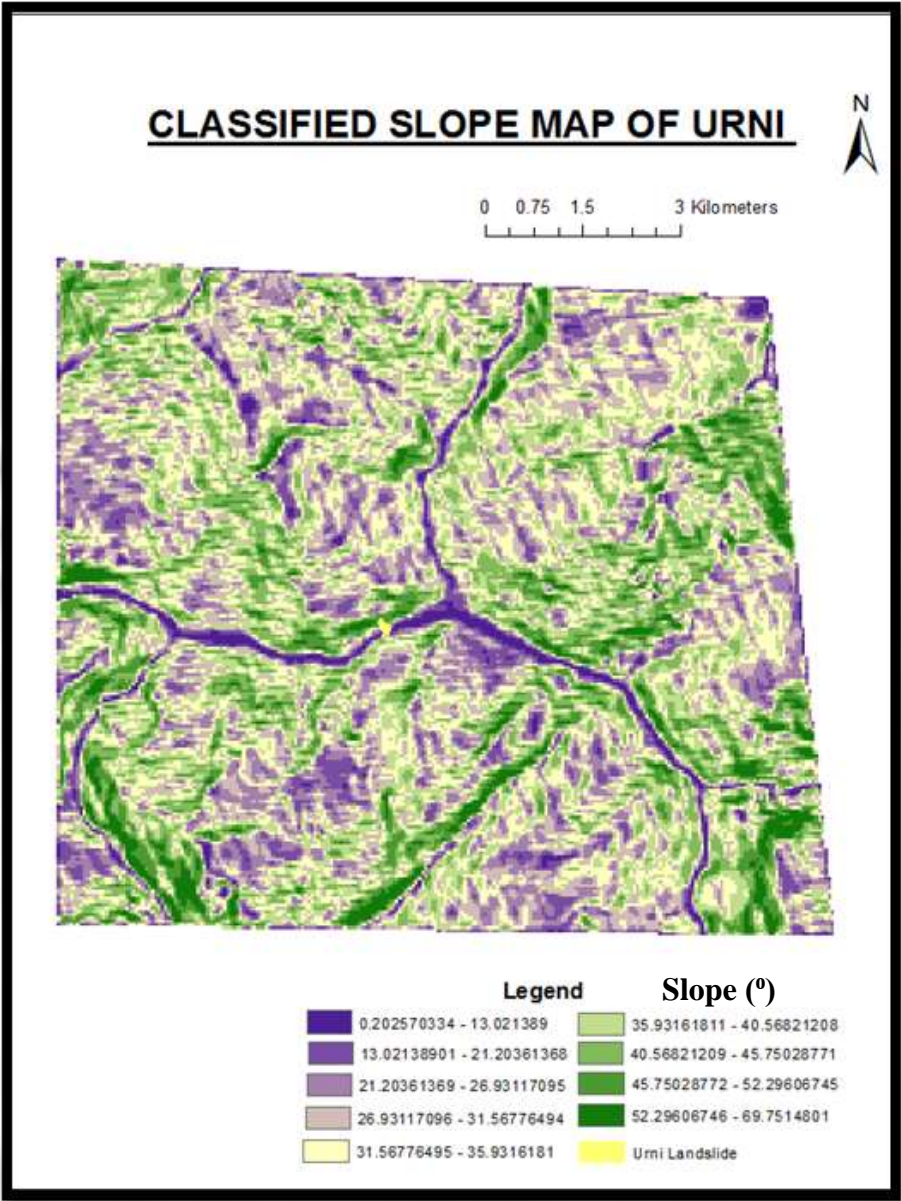
Plate 2 Slope map of Urni area showing the location of Urni landslide

The Urni landslide is on the right bank of Sutlej River which is flowing towards the WSW direction. The slide exhibits a moderate slope of 40°-45° **(Plate 2)**. Whereas, the left bank of the Sutlej River exhibits a steep rocky knob, the right bank exposes thick overburden comprising of debris.

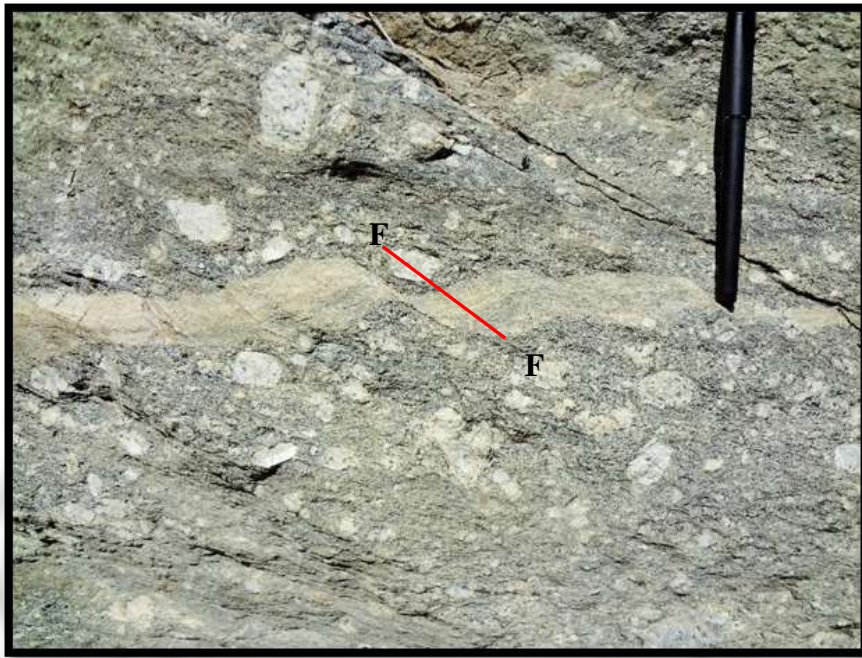
Fig 1 Rock showing feldspar crystals along with boudins and micro fault.

The study area is bounded by MCT (Main Central Thrust) in the south and Indus Tsangpo Suture Zone in the north. The lithounit exposed in the study area comprises of augen / porphyroblastic gneiss with K and Na Feldspars in association with biotite, muscovite and quartz. **(Fig-1)**. The bedrock is overlain by thick glacio-fluvial deposits with silt sized sediments and many erratic boulders. The rock has well developed foliation trending N75°W- S75°E and dipping 30° towards NE direction which is against the valley slope. Also, the rock shows three sets of prominent joints, the characteristics of which are enumerated in Table-2. The interplay of these joint sets forms wedge failures, observed along the road section. Valley dipping joint J₂ with intersection of J₁ and J₃ joint sets leads to the slope failure. Field data reveals that, the area had undergone poly phase deformations vise fold, faults, shears, etc. as evidenced by the development of augen structures in the gneisses, stretching and realignment of mineral grains, boudins, striations, slickensides, etc. **(Fig-2,3)**. Further, a N-S trending fault has also been reported near Kilba (B.S Dorka et al- 1997).
