**A NOTE ON THE PRELIMINARY ASSESSMENT OF LANDSLIDES ALONG THE
KALKA-KHAB NATIONAL HIGHWAY-05, COVERING PARTS OF SOLAN, SHIMLA &
KINNAUR DISTRICTS AND AROUND SHIMLA URBAN AREA HIMACHAL PRADESH**

(SoI Toposheet No.: 53B/13, 53F/01, 53E/04, 53E/08, 53E/11, 53E/14, 53I/02 & 53I/09)
[Item No. M4EGG/C/NR/SU-PHP/2023/45656]
(Mission - IV/ Field Season: 2023-24)

जनवरी /January, 2024

By
Lalit Mohan, Senior Geologist,
Shreyasi Mahapatra, Senior Geologist,
Geological Survey of India,
State Unit: Punjab, Haryana & Himachal Pradesh,
Chandigarh

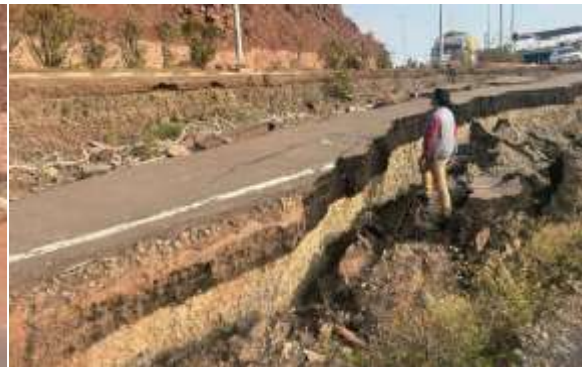
A rotational failure has been suspected along the slided slope. The manifestation of the same on ground was in the form of arcuate subsidence zones prevailing at least at two levels as observed during field study. Several wide cracks were observed at the Dimple dhaba. The cracks were trending $N25^{\circ} E$ and upto 6 -10 m long and 1m wide (Figure 6a and 6e). The subsidence in the land was upto 3m. The Dimple Dhaba had completely collapsed due to the slide (Figure 6b and 6d).

Figure 6 (b) subsidence upto 2 m near Dimple Dhaba.

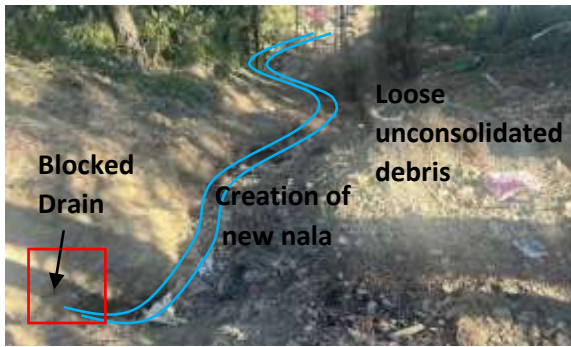
The landslide zone is located on the Shimla Bypass road at N 31°5'50" and E 77°9'13" and falls in Survey of India Toposheet no. 53E/04. The slide lies at an elevation of ±1941m MSL. On the night of 14th August 2023, at around 8:30 pm, approximately a 05-m stretch of the NH caved in following a major slide. The slide was primarily caused by oversaturation of the loose overburden material owing to the incessant rains on preceding days of 12th and 13th of August, 2023. On inspection of the crown portion of the slide, a blocked drainage pipe of approx. dia. 25 cm and a leaking agricultural pipe was observed as shown in fig 7 (b). The blocked drain has led to a creation of a new nallah having dimensions roughly 1.5 m wide and 1 m deep as depicted in fig 7(a).

Figure 7 (a) New nalah created at site of slide

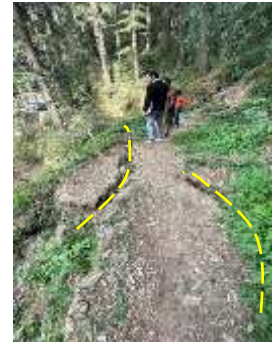
The observations revealed the landslide to be a debris slide presently triggered due to slope saturation. Landslide is a result of rotational mass failure occurred due to slope failure of unconsolidated slope material and saturation due to rainwater ingress and excessive erosion by the nalas. A retrogressive rotational failure is confirmed by presence of tension cracks, subsidence and titling of trees (Fig8 (f) and (g)) at the crown of the slide as confirmed by the locals.

Figure 8 (g) Titling of trees and ground cracks observed at crown

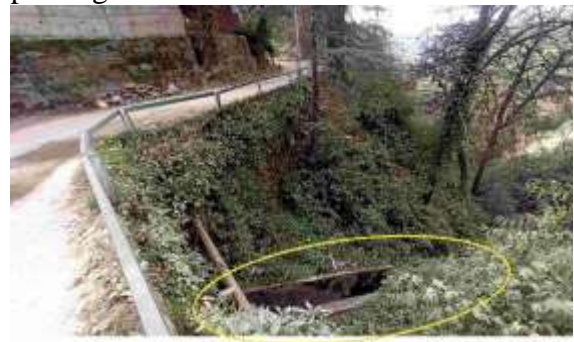
f) Flowing nala along the right flank of affected area.

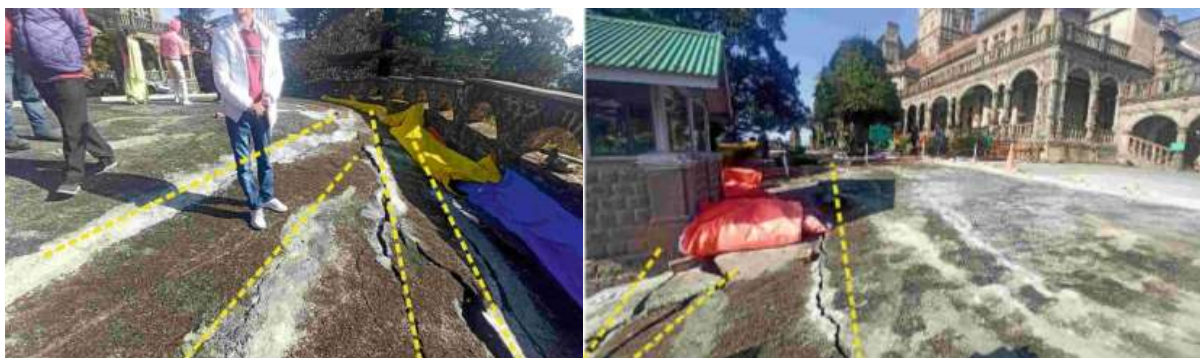
b. Easterly facing affected zone.

c. Westerly facing affected zone.

Fig. 10 Gound cracks observed at the main entrance of IIAS.

The width of cracks ranges from a minimum of 5mm upto a maximum of 25cm and can be traced upto a length of 10-15m. These ground fissures have a general trend of N50°-70° and are mostly longitudinal in nature (Fig. 10b and c). An approximate ground subsidence of 1-1.5ft could be observed towards the boundary wall side, just at the entry point. The inner boundary wall itself has suffered damage and is tilted. The retaining wall has bulged and partially damaged at one location and its highly possible that it may fail in case of heavy rainfall (Fig. 10 c, d, e and f).

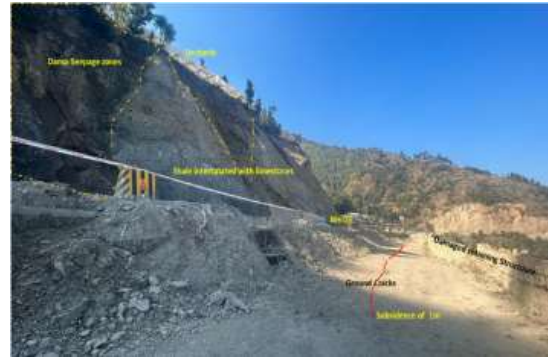
Several seepage spots were also observed below road level (Fig 13 (f)) and within the erected retaining wall towards valley side. The gabion walls constructed within the distressed zone have been tilted, partly damaged and needs to be repaired (Fig 13 (b) & (d)). Within the affected area loose boulder to pebble size with semi consolidated sand and silt and minor clay material formed the dominant slope forming material of the slide.

Figure 13 (f) Damp zones and orchards on upslope of Mansar slide

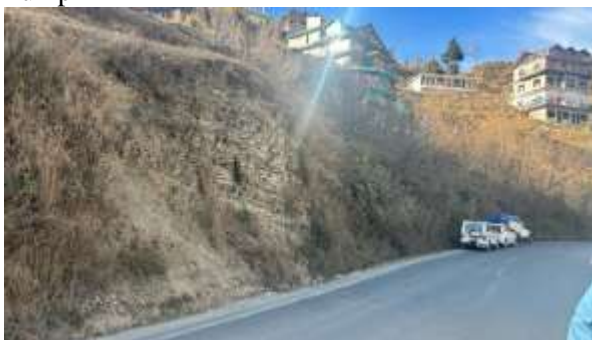
Figure 16 (c) Alternate bands of quartzite and slate of Basantpur Formation

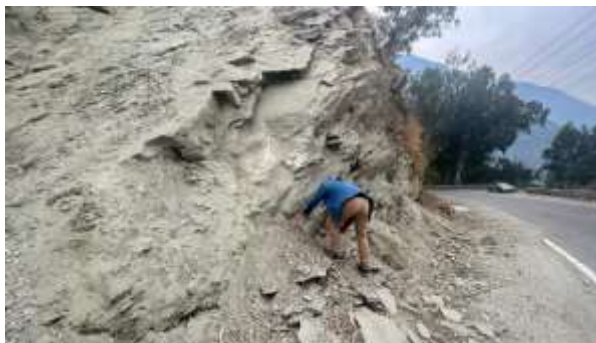
Figure 19 (c) Jointed Phyllites of Banjar Formation of Rampur Group

The area has already been identified as Moderate landslide susceptibility zone by Geological Survey of India (GSI, 2018-2019). The quartzite and phyllite are highly jointed (Fig. 19 (c) & (d)). Three set of joints were observed. The details of the joints as observed at the site is tabulated in Table 9.

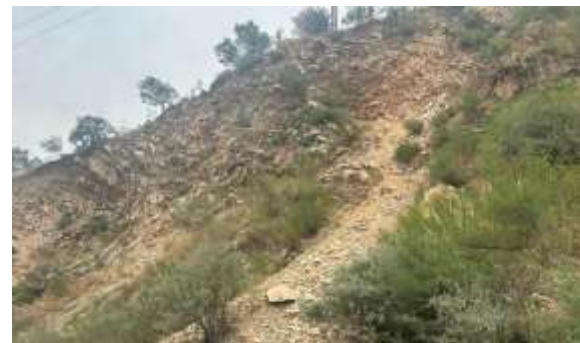
Figure 19 (d) Highly weathered and Jointed quartzites of Manikaran Formation

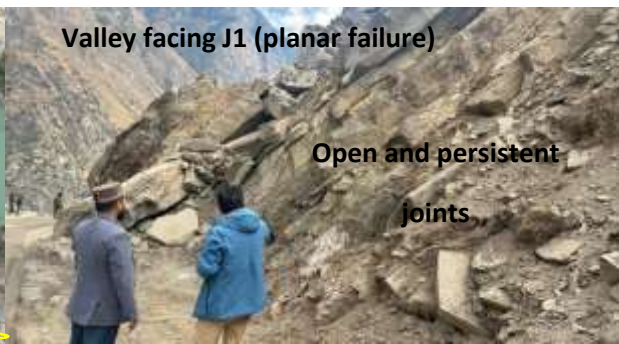
The presence of highly jointed fragile rock mass with large open joints with overhanging rock blocks acts as a catalyst to engrave the size of landslide. The steep escarpment is the source for rock material, which during heavy rainfall (Figure 25 (g)), destabilizes the zone further. The bed rock mostly comprises rocks of Jeori-Wangtu gneiss. The rocks are highly jointed and dipping N265 that is towards the valley (Figure 25 (e)).

Figure 25(e) Open and persistent Valley facing joints

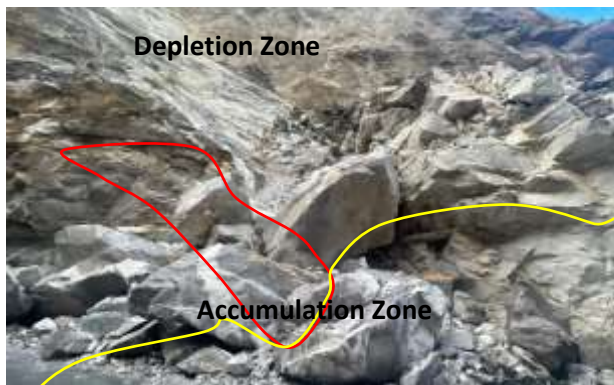
The rock-slide area is located on the left bank of Sutlej River, constitutes a steep sun-facing hill slope as shown in Fig 26(a). The rock-fall, in fact rock wedge failures frequently occurs in the upper part of a major escarpment represented by highly jointed quartzite and phyllite of Morang Formation of Vaikrita Group intruded by Nako Granite (Fig 26 (b)).

Figure 26(a) Rock slide at Khab, Kinnaur

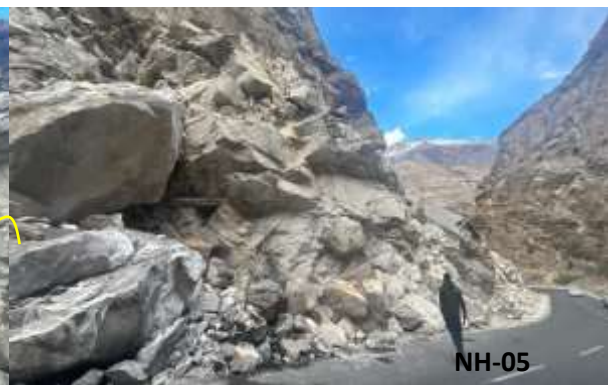
Figure 26(b) Large boulders along NH-05, Kinnaur

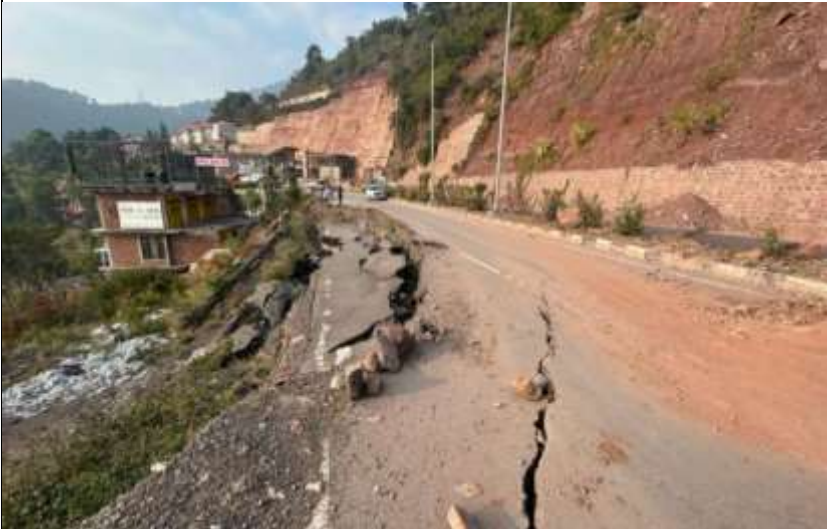
40	Summary/Abstract	<p>It was observed that there is creep movement for most parts along the hill slopes along which the road twirls. The evidences of creep movement such as tilted trees, bulging in retention structures/walls, differential settlements etc. were observed during the uphill and downhill trekking. It was found that the buildings were constructed over the unconsolidated debris material comprising silty sand matrix. The slope instability affected locations are in the form of a slip circular failure. The manifestation of the same on ground was in the form of arcuate subsidence zones prevailing at least at two levels as observed during field study. Several wide cracks were observed at the Dimple dhaba. The cracks were trending 25° and upto 6 -10 m long and 1m wide. The subsidence in the land was upto 3m. the dimple dhaba had completely collapsed due to the slide.</p>

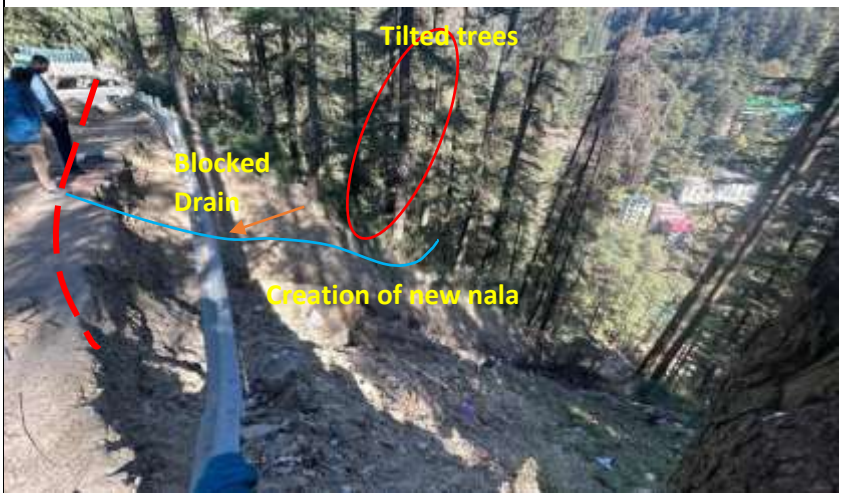
<p>own of slide at the road level</p>
40	Summary/Abstract	<p>The slide was primarily caused by oversaturation of the loose overburden material owing to the incessant rains and the blocked drain. The debris slide is attributed to weakened slope debris due to water ingress and subsequent slope saturation by heavy rain. The landslide is active having its toe terminating in mid hill part with its debris material running to the houses beneath. The landslide incidence caused deaths of 6 livestock (cows) and injury to several people. The cow shed located just below the slide zone was completely damaged. Many trees (Forest Numbered) were also uprooted. Shallow rotational failure triggered due to the super saturation of the overburden cover material. The creation of the new nalah along the steep slope will further widen during the successive monsoon season. Necessary remedial measures have been suggested to contain the road to cave in further which included Construction of proper lined drainage along hill side to arrest maximum infiltration of water surface water into distressed zone. It is also suggested that the trained drainage should be connected with the main Khad to avoid surface water discharge on the distressed slope.</p>

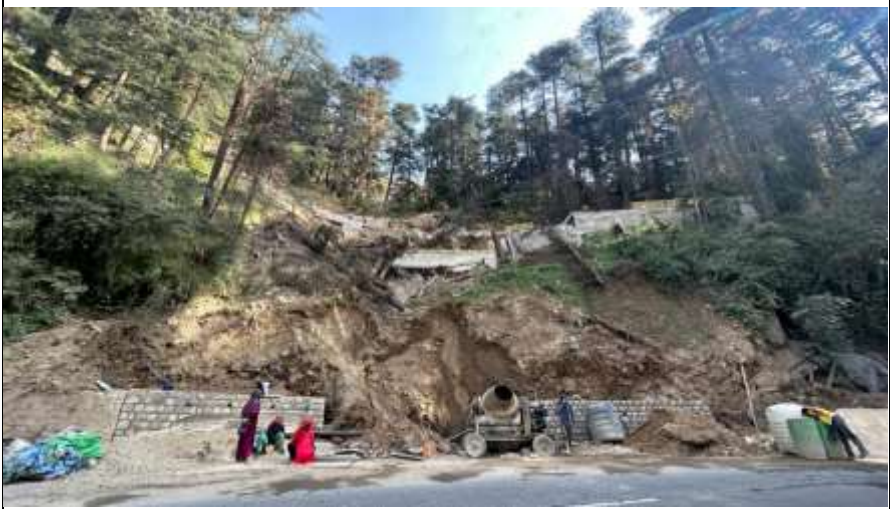
40	Summary/Abstract	<p>The slide was primarily caused by oversaturation of the unconsolidated overburden material owing to the incessant rains. The debris material charged with large boulders brought down by a flood like situation washing away a major portion of the CPWD road, retaining structures and vehicles on the downslope. The adjoining landmasses on right flank have also been disturbed due the incidence. It has been observed that the adjoining hill masses also suffered moderate landslides of smaller magnitude. It was observed that the area was still damp and the ground water was very shallow at the site. Landslide is a result of rotational mass failure occurred due to slope failure of unconsolidated slope material and saturation due to rainwater ingress and excessive erosion by the nalas. A retrogressive rotational failure is confirmed by presence of tension cracks at the crown of the slide as confirmed by the locals. The slide is retrogressive and enlarging in nature and confirmed by the development of tension cracks on the upslope. Remedial measures including proper channelization for water to avoid its further ingress at the earliest away from the sliding zone and the benching in uphill debris mass as well as in rock mass have been suggested.</p>

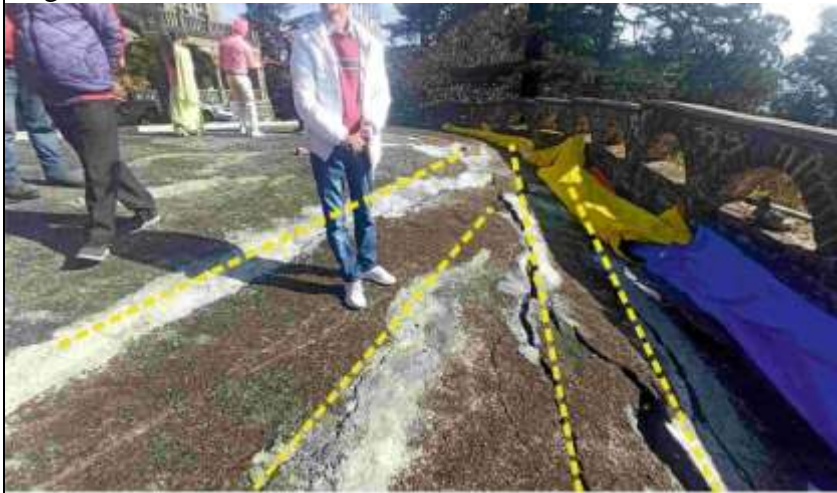
<p>Easterly facing affected zone.</p>

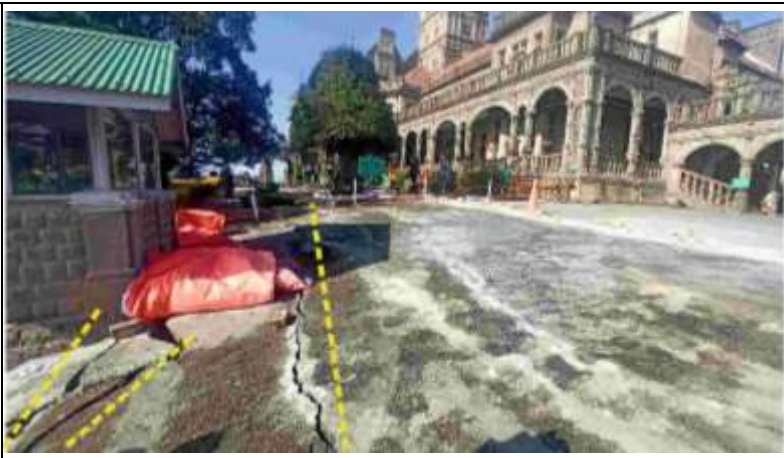
<p data-bbox="598 645 1385 683">Westerly facing affected zone</p>
41	Pdf	Attached
42	Landslide category	II

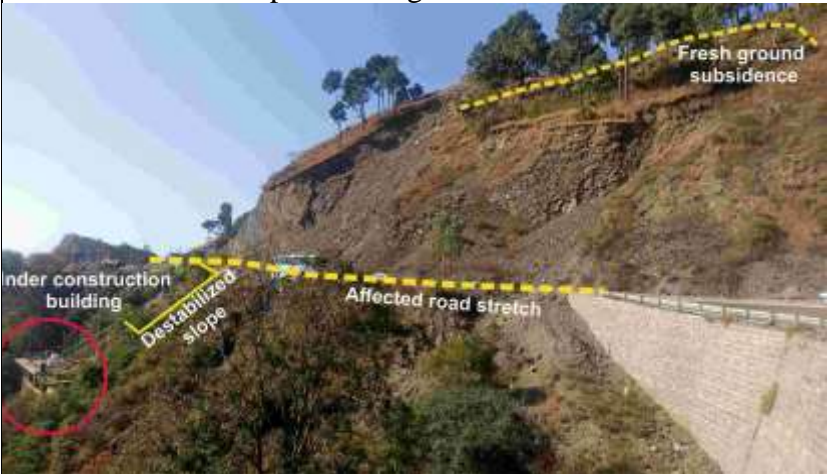
<p>Affected road stretch and downslope area</p>
41	Pdf	Attached
42	Landslide category

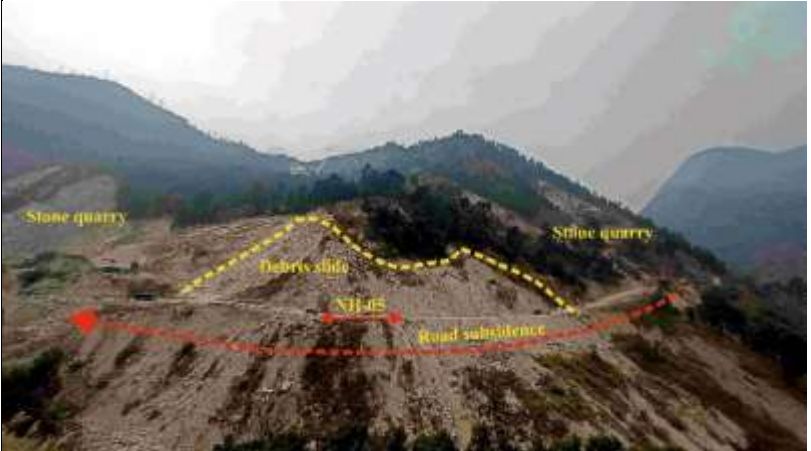
<p>Panaromic view of the landslide affected stretch to NH-05</p>
41	Pdf	Attached
42	Landslide category	II

<p>provided above the crown of the landslide to divert runoff water.</p> <ol style="list-style-type: none"> 4. The settlements below the road level towards Jhakri side needs to be monitored for any ground cracks or any damage to the building. The drain water from individual houses must be channelized effectively to avoid any ground water saturation. 5. In order to monitor small levels of ground creep, installation of a geodetic system may be considered at first in consultation with site geologist/ geotechnical engineers. 6. The surrounding area susceptible to further slope failure along with the buffer zone may be identified and no new construction/ mining activity or slope modification work should be carried out in this zone. 7. In view of the instability conditions along this road stretch, possibilities for realigning the road through the safer/ stable slopes must be taken into consideration. To avoid this unstable zone, the right bank of River Sutlej can be explored for an alternate road connectivity. 8. The area is highly fragile in nature and bears a complex geological problem due to the presence of NW-SE trending thrust zone and thus formulating any long-term remedial measure needs a Detailed Geological & Geotechnical Investigation.

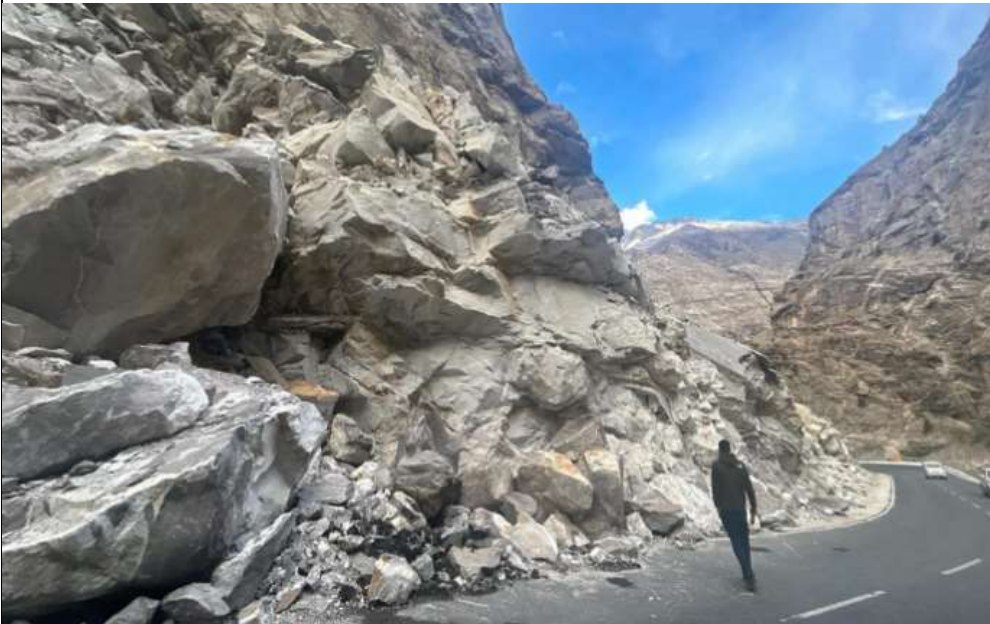
40	Summary/Abstract	The rock-fall area is located on the left bank of Satluj River, constitutes a steep sun-facing hill slope. The rock-fall, in fact rock wedge failures frequently occurs in the upper part of a major escarpment represented by highly jointed quartzite and phyllite of Morang Formation of Vaikrita Group intruded by Nako Granite.

The rocks are highly fractured due to different sets of joints transforming them in a distress rock mass, particularly the valley dipping joints and the foliation joints which leads to different wedge (J2 & J3) as well as planar (J1) failures in the area.
41	Pdf	
42	Landslide category	II

26	Structure	
27	Land use/ Land cover	Barren land
28	Hydrological condition	Dry
29	Triggering Factor	Anthropogenic activity for road cutting.
30	Death of persons	Nil
31	People affected	Local villagers and daily commuters.
32	Live-stock loss	Nil
33	Communication	NH-505
34	Infrastructure	
35	Agriculture/forest/ Barren	Barren
36	Geo-scientific causes	Steep road cutting for road widening Inadequate slope support
37	Remedial measures	Rock bolting, Shotcrete, scaling of the upslope area.
38	Remarks, if any	
39	Photos. Sketch of Plan & section of the slide
