## Landslide Compendium of Northwestern Himalayas

विशेष प्रकाशन संख्या 107  
SPECIAL PUBLICATION No. 107

भारतीय भूवैज्ञानिक सर्वेक्षण  
GEOLOGICAL SURVEY OF INDIA

कोलकाता, 2016  
**Kolkata, 2016**

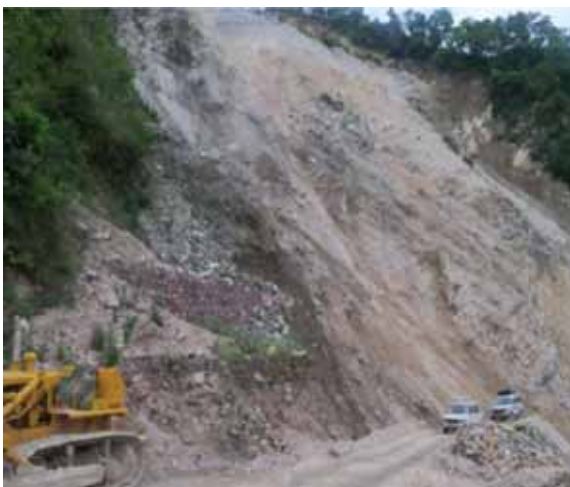
**Middle part of Sirohbagar (Kaliyasaur) Landslide near Srinagar (Pauri Garhwal)**

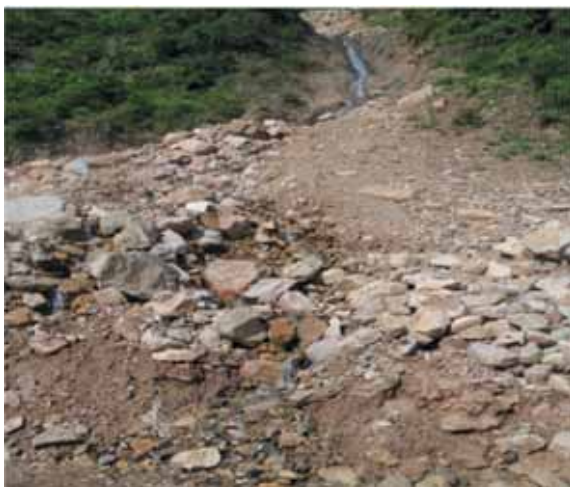
**Debris floe along nala channel at Naulapani (Tilwara -  
Rudraprayag)**

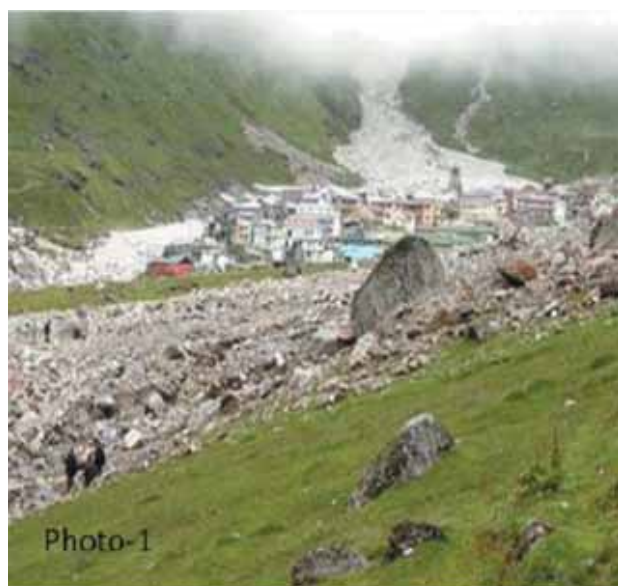
**Panoramic view of Kedarnath Area (Post Disaster)**

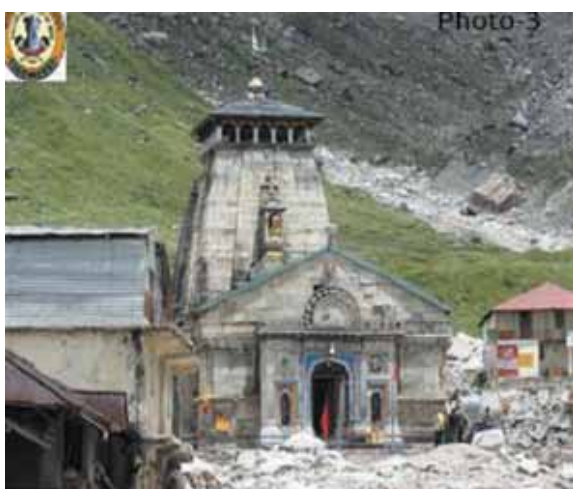
Kedarnath Temple (Post Disaster)

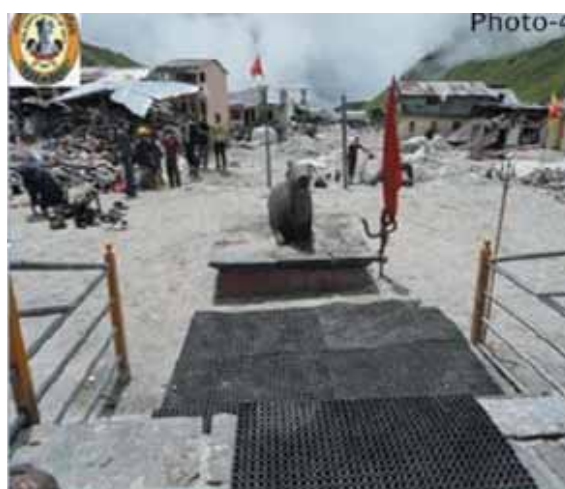
Market Area near Kedarnath Temple (Post Disaster)

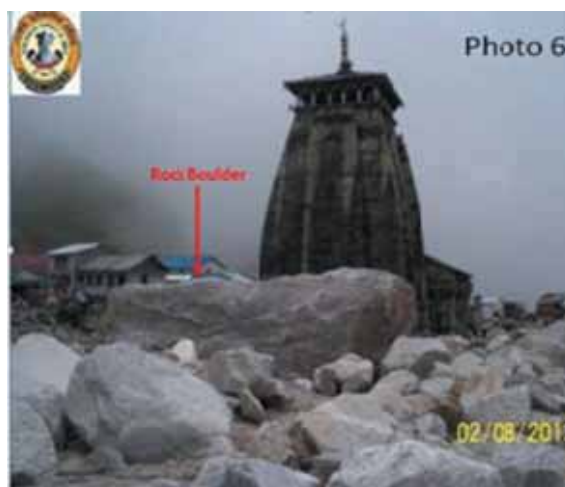
Closeview from backside of the temple along with the Rock Boulder which saved in Temple

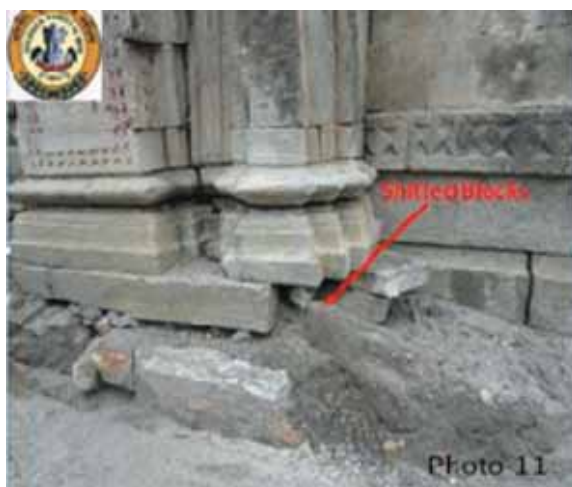
Dislodgement of blocks from the basal part of the temple

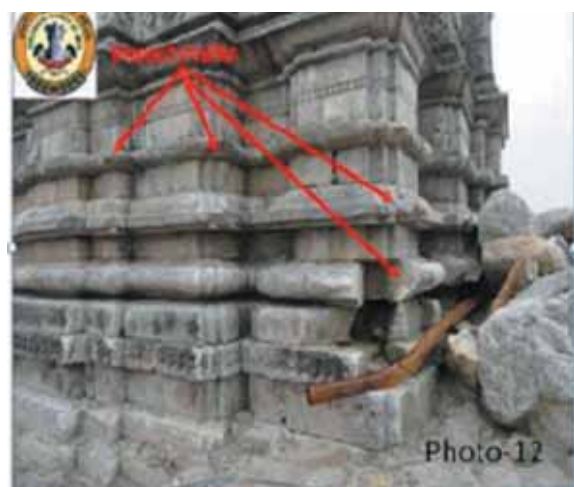
Impact marks on northeastern part of the temple
