**A site visit report on Short and Long term mitigation measures for
landslides and land subsidence across Sirmaur district in the state of
Himachal Pradesh**

**Submitted to
Himachal Pradesh State Disaster Management Authority (HPSDMA)
Himachal Pradesh**

**Submitted by
Geotechnical Engineering and Geo-Hazard Group
CSIR-Central Building Research Institute
Roorkee-247667, Uttarakhand**

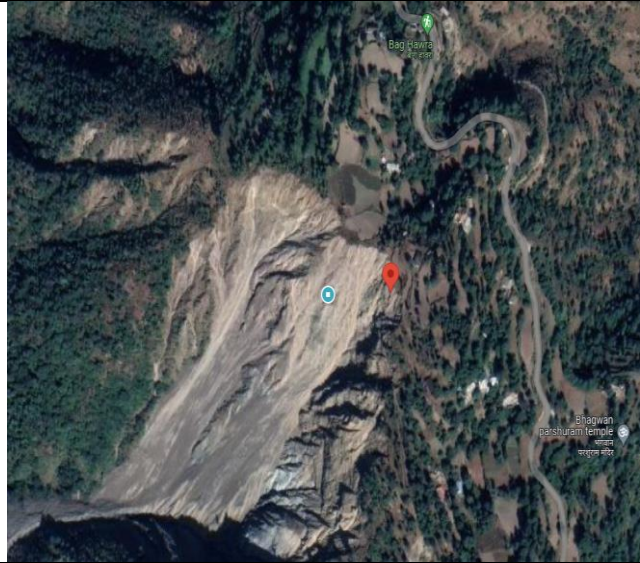
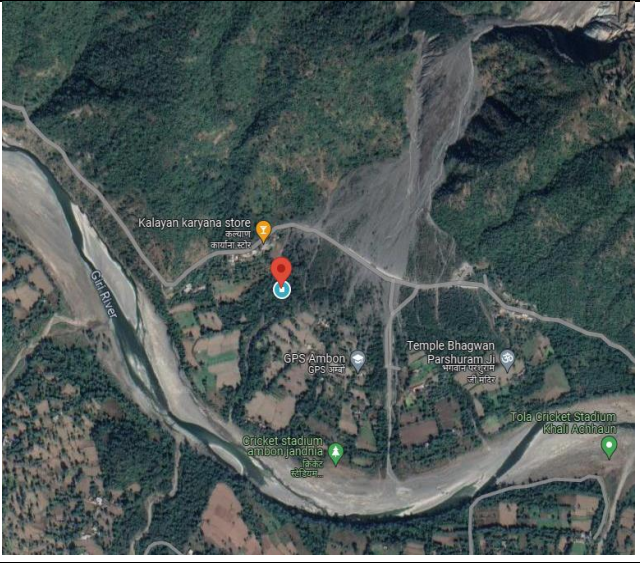
Bag Habra site, Kaffota subdivision (houses, residential building 7 land on head of slide)	Ambon & Jandniya site, Chandni Panchayat, Kaffota Subdivision (road & habitation near site)

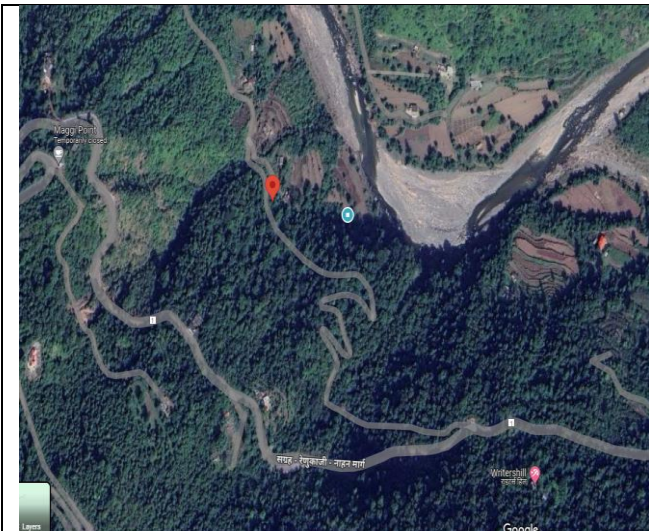
Malgaon site, Nehli Dheeda Panchayat, Nahan Subdivision

Malgaon site, Nehli Dheeda Panchayat, Nahan Subdivision	Height of slide around 50 m on hill side and 50 m on valley side	Width of site is approximately 50 m	Moderate Steep slope between 50° to 70°	30°36'52.7"N , 77°22'04.3"E	Fine soil with Debris materials, boulders		Water ingress in slope during rains, Building loads on slope, Improper drainage of existing buildings	Work is already going on at site by state department	D.1
Jarog site, Nahan Subdivision	Height of slide around 1500 m on valley side	Width of site is approximately 2000-2500 m	Steep slope between 60° to 80°	30°38'09.9"N , 77°28'03.0"E	Highly disintegrated rock mass overlain by a thick layer of soil mix boulder matrix	Not chronic	Water ingress in slope during rains, Building loads on slope, Improper drainage of existing buildings & crop watering on slope, Toe cutting by river	Provision of drainage holes, drainage paths, culverts etc. along the slide. River training works at toe, Piling near terrace, Self-drilling anchors, Retaining structures, bioengineering etc. Building condition survey (BCS) for existing infrastructure, Regular monitoring of slope, emergency evacuation and rehabilitation plans	D.2

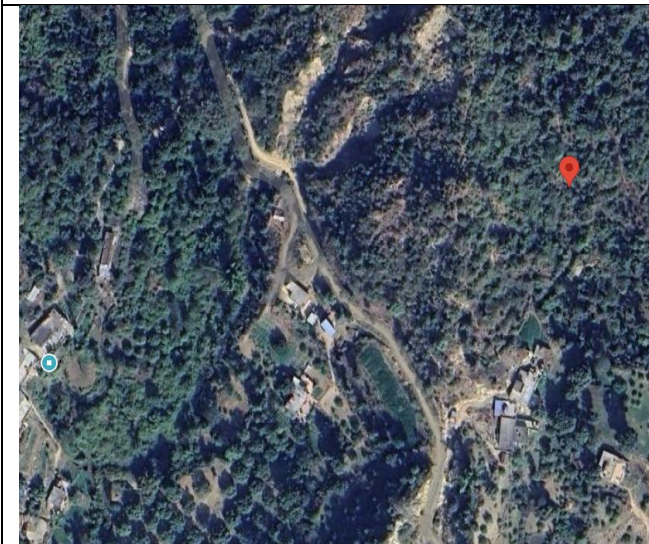
Agdiwala site, Mattar panchayat, Nahan Subdivision (Location 1)

Agdiwala site, Mattar panchayat, Nahan Subdivision	Height of slide around 100 m , Length of site is approximately 1000-2000 m at location 1	Height of slide around 30-50 m , Length of site is approximately 150-250 m at location 2	Moderately Steep slope between 60° to 80°	30°28'11.9"N, 77°22'56.9"E (Location 1) and 30°28'09.3"N , 77°22'45.4"E (Location 2)	Low plasticity clay and silt, sand	Not chronic	Water ingress in slope during rains, Building loads on slope, Improper drainage of existing buildings & crop watering on slope	Provision of drainage holes, drainage paths, culverts etc. along the slide. Self-drilling anchors, Retaining structures, bioengineering etc. Building condition survey (BCS) for existing infrastructure, Regular monitoring of slope, emergency evacuation and rehabilitation plans	D.3

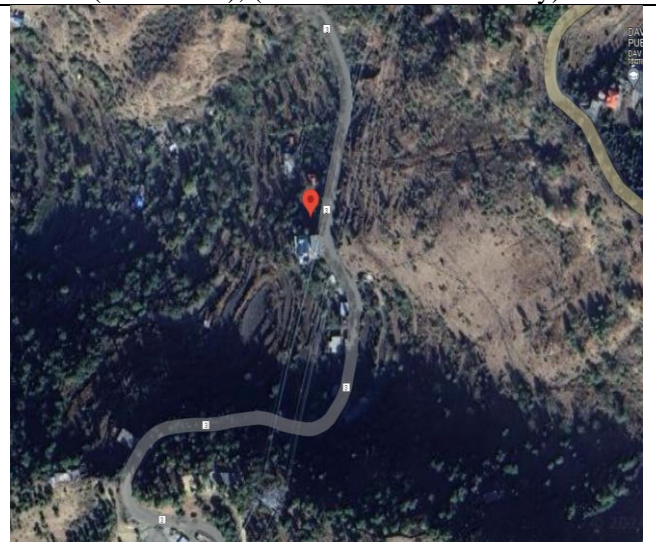
Shallana site, Rajgarh Subdivision (major road being affected)

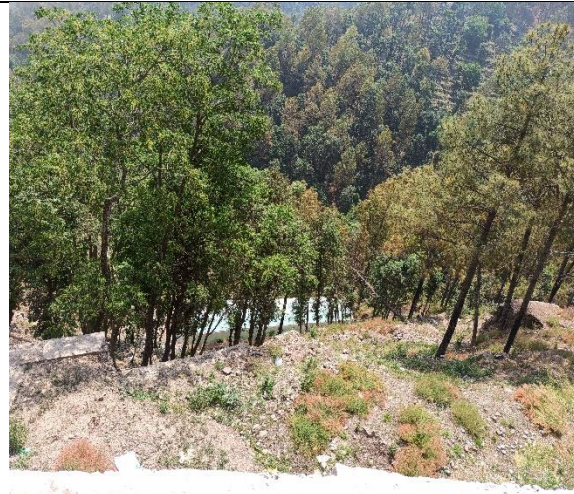
Fig. 4 Agricultural land and structures existing on valley side

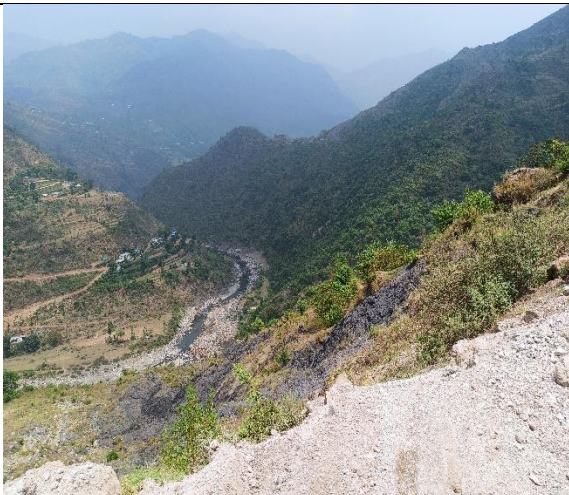
Fig. 5 Giri river cutting the toe of slide

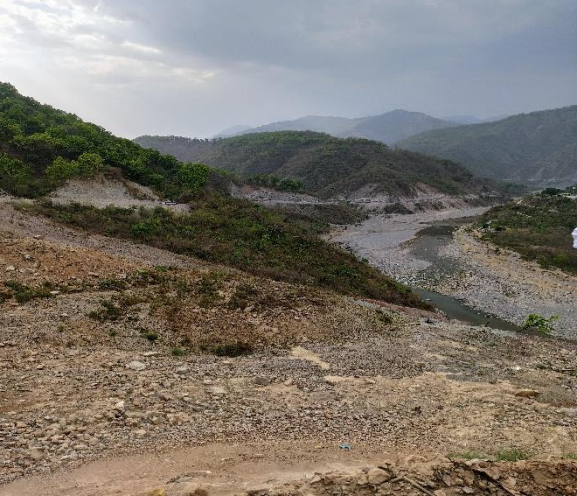
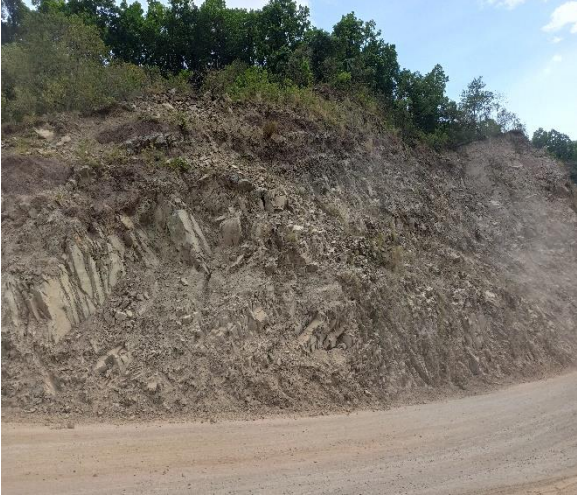
<p>Fig. 3 Toe cutting by river at base of landslide</p>	<p>Fig. 4 High rock fall potential at site</p>

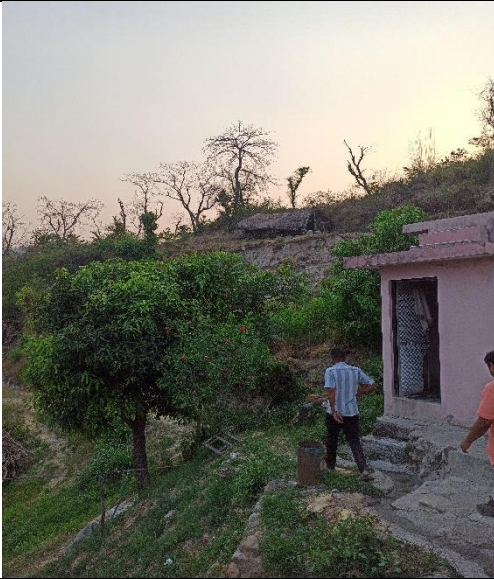
Fig. 3 Residential habitation near site (location 2)

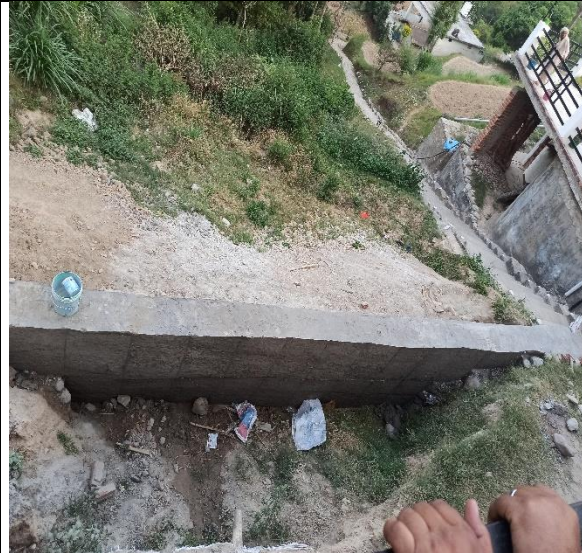
Fig. 4 Building load on site (location 2)

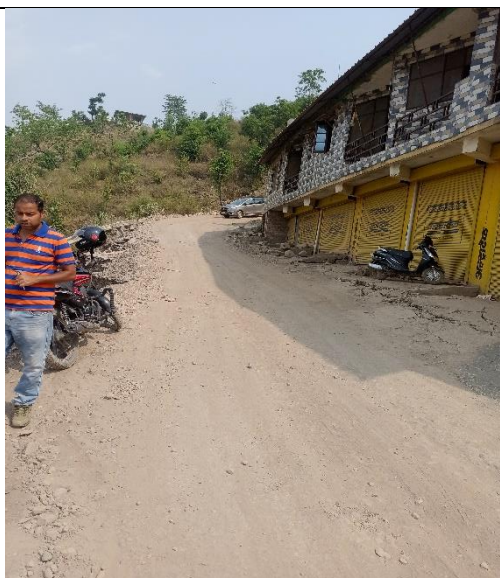
the major district road and 2-3 multistoried buildings on the hill side. This heavy building loads may lead to further instability of the slope. In addition to fines with debris material, boulders are also present on the site and may lead to rock fall. Valley side instability has led to erosion of the road and its settlement affecting traffic flow. Presence of river near toe slope can have detrimental effect on slope when water level in river is high. It was informed by local officials that this slide is not chronic.

Fig. 1 Major district road and multistoried buildings

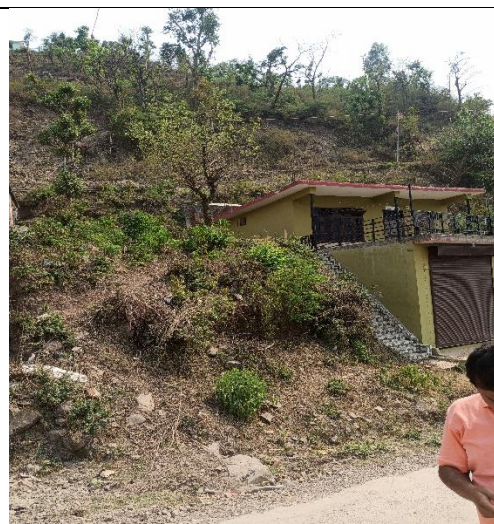
Fig. 4 Rock fall potential at site

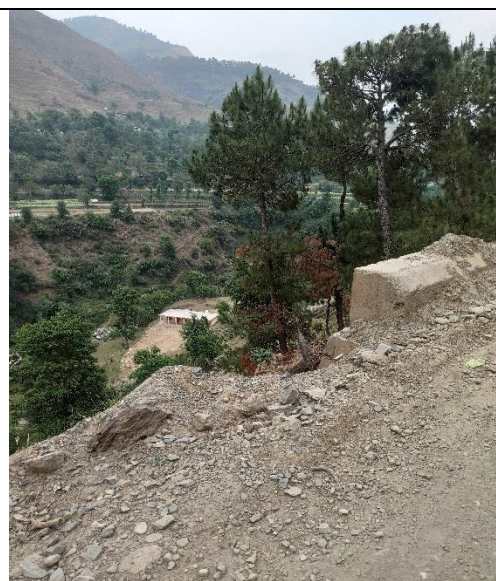
Fig. 2 Habitation and school present on the valley side

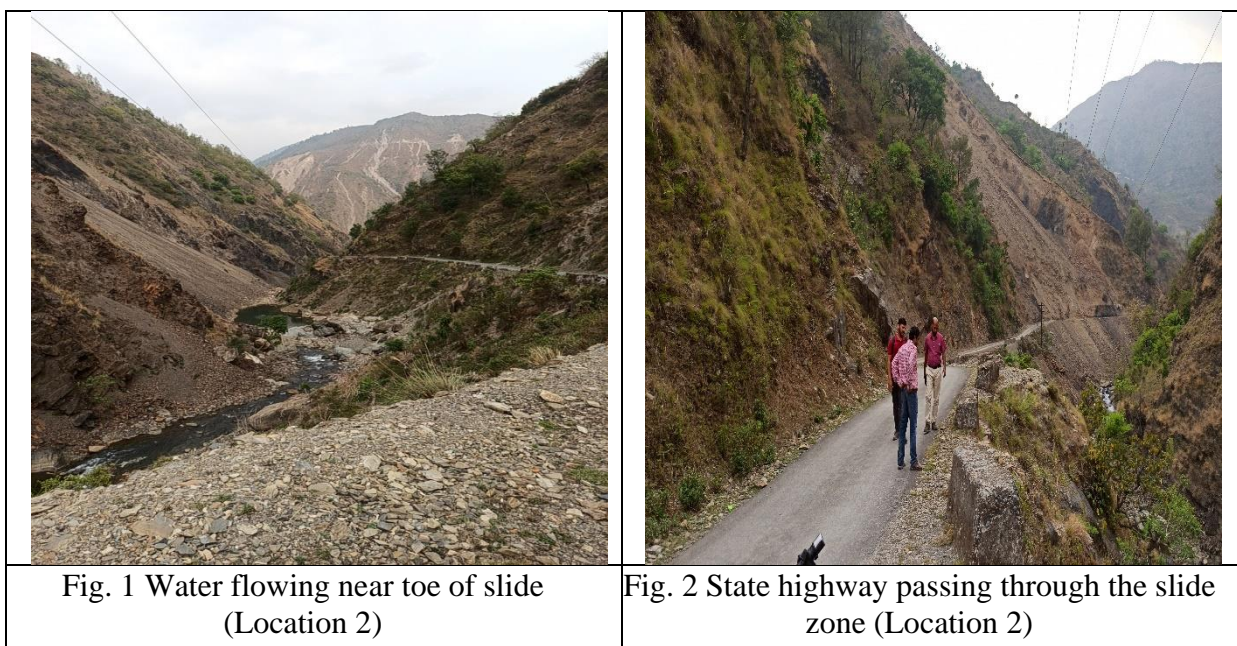
Location 2 indicates massive failure of slope with presence of thick layer of debris material and disintegrated rock mass at different locations. Presence of free thick layer of debris on the slope and boulder outcrops indicate the potential for rock fall and shooting stones. Massive hill cutting was observed at site due to landslide with visible overburden. This has further weakened the slope and more slides may happen with increase in moisture content of strata during rains. Further at some stretches, instability of valley side is observed leading to settlement and displacement of the passing state highway. Detailed investigation of this slide is necessary for smooth movement on this state highway. No mitigation measures were observed to be implemented on site. Water flowing near toe of slide may cause toe cutting and further instability of the slope. During rainy season, the slope shall become more susceptible to failure due to water ingress.

Perforated drainage holes, lined stepped down drains (preferably with geosynthetic), culverts and other drainage measures may be employed to reduce probability of any potential slide and increase ground stability. For location 1, on the hill side slope, self-drilling anchors, retaining wall and rock net may be installed. On the valley side river training works and retaining wall structure may be required.
